ARBORIST REPORT

Prepared For: Craig & Caitlin Hornsby
15 Morningside Place
Alamo, CA 94507

SUPPLEMENTAL REPORT

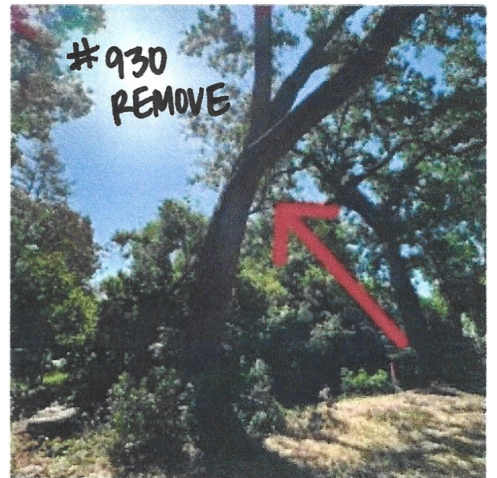
#930
REMOVE

- This tree was also a volunteer that was overcrowded and grew with excessive lean and poor structure. This tree is located next to tree stump #929 which caused it to grow very poorly toward new proposed construction. I recommend this tree be removed.

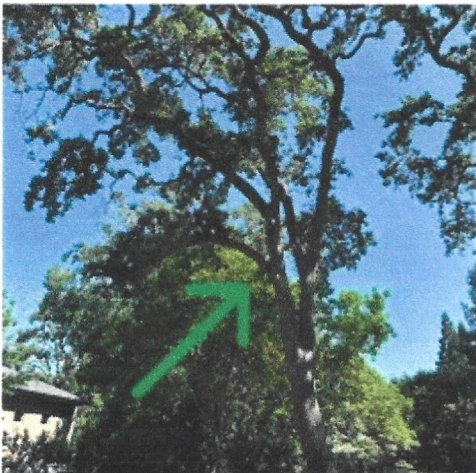
#935 PRESERVE

- Tree is healthy with growth and no concerns. I also recommend trimming the widespread of its canopy to accommodate for newly proposed construction and

upcoming structures. This tree will continue to thrive after clearance cuts. I recommend tree to be preserved during construction, following guides of the tree protection zone or TPZ.

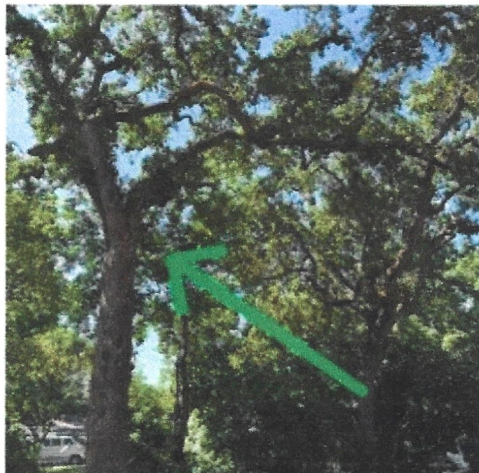
#933 PRESERVE

- Tree is healthy with growth and no concerns. I recommend trimming the widespread of its canopy to accommodate newly proposed construction and upcoming structures. This tree will continue to thrive after clearance cuts. I recommend tree to be preserved during construction, following guides of the tree protection zone or TPZ.

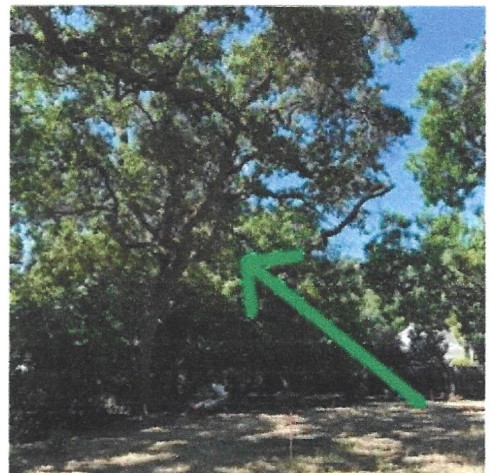
#934 PRESERVE

- Tree is healthy with growth and no concerns. I also recommend trimming the widespread of its canopy to accommodate for newly proposed construction and upcoming structures. This tree will continue to thrive after clearance cuts. I recommend tree to be preserved during construction, following guides of the tree protection zone or TPZ.
