Tree Evaluation

Bradley and Lesley Wolff

532 Hemme Avenue

April 18, 2024

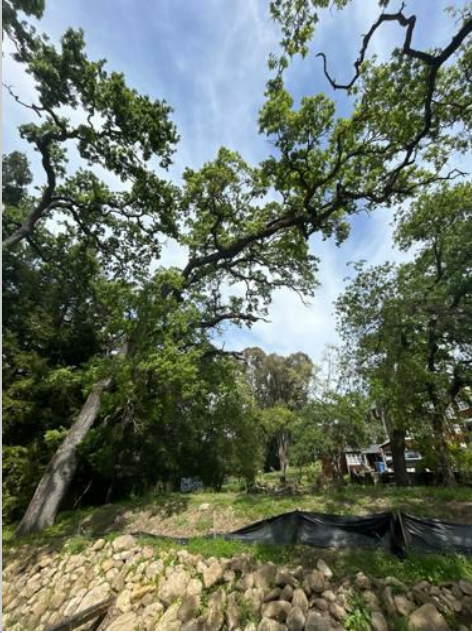
Quercus lobata ID# 1
Valley Oak
Height: 46'-60' DBH: 50.2
Health: 40% - Poor

My conclusion is that there is no safe way to prune these trees to make them safe. The neighbors that these trees border, and you, all have concerns about the recent limb failures and the frequencies at which they are failing. Because of the location to your neighbor's properties, the size of each tree, age, and condition I do recommend removing all three trees before they fail and cause harm to people and property.

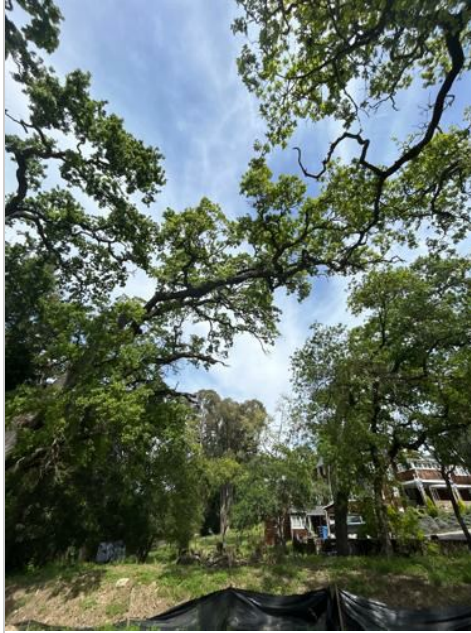
Quercus lobata ID# 1
Valley Oak
Height: 46'-60' DBH: 50.2
Health: 40% - Poor

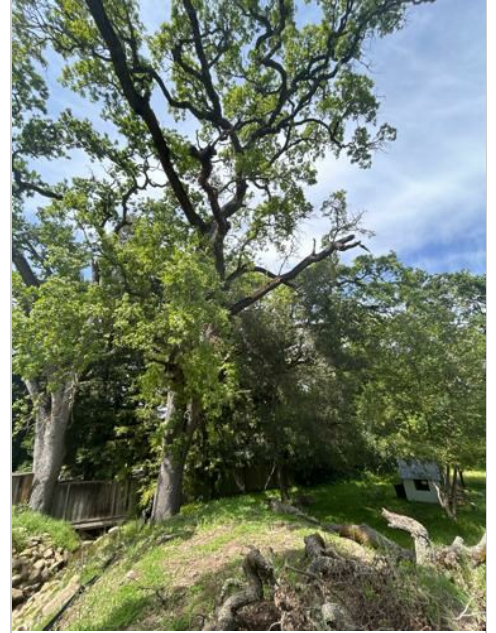
Quercus lobata ID# 1
Valley Oak
Height: 46'-60' DBH: 50.2
Health: 40% - Poor

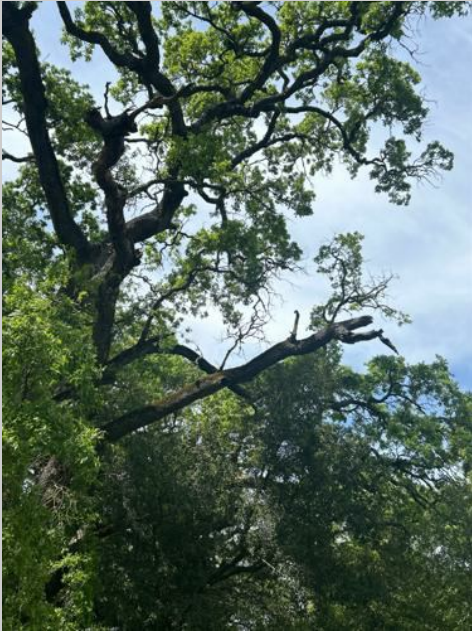
Quercus lobata ID# 1
Valley Oak
Height: 46'-60' DBH: 50.2
Health: 40% - Poor

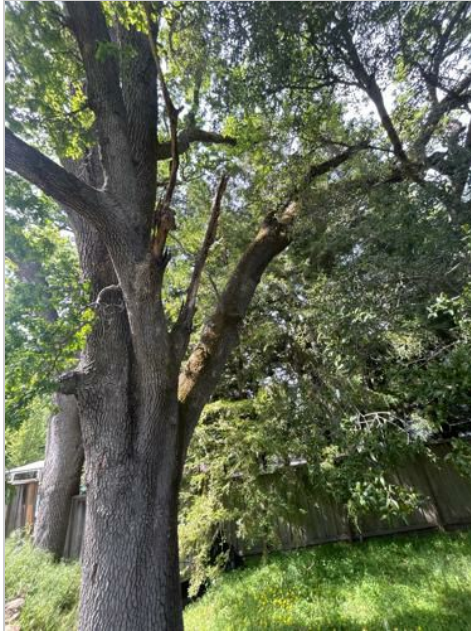
Quercus lobata ID# 1
Valley Oak
Height: 46'-60' DBH: 50.2
Health: 40% - Poor

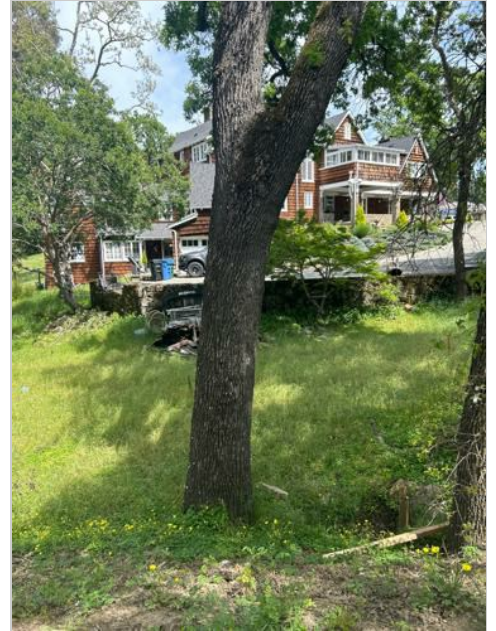
Quercus lobata ID# 2
Valley Oak
Height: 46'-60' DBH: 24"
Health: 40% - Poor

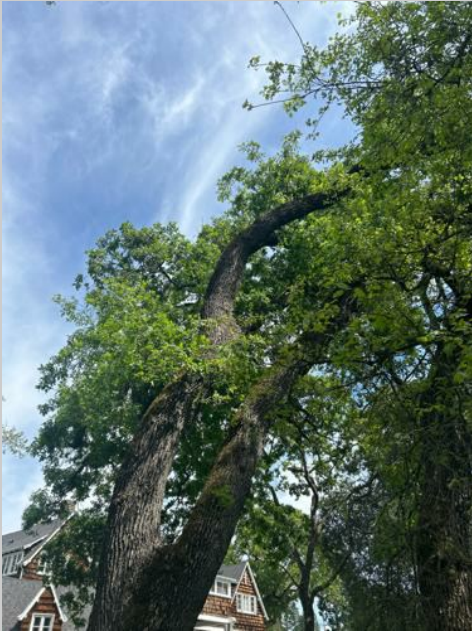
Quercus lobata ID# 2
Valley Oak
Height: 46'-60" DBH: 24"
Health: 40% - Poor

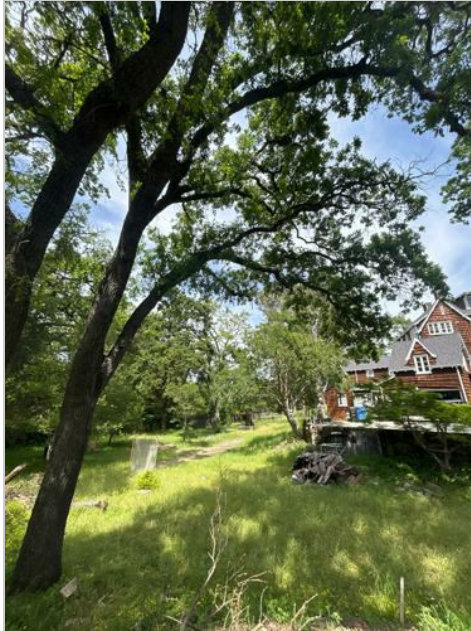
Quercus lobata ID# 2
Valley Oak
Height: 46'-60" DBH: 24"
Health: 40% - Poor

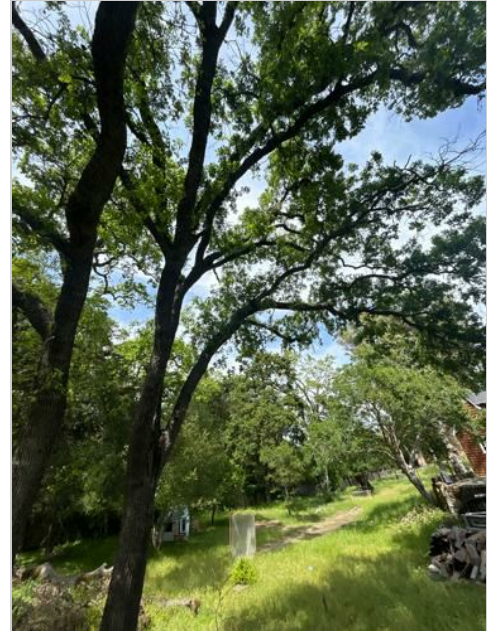
Quercus lobata ID# 2
Valley Oak
Height: 46'-60" DBH: 24"
Health: 40% - Poor

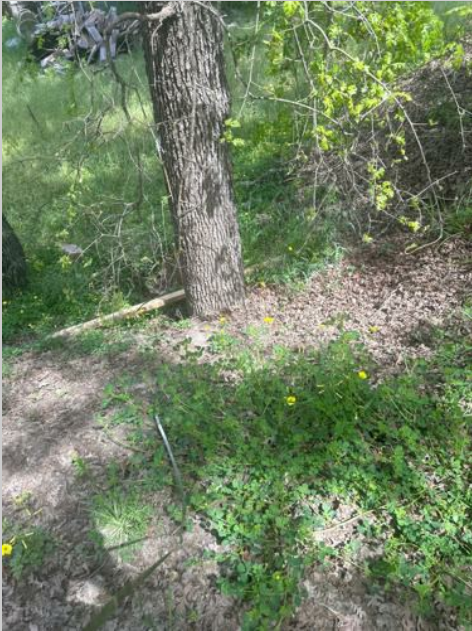
Quercus lobata ID# 3
Valley Oak
Height: 46'-60' DBH: 15.4
Health: 40% - Poor

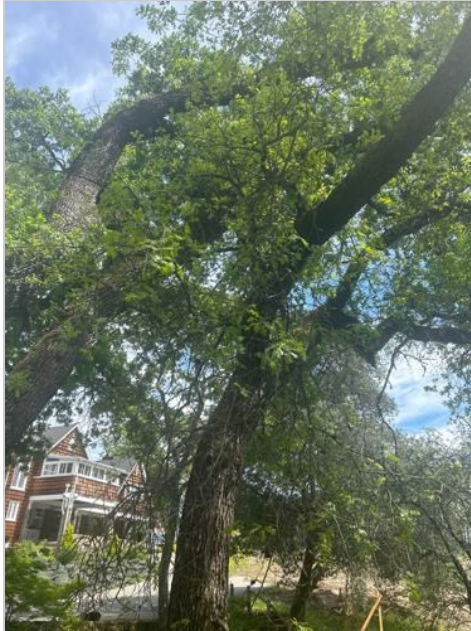
Quercus lobata ID# 3
Valley Oak
Height: 46'-60' DBH: 15.4
Health: 40% - Poor

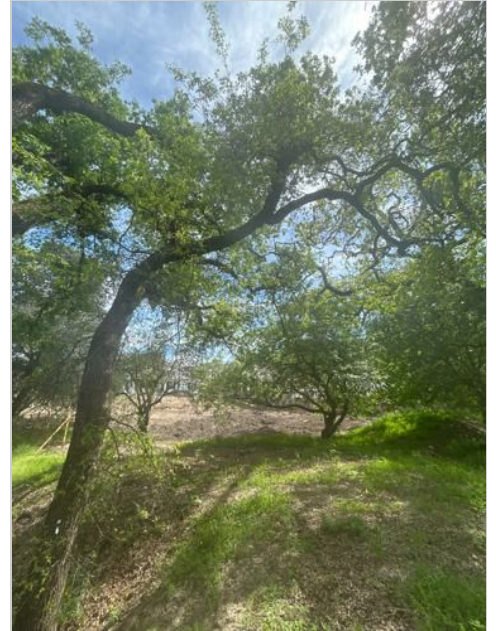
Quercus lobata ID# 3
Valley Oak
Height: 46'-60' DBH: 15.4
Health: 40% - Poor

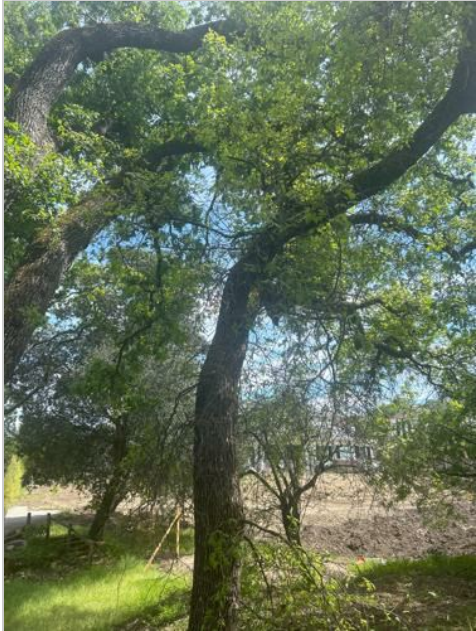
Quercus lobata ID# 3
Valley Oak
Height: 46'-60' DBH: 15.4
Health: 40% - Poor
