# **Assessing Trees at Wither Avenue in Pleasant Hill, CA 94523**

Prepared for:  
Pallav Chatterjee  
Freemont, CA

Submitted by Tony Wayne Wolcott Consulting  
Registered Consulting Arborist #685  
959 Cheyenne Drive,  
Walnut Creek, CA, 94598

August 7, 2022

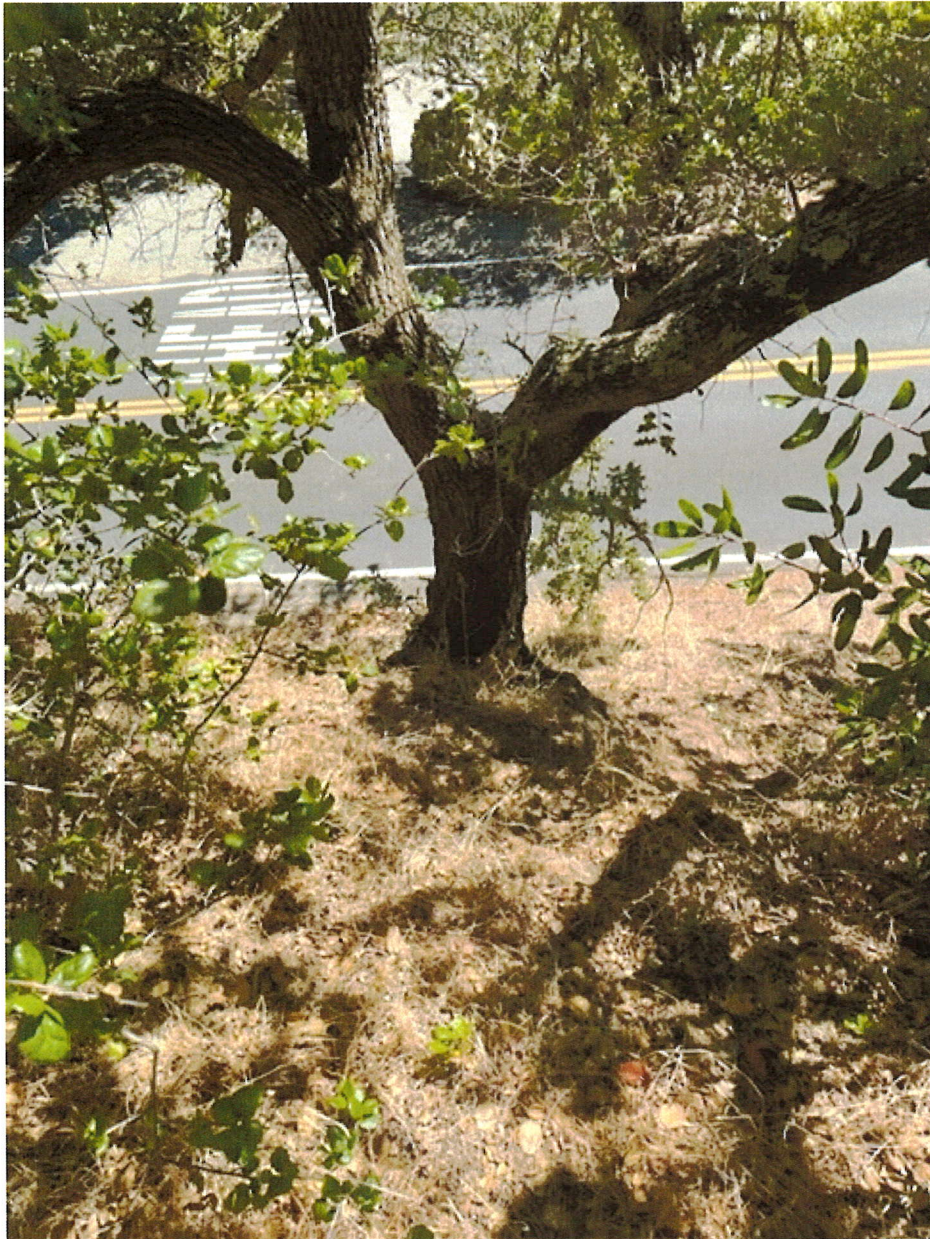
One of many valley oaks, this tree sits above the steep slope of Withers Avenue.

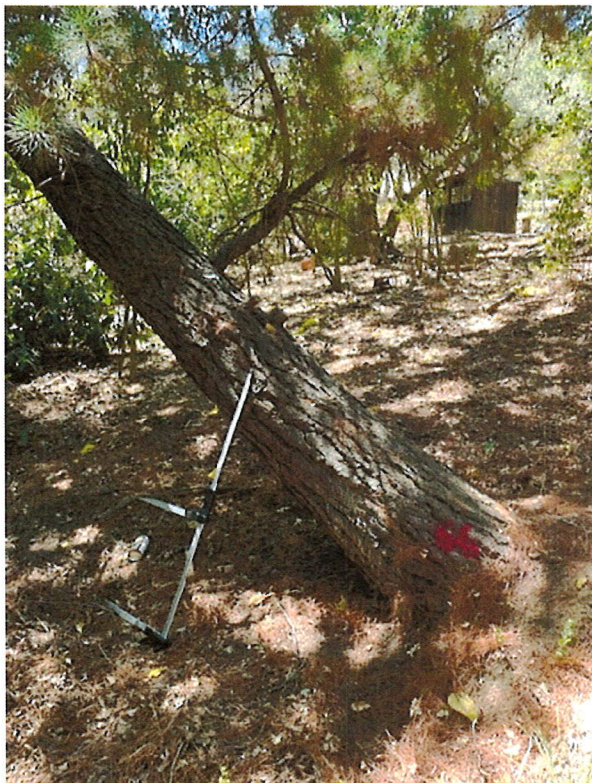
The above photo shows a pine tree falling into the subject property.
