VESTING TENTATIVE MAP SUBDIVISION SD20-9531 1024 & 1026 GRAYSON ROAD

CITY OF PLEASANT HILL, CONTRA COSTA COUNTY, CALIFORNIA

TOTAL UNITS: 10 RESIDENTIAL

VESTING TENTATIVE MAP

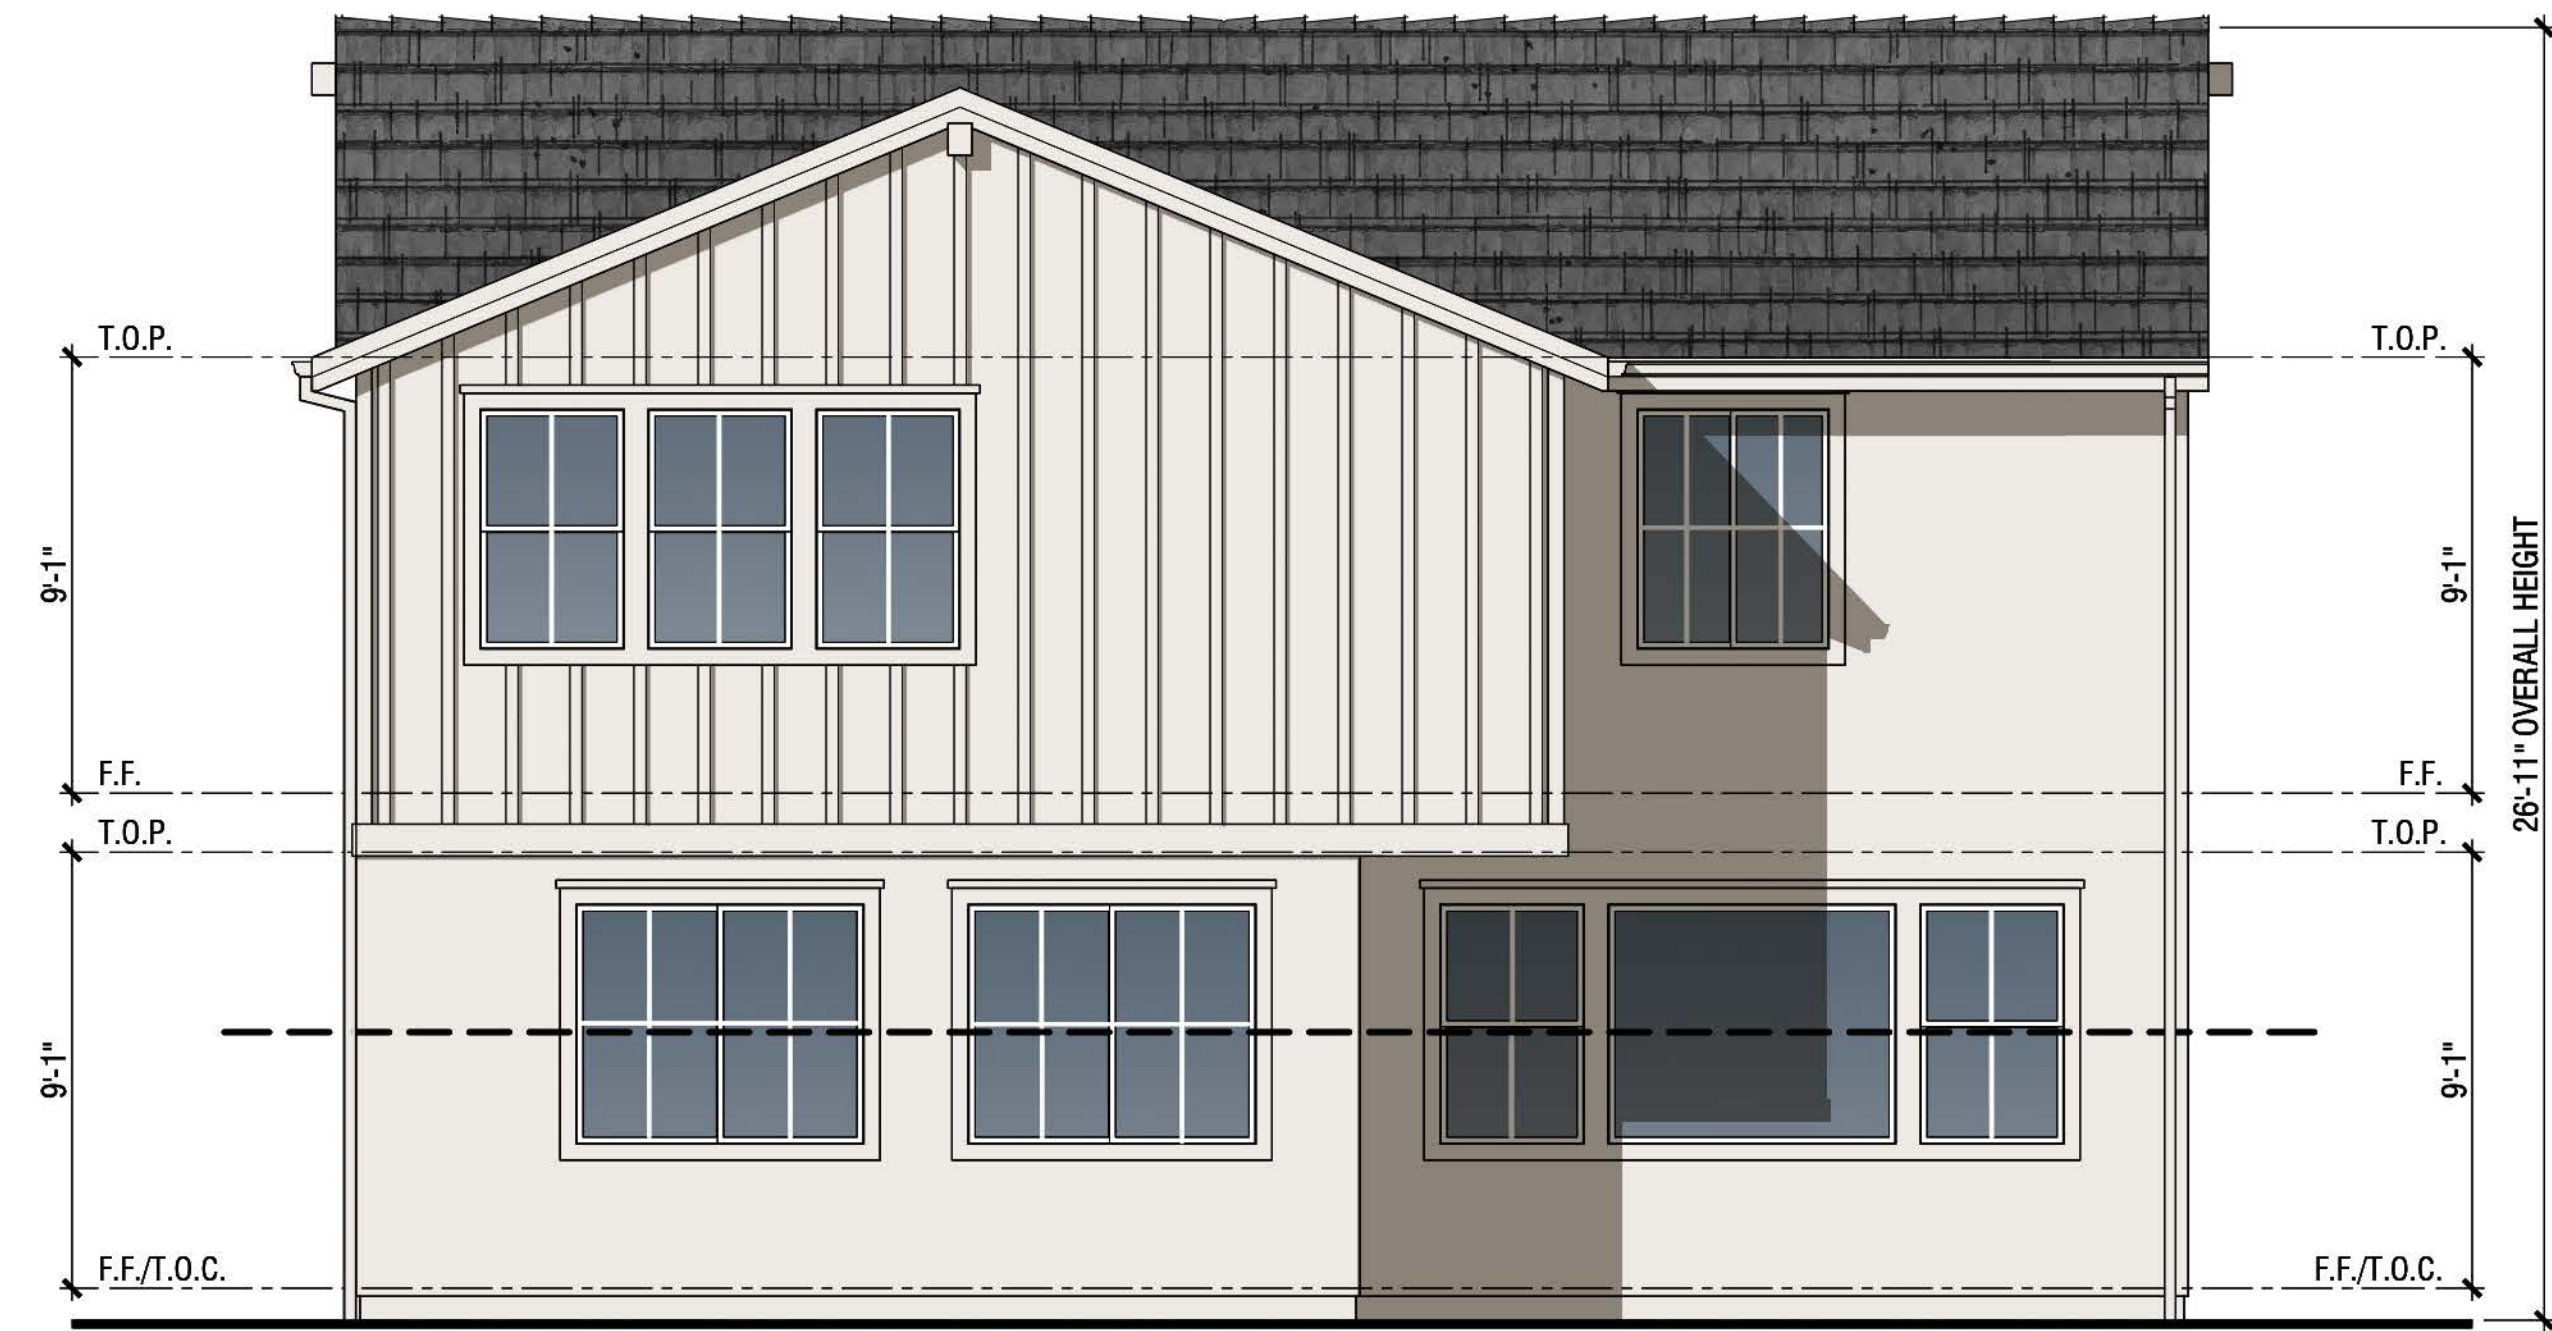
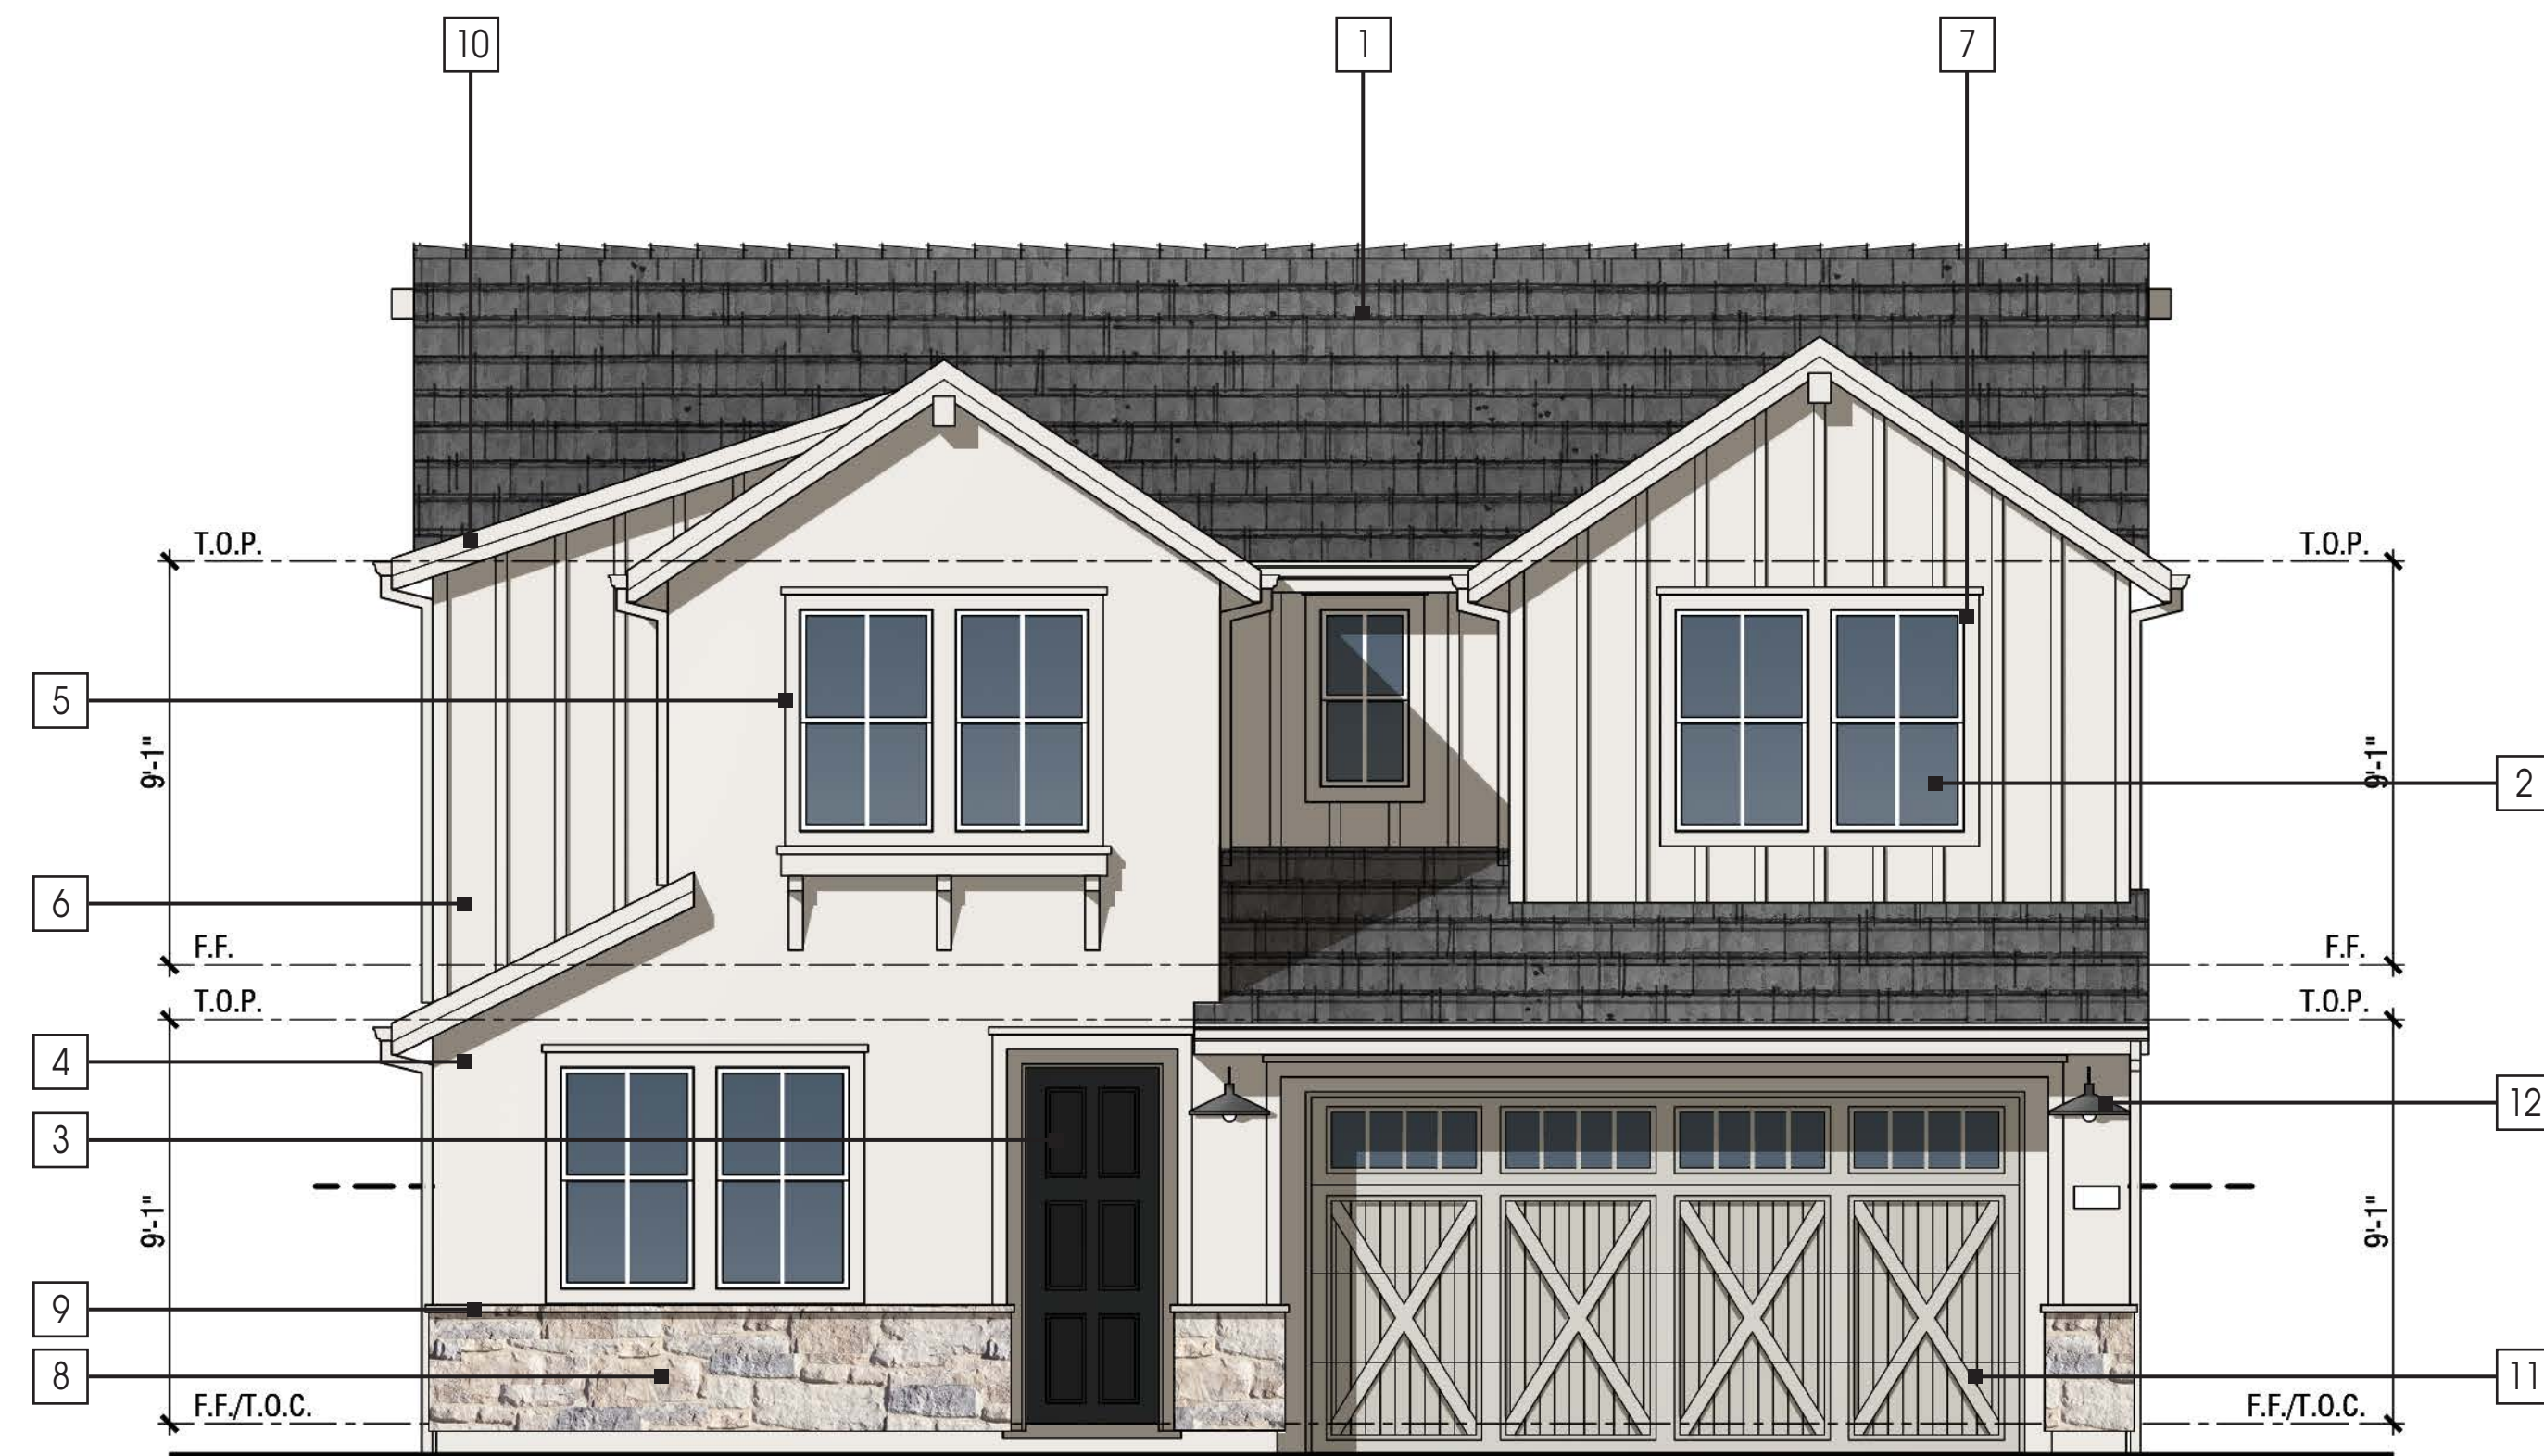
EXTERIOR MATERIALS:
Elevation A - Color Scheme 1

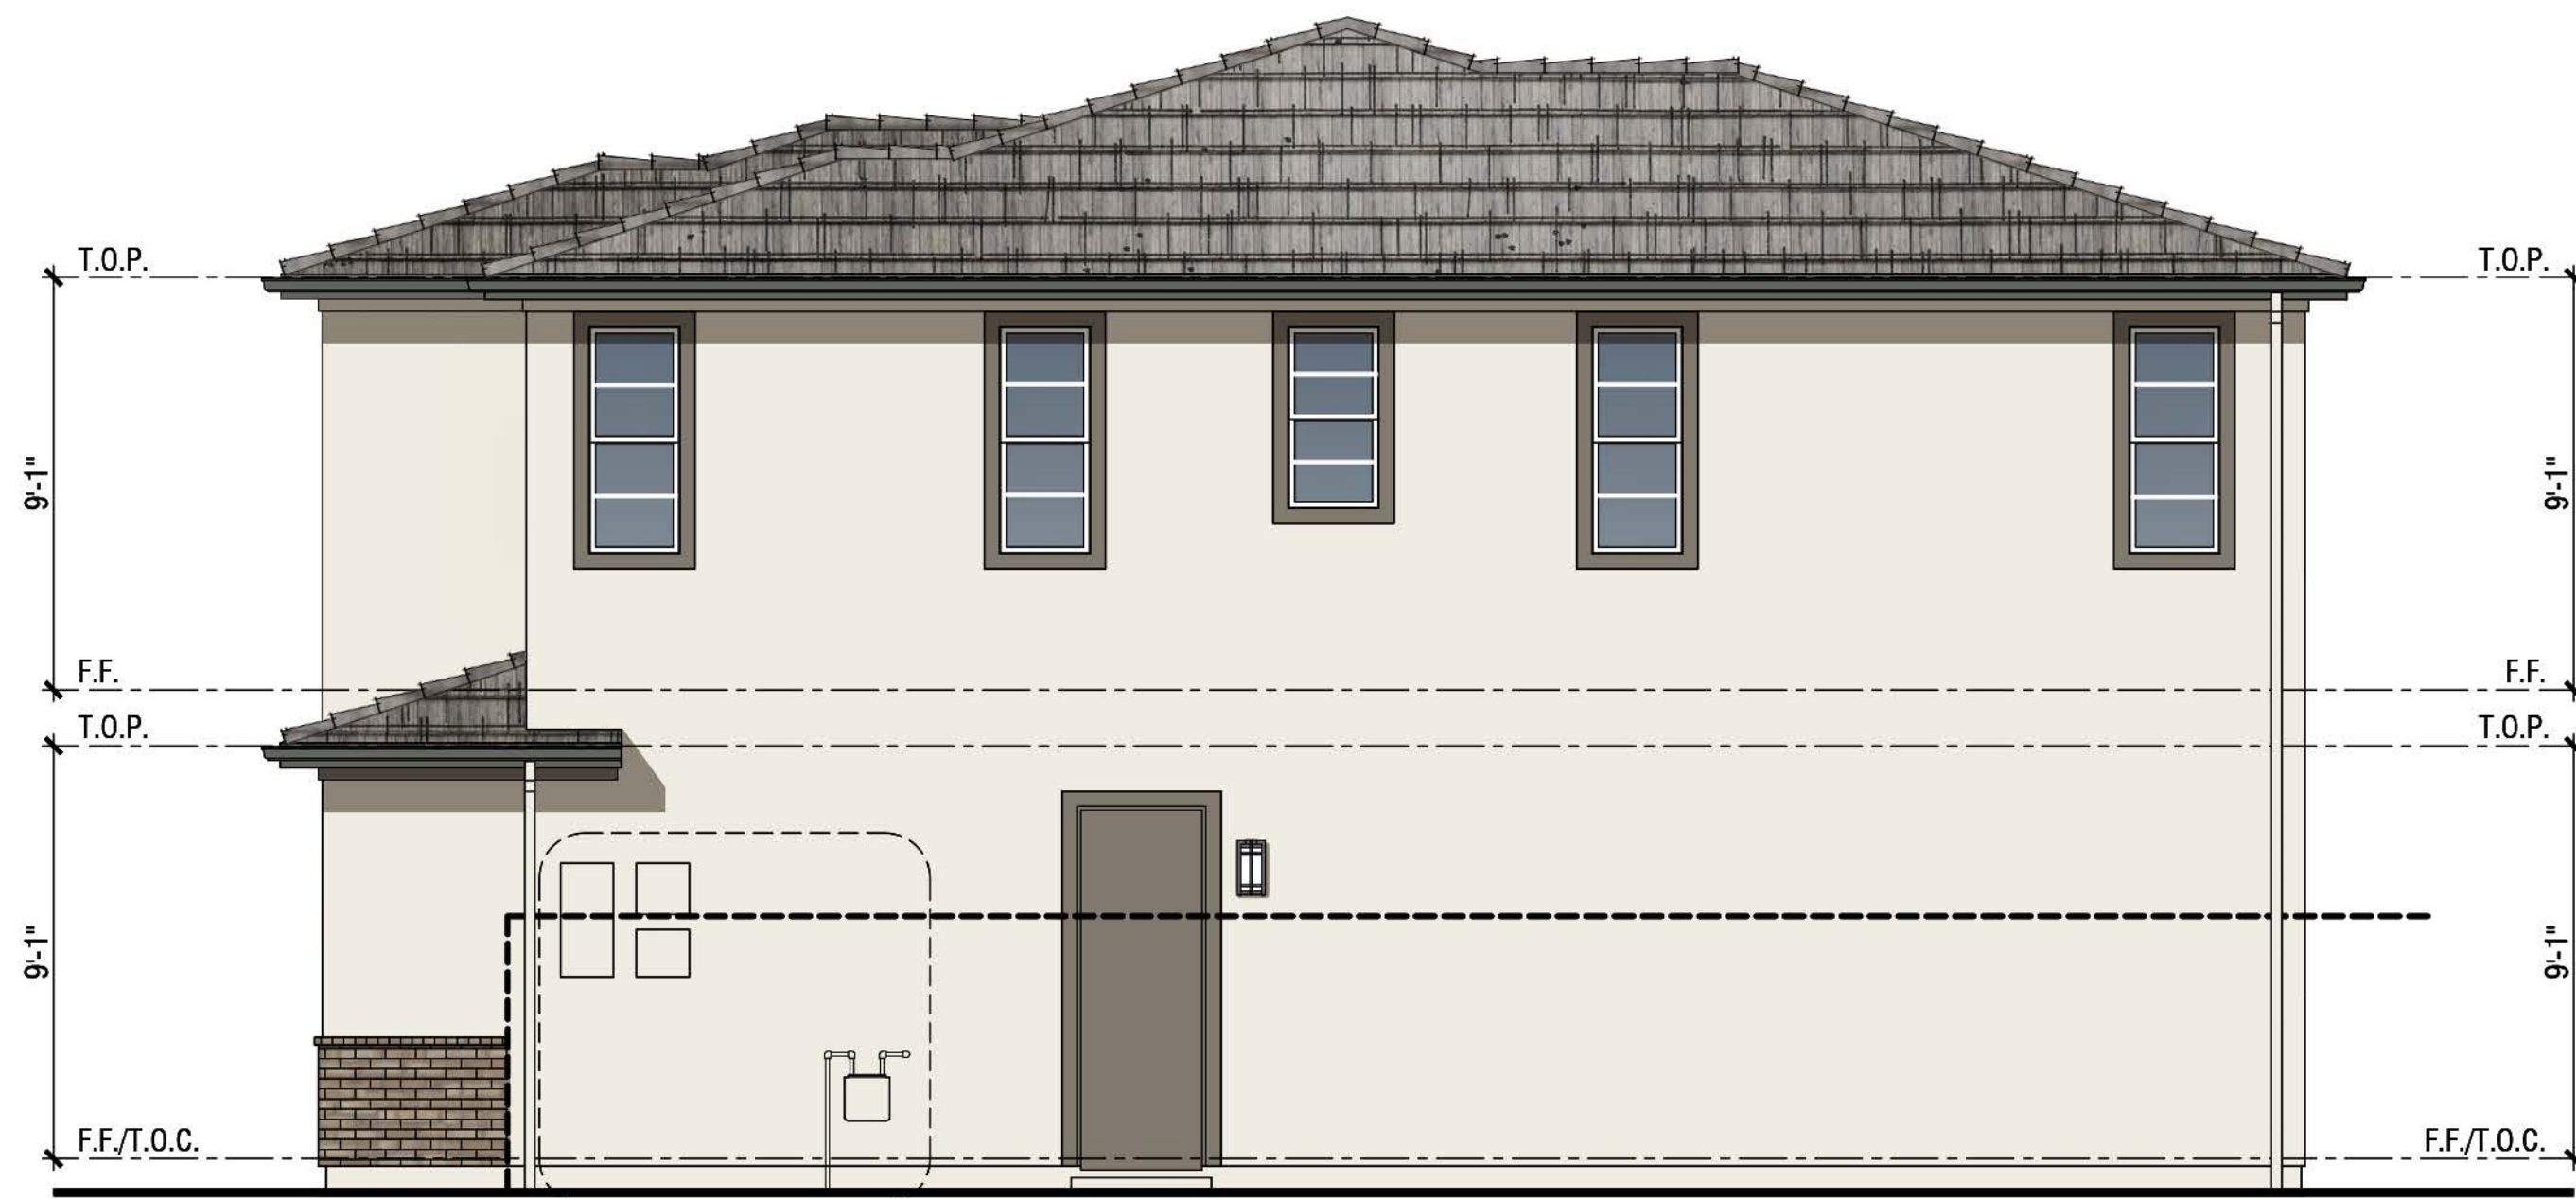
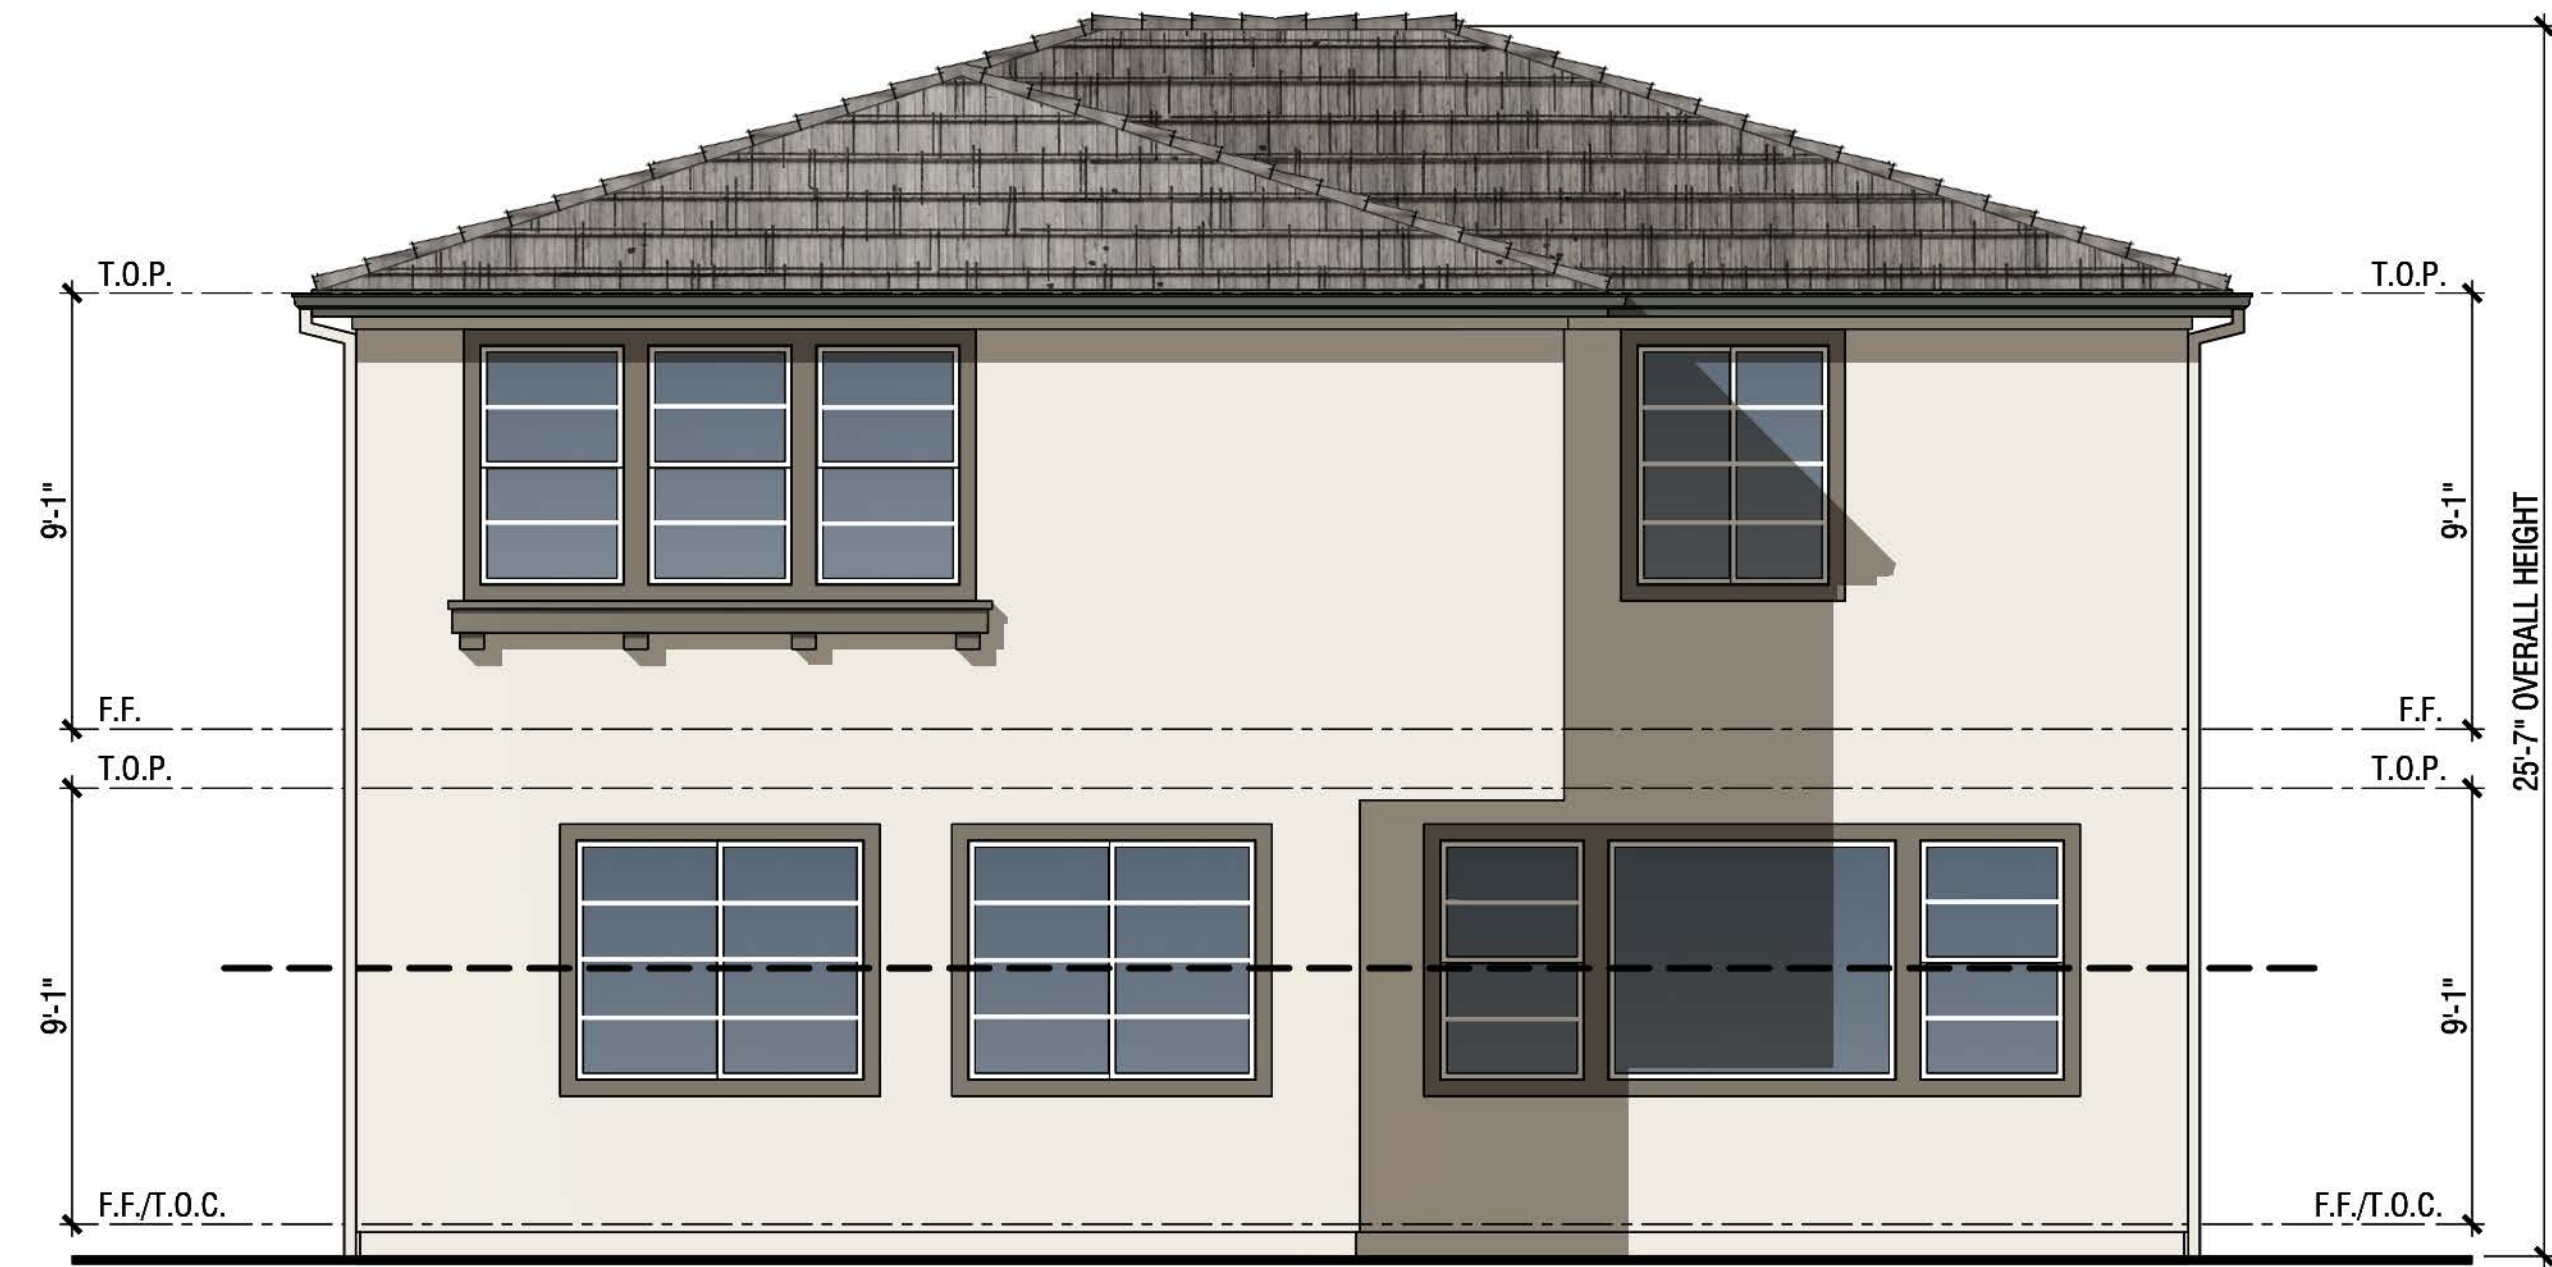
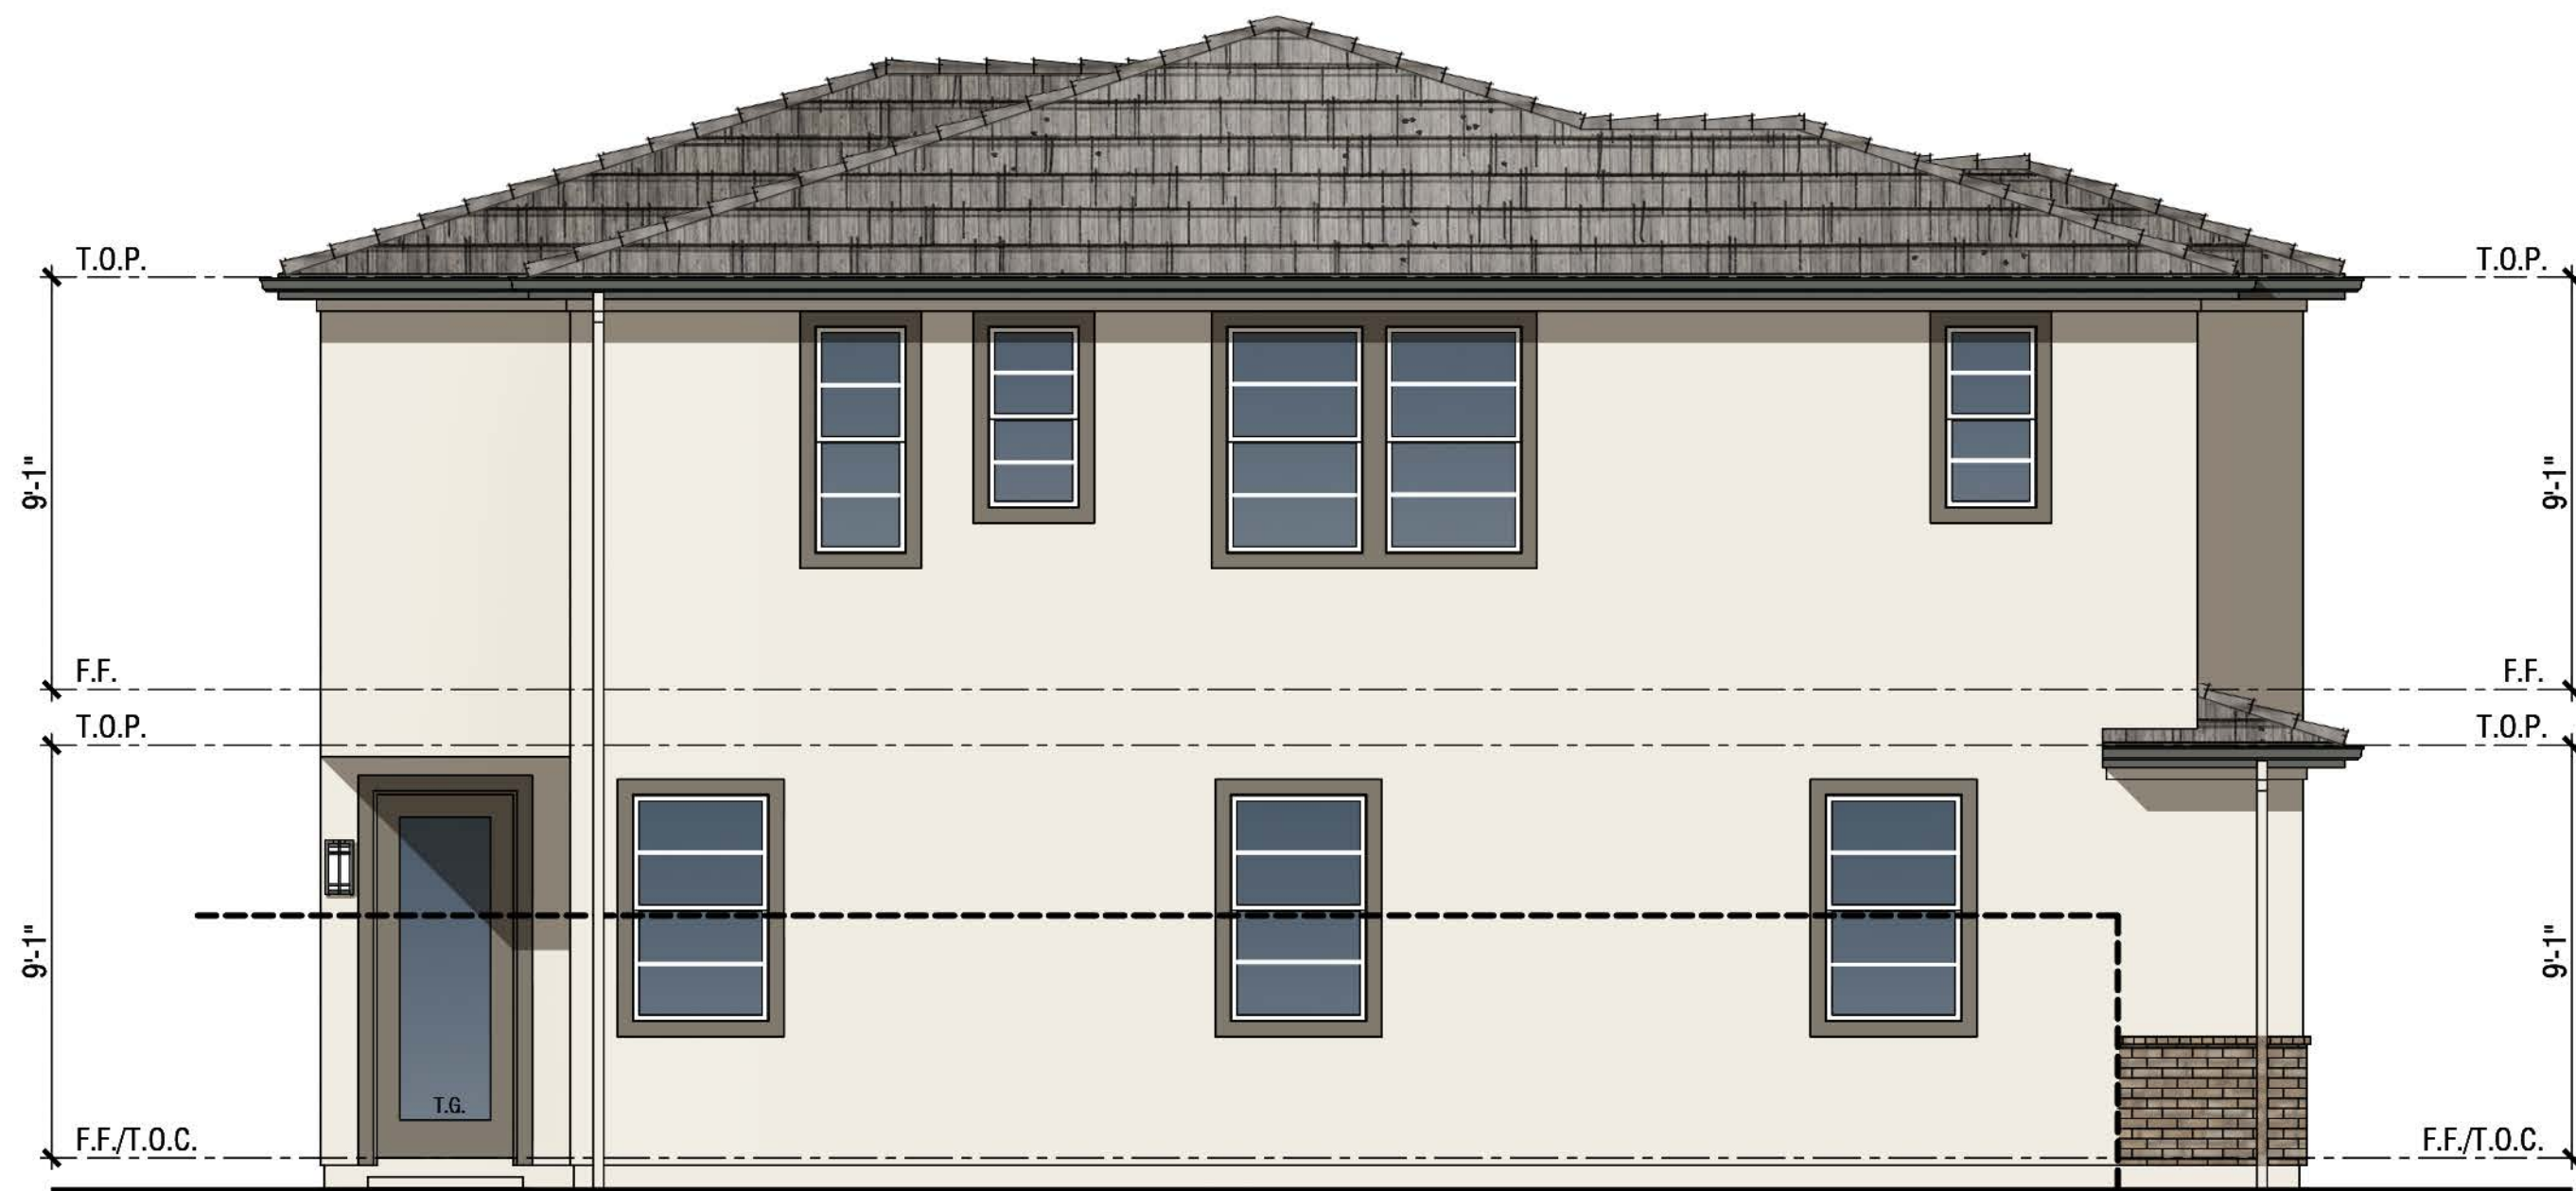
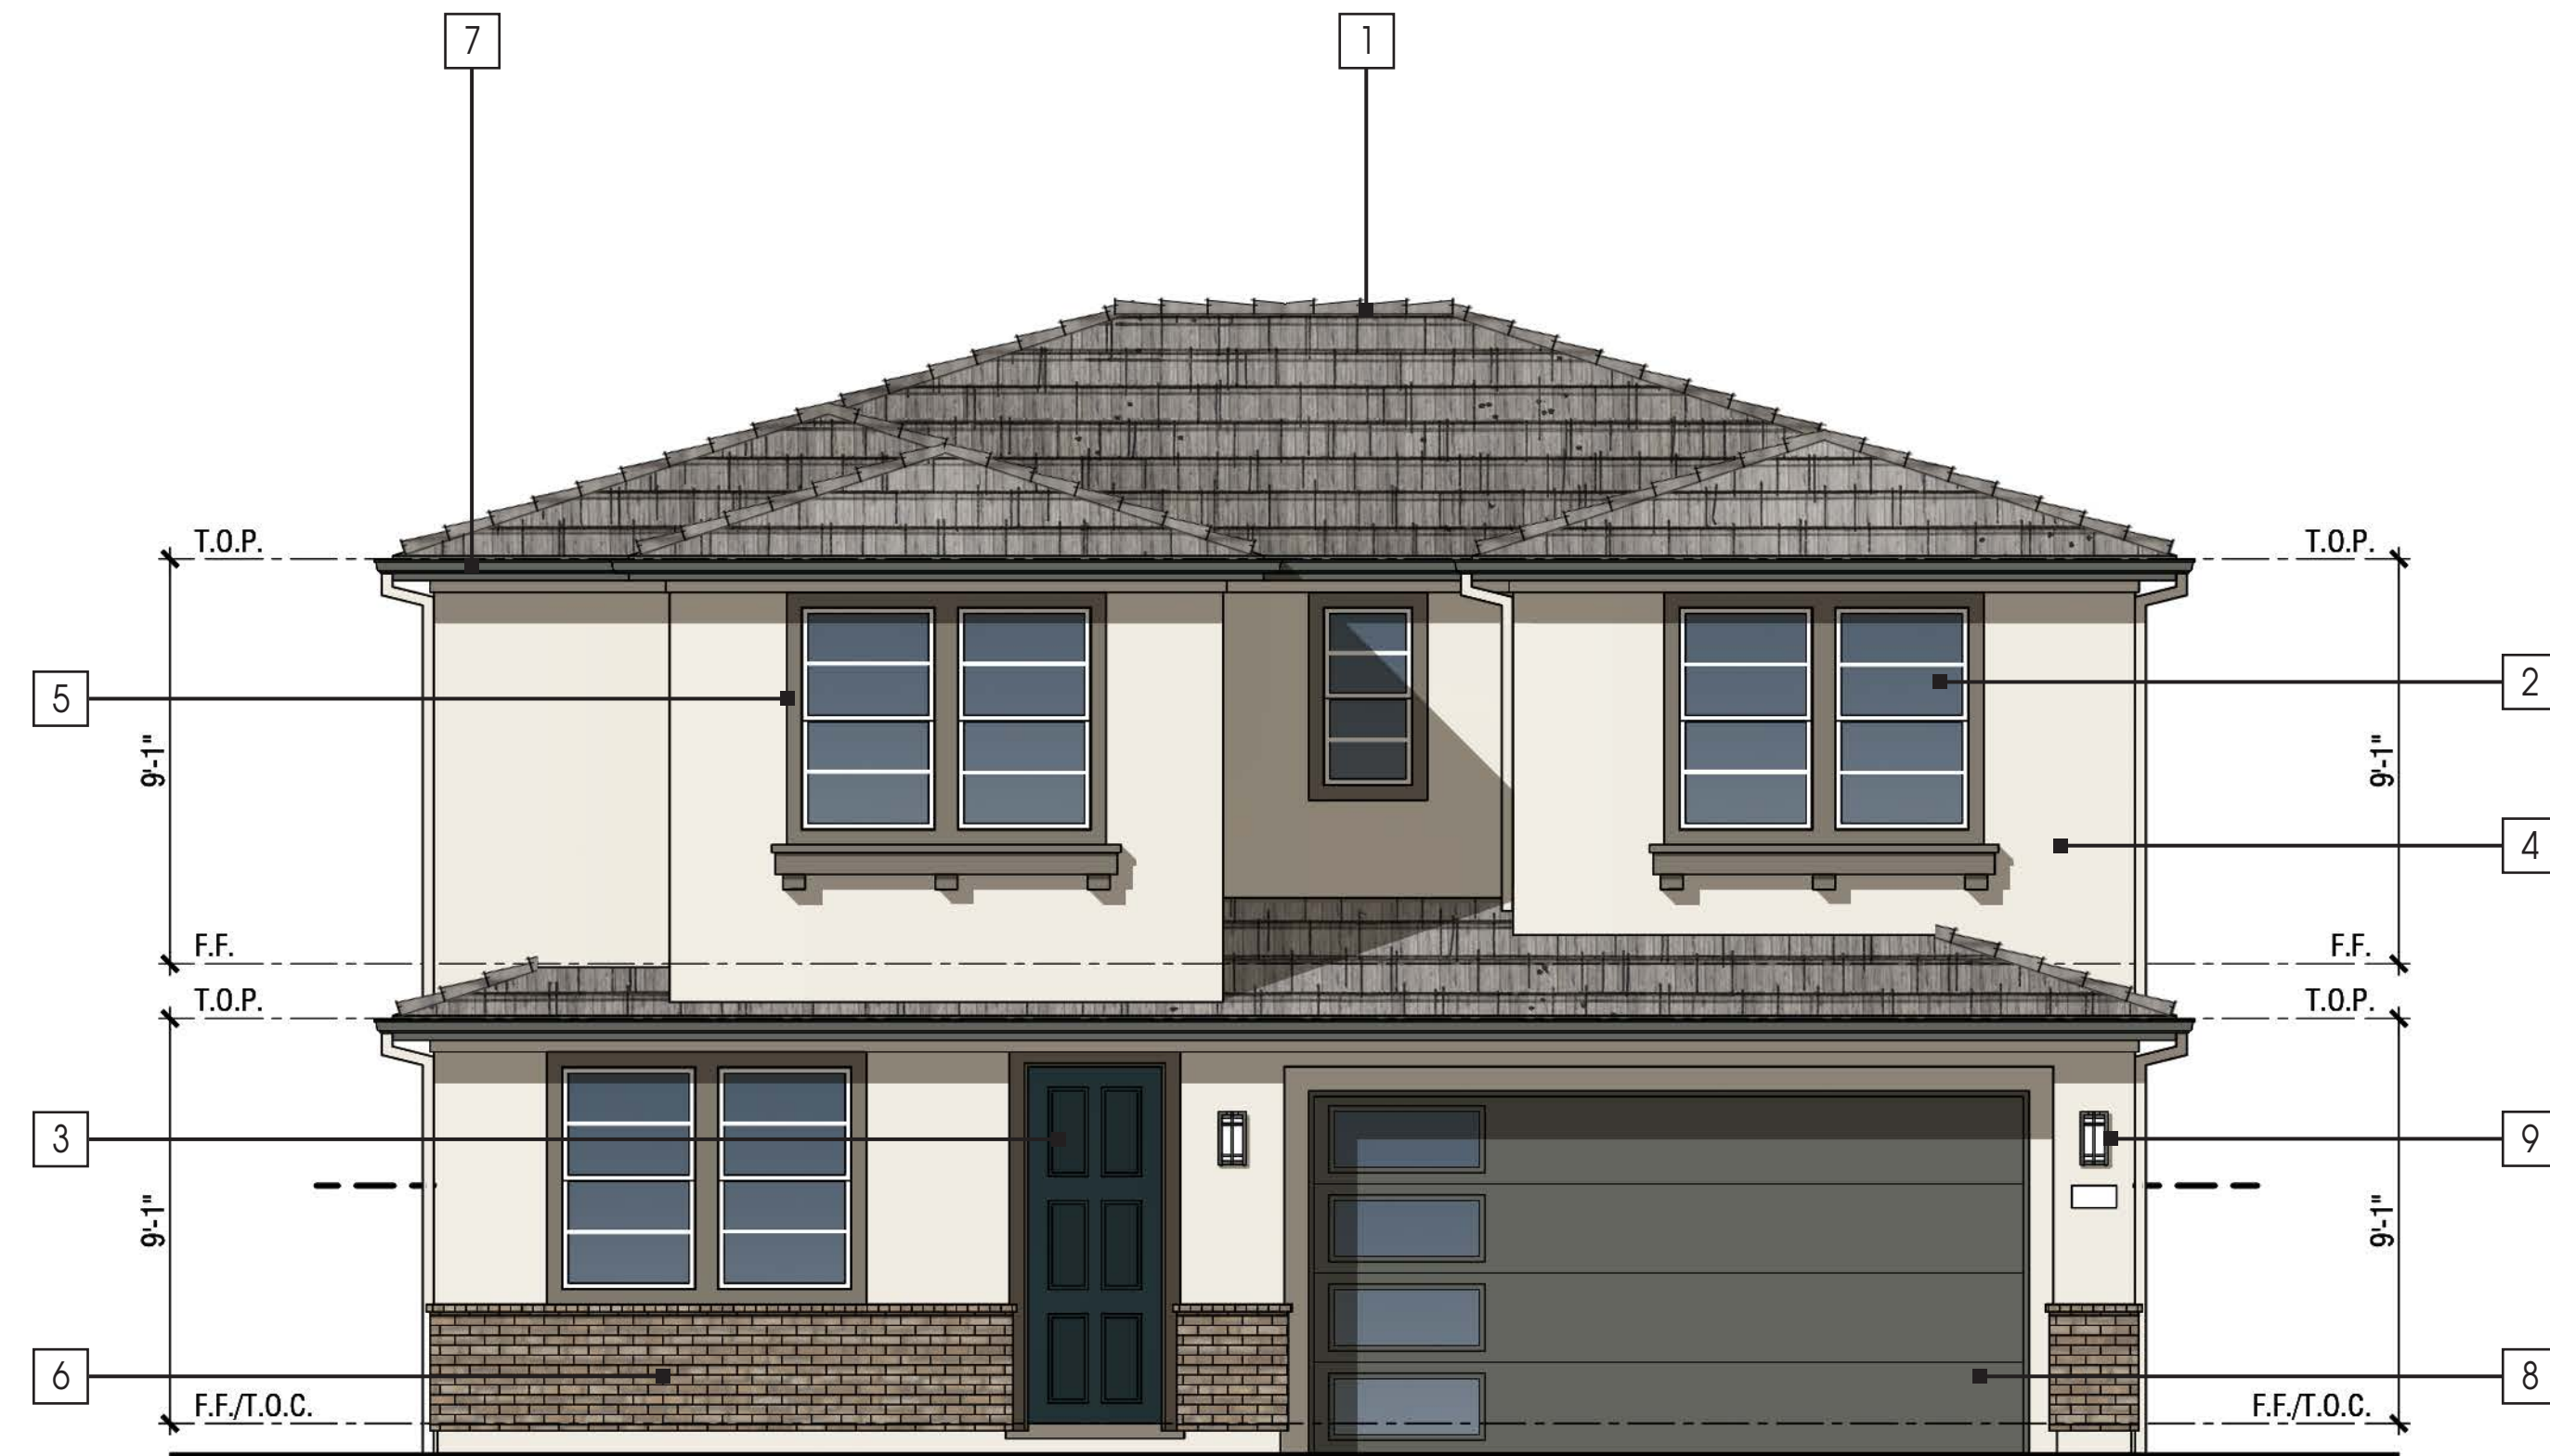
EXTERIOR MATERIALS:
Elevation C - Color Scheme 6

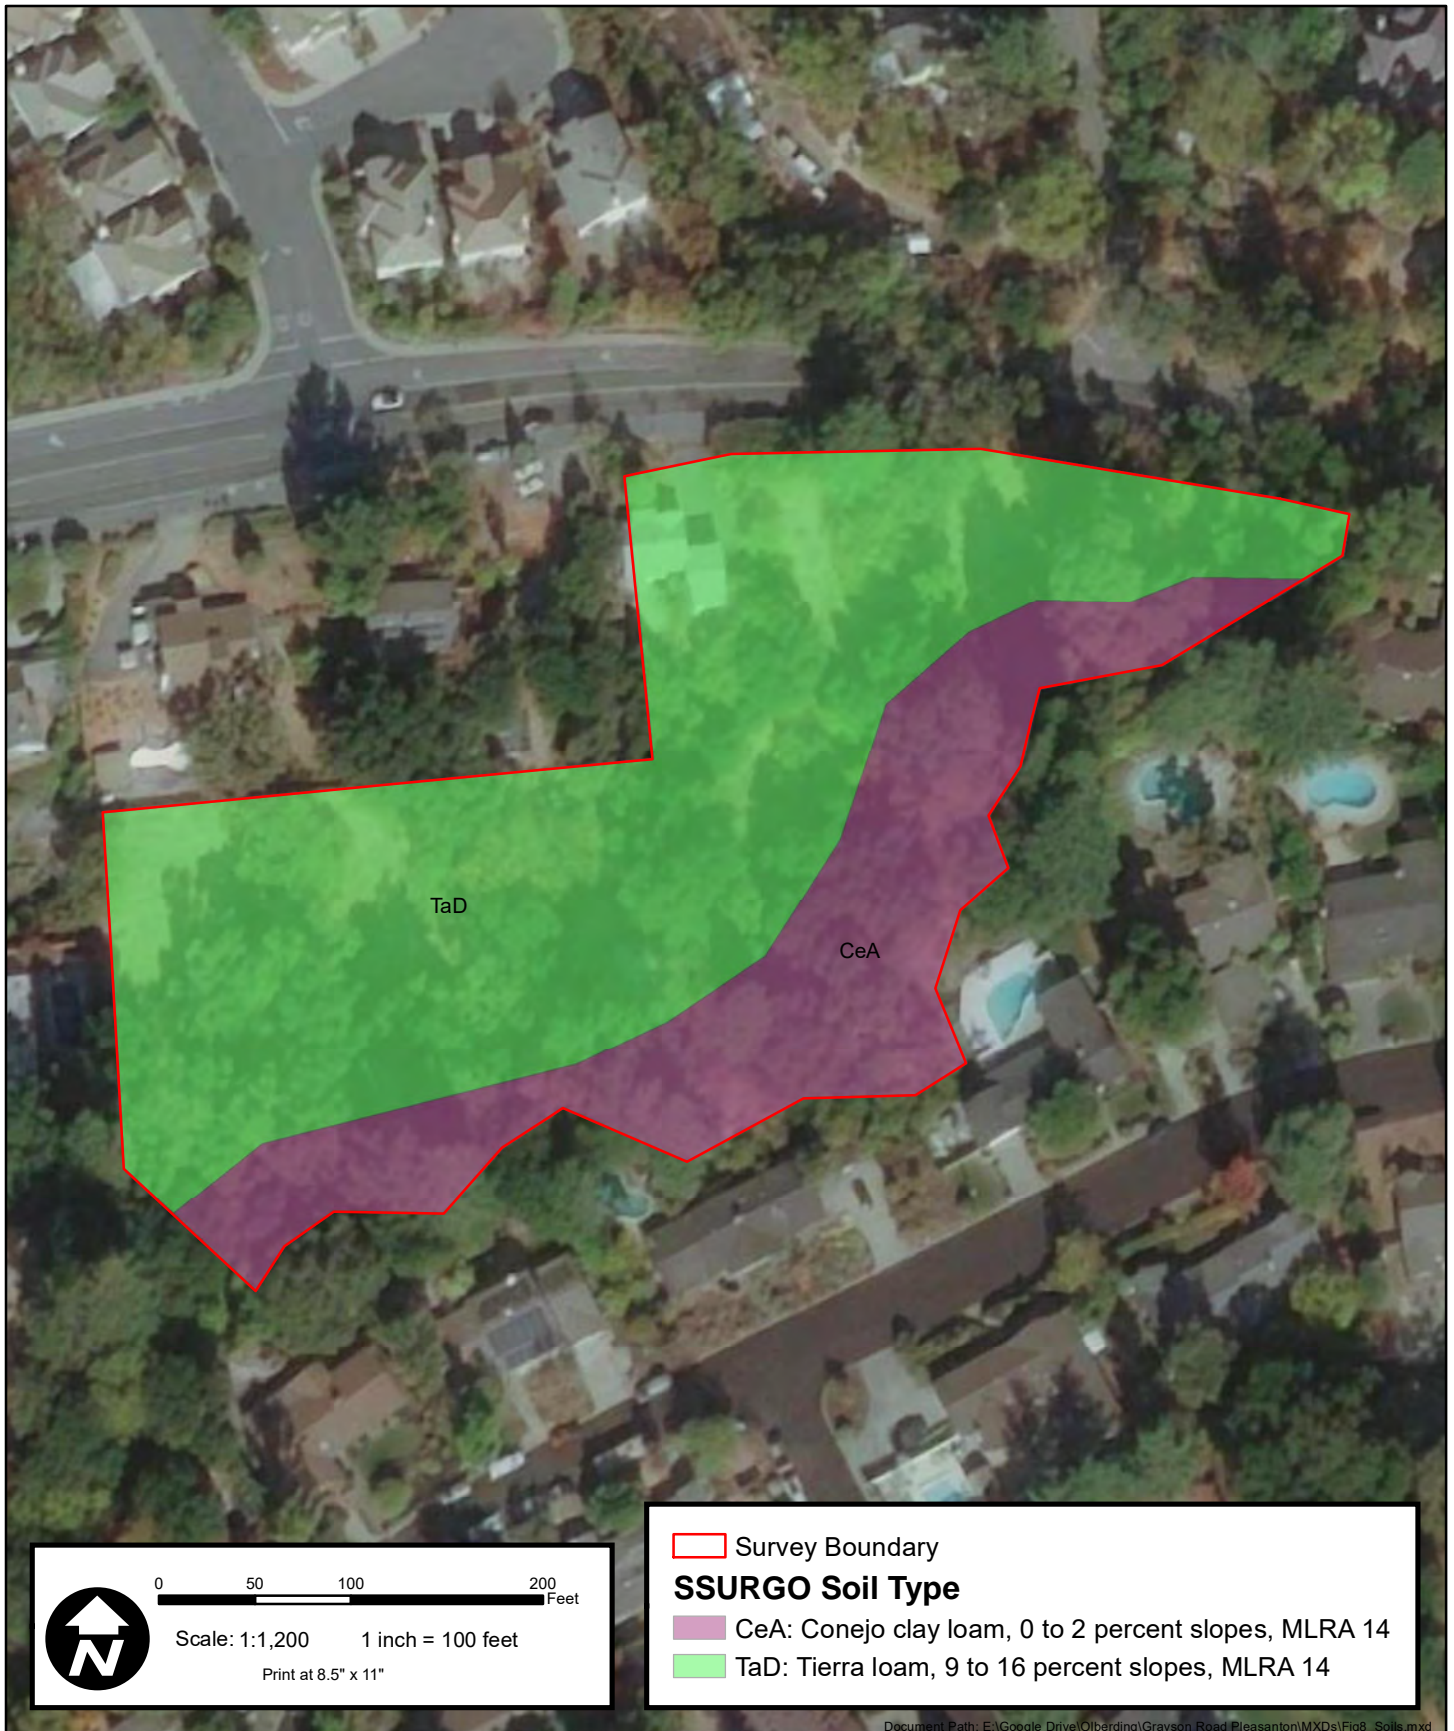
Figure 8
Soils Map

Figure 8: Soils Map
Grayson Road Property
Contra Costa County, California

Ap--0 to 7 inches; grayish brown loam, very dark grayish brown moist; hard, friable, slightly sticky; strongly acid (pH 5.5).
