# Improving Safety on the Iron Horse Trail Danville, California Bollards, Bicycles & Pedestrians

February 1, 2023

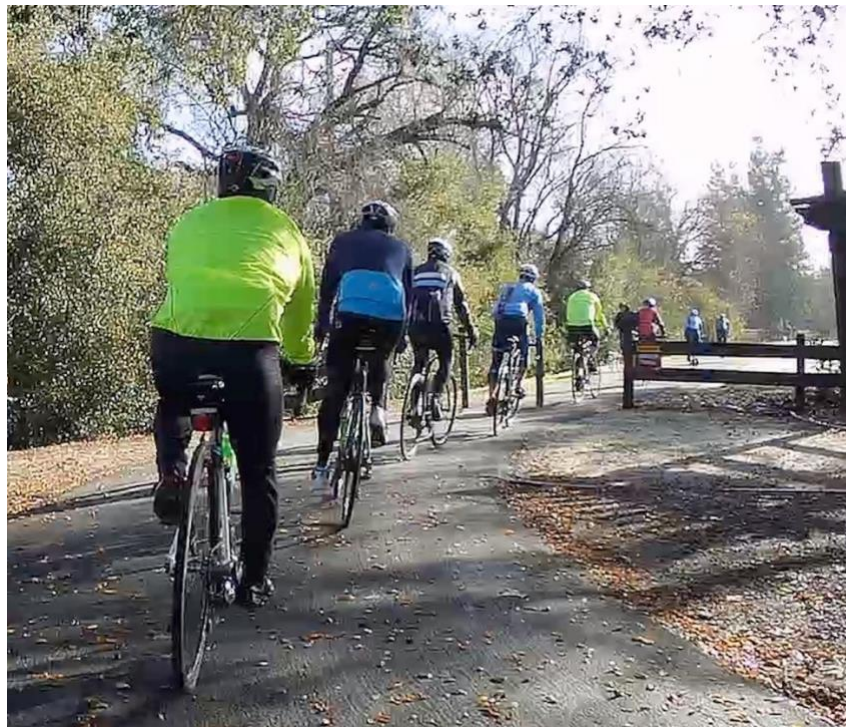
**The Problem with Bollards.** Cyclists frequently ride in small groups (peloton) chatting along the way. As a result, the front cyclist(s) often block the line of sight for cyclist(s) at the back of the peloton. Yes, front-middle cyclists should call out and/or provide hand signals notifying riders behind about hazards ahead. Unfortunately, noise, distractions, areas of shade, low visibility, fog, rain, twilight, hearing disabilities etc. all contribute to the cyclists near the back NOT hearing or seeing the warning and could easily result in a collision with the bollard.

All the bollards on the IHT are 4” PVC pipes painted a dull dark brown with a single fluorescent strip of 4-inch tape near the top. None of these dark brown bollards are illuminated at night. This makes them hard to see in low light or bright sun/shade conditions. Some crossings have one bollard (two travel lanes) and some have two bollards (three travel lanes – photo above). None are marked on the pavement to warn trail users of their presence.

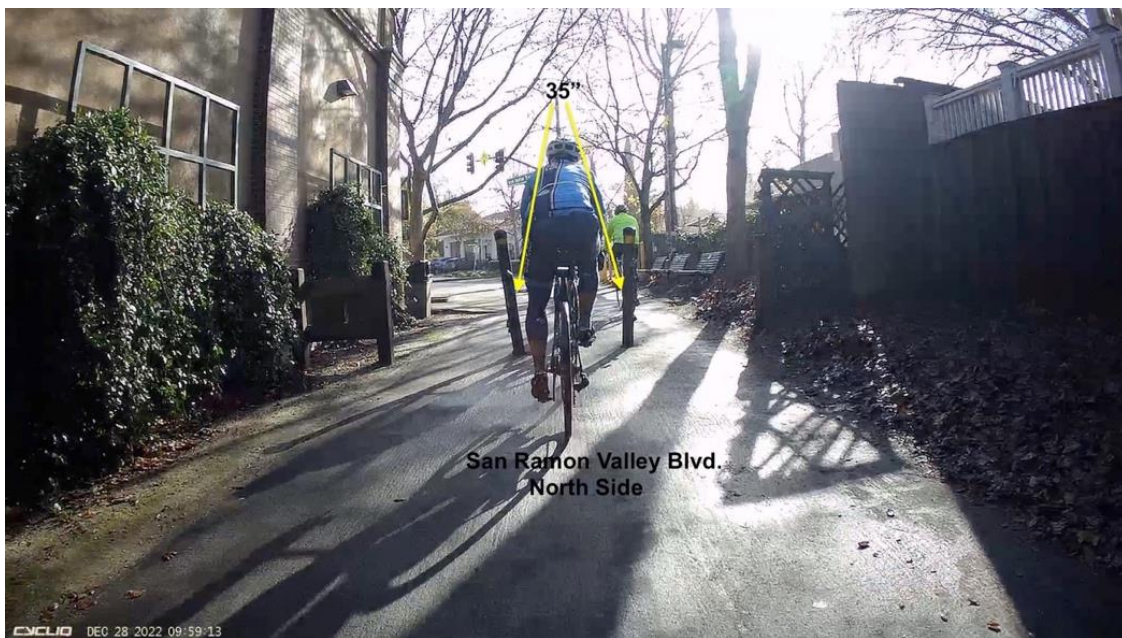
According to our measurements, 41 (89%) of the 46 bollard path openings (photo below) were significantly below the minimum 60-inch distance for bicycles to pass between safely. In fact, almost half of the 46 bicycle path openings were 35” to 50” wide.

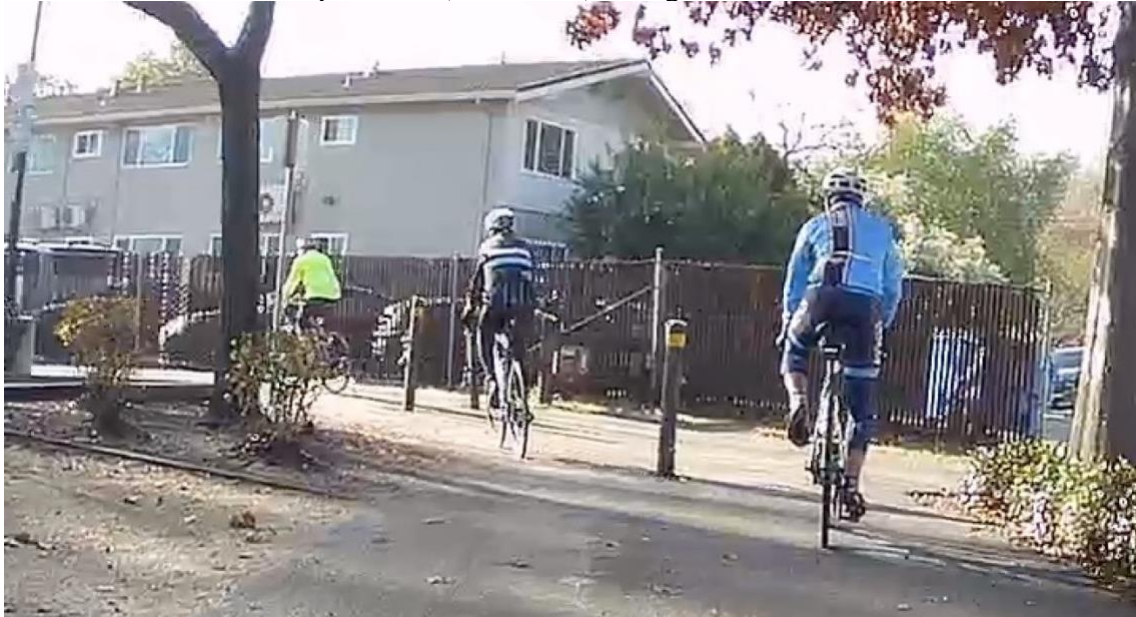
West Prospect Ave (South side) - Single & Double Bollards

**The Problem with Bollard Visibility.** At certain times of the day, the dull dark brown bollards seem to blend into their surrounding and become camouflaged (photo above & two photos below). This is especially the case in shady areas on a bright sunny day, and during times of low visibility such as fog, rain and twilight hours. Dark brown bollards are a Clear and Present Danger to cyclists who ride in a group, especially those at the back of the group where their line of sight is blocked by riders ahead and groups of pedestrians walking on the trail. The dark brown color significantly increases the probability of collisions, injuries and possible fatalities (photos below).

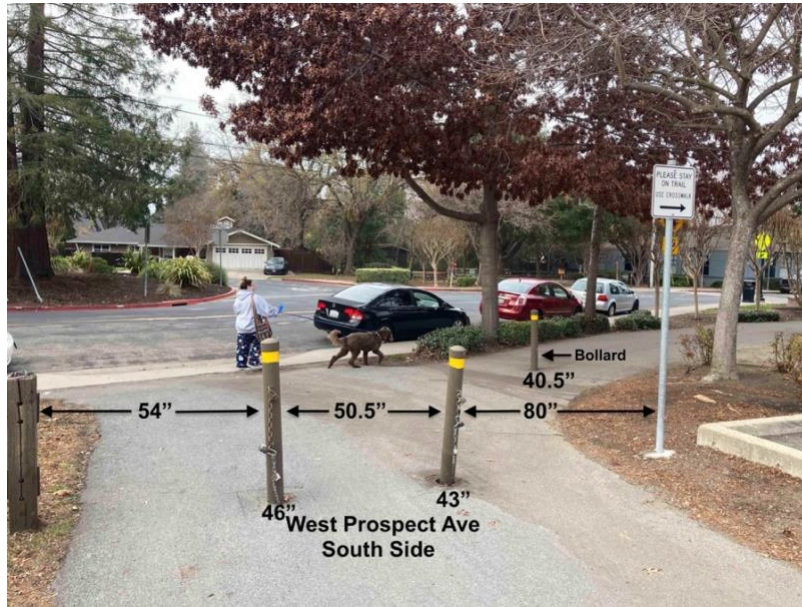
**The Problem with Multiple Bollards.** The Highway Design Manual discourages multiple bollards: “If the decision is made to add bollards, an odd number of openings increase the risk of head-on collisions if traffic in both directions tries to use the same opening.” Several of the IHT crossing locations had an odd number of path openings between bollards (photo below). The occasional 3-path bicycle openings significantly increase the probability of a cyclist colliding with another trail user or colliding with a bollard and being seriously injured or killed.

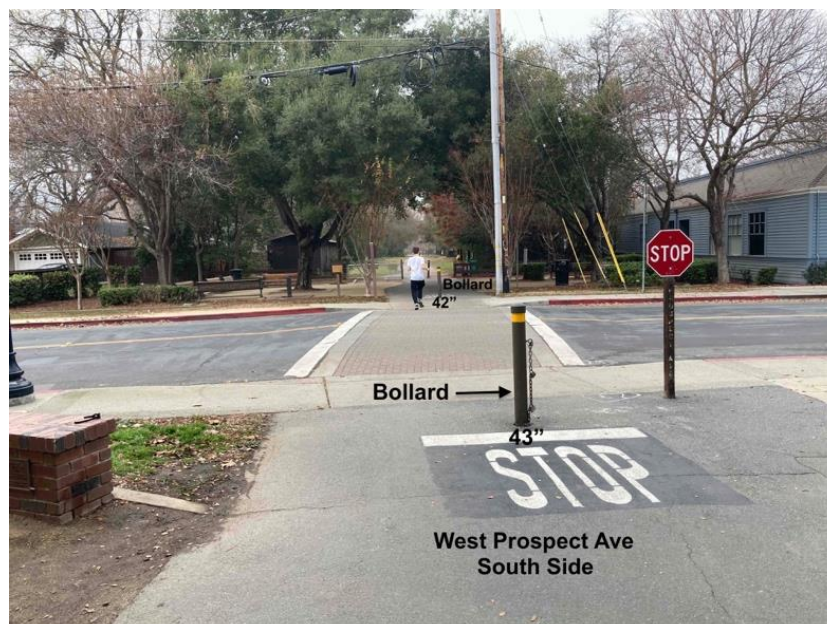
**The Problem with Standalone Bollards.** Standalone single bollards in the middle of the trail located in areas that seem unnecessary present an additional hazard to unsuspecting cyclists (photo below). As cyclists approach an intersection, they are constantly multitasking, looking left and right for vehicles and attempting to make eye contact with motorists, pedestrians, joggers, dog walkers and other cyclists. They are NOT expecting see a standalone bollard in their path.

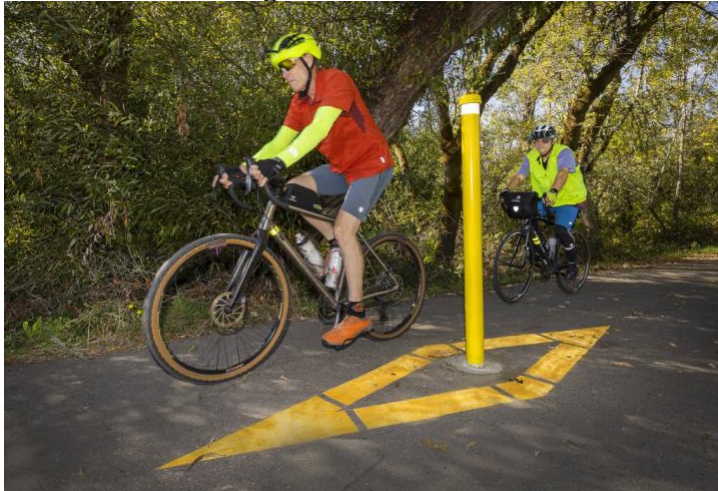
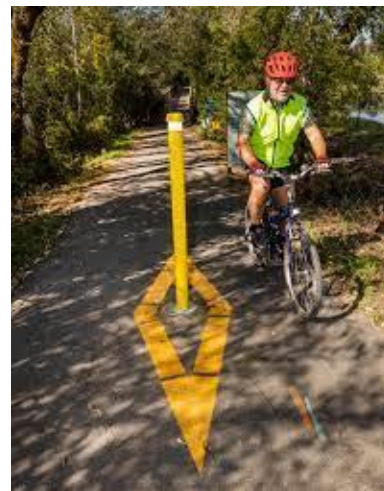
**Press Democrat Newspaper:** “The controversial poles along Sonoma County’s bike path have been repainted and striped yellow (photos below) to the paths safer after a **cyclist crashed into one and died in August.**”

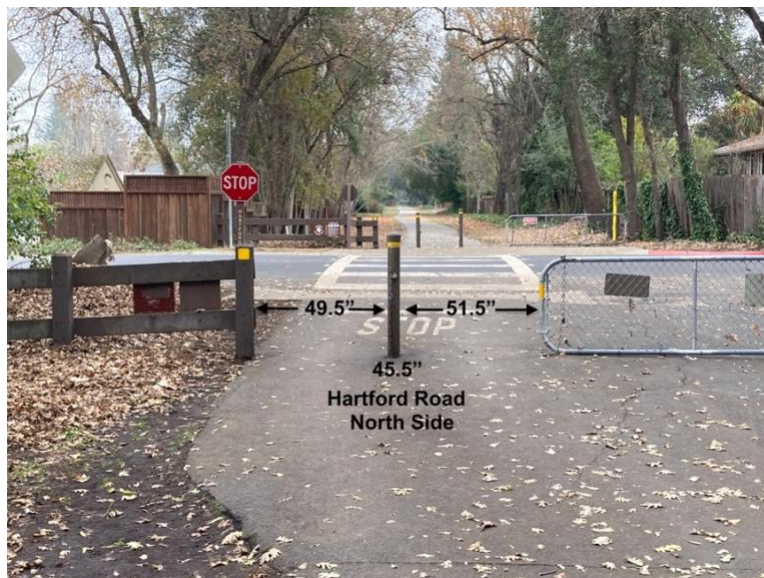
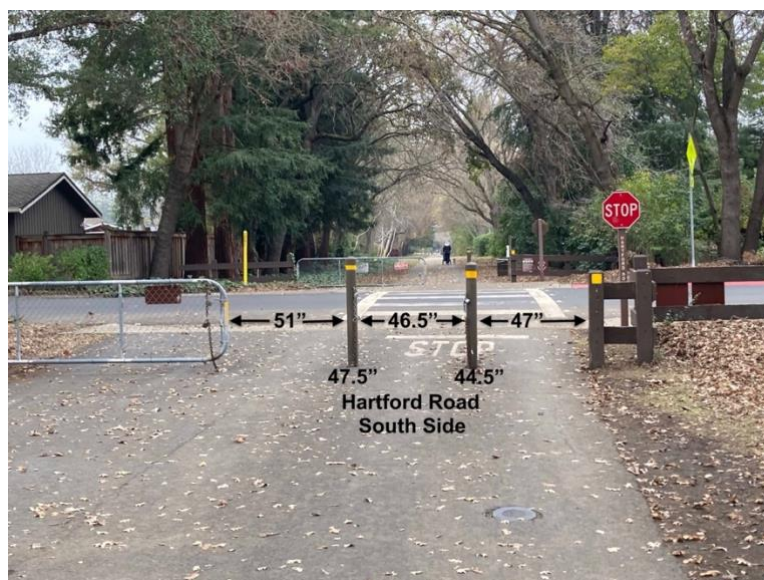
- 1. Hartford Road IHT Crossings:** North Side has a single dark brown bollard (2-path opening) and the South Side has double dark brown bollards (3-path dangerous openings). Both sides are below the minimum 60” width recommendation. Notice the different size gates, resulting in the South Side having a 3-path dangerous opening.

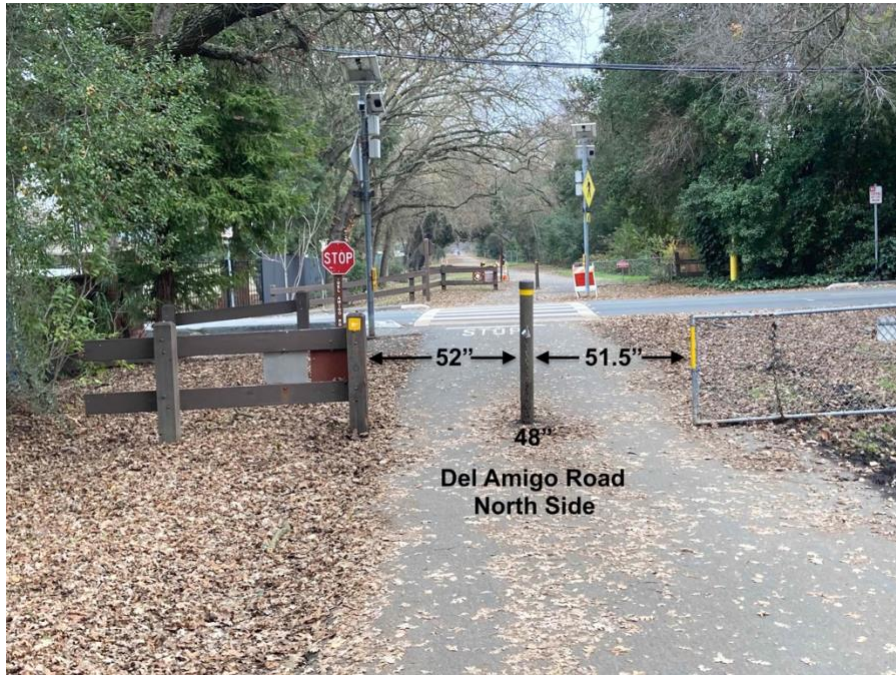
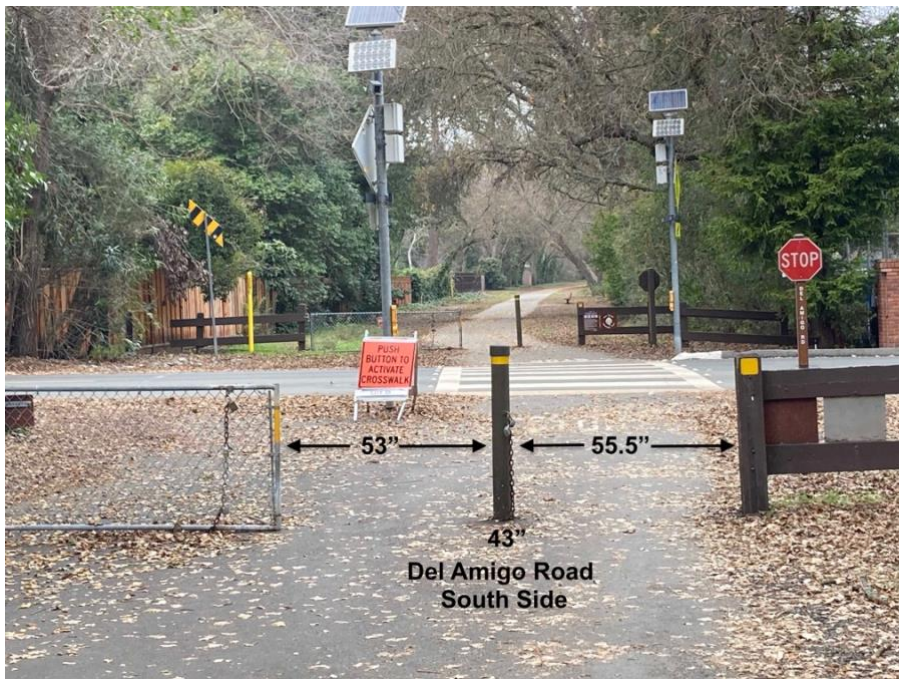
2. **Del Amigo Road IHT Crossings:** North side single dark brown bollard (2-path opening). South Side Below dark brown bollard (2-path opening). Both sides are below the minimum 60" width recommendation.

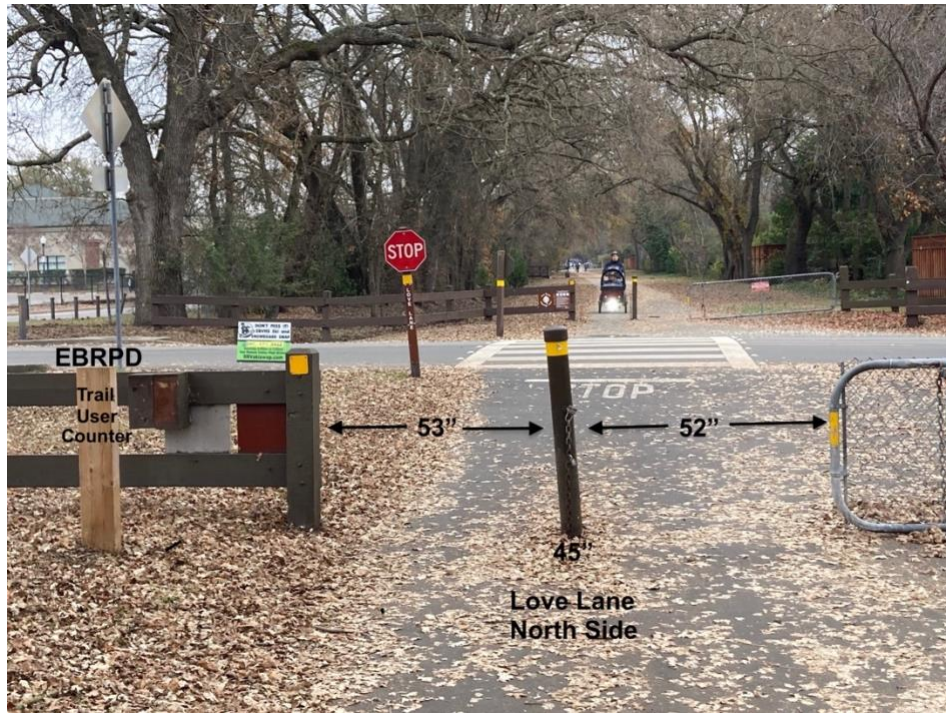
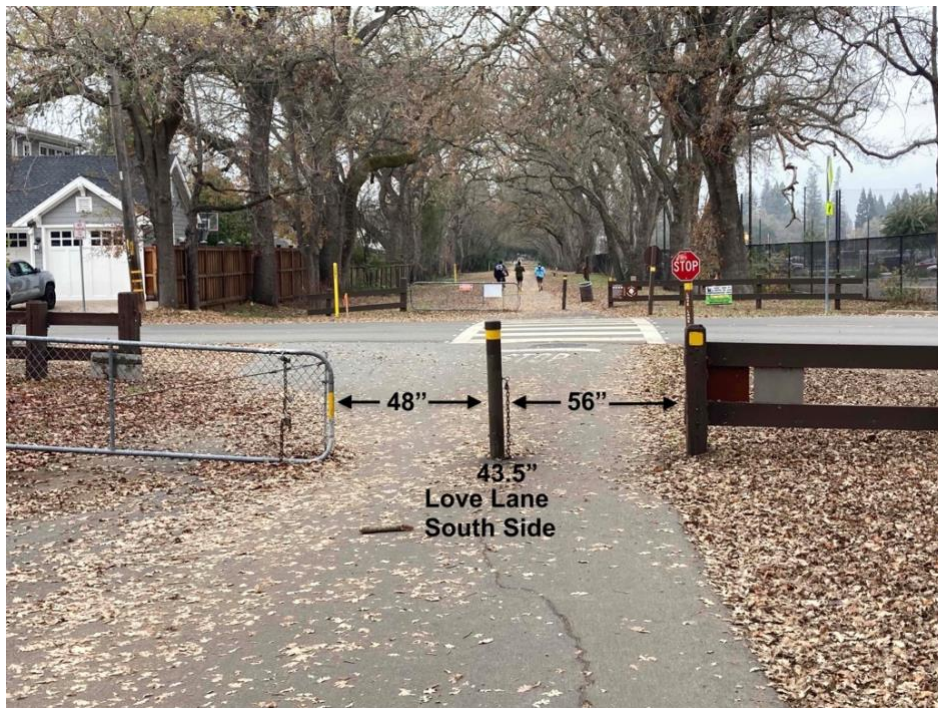
3. **Love Lane IHT Crossings:** North and South sides single dark brown bollards (2-path opening). Both sides are below the minimum 60" width recommendation.

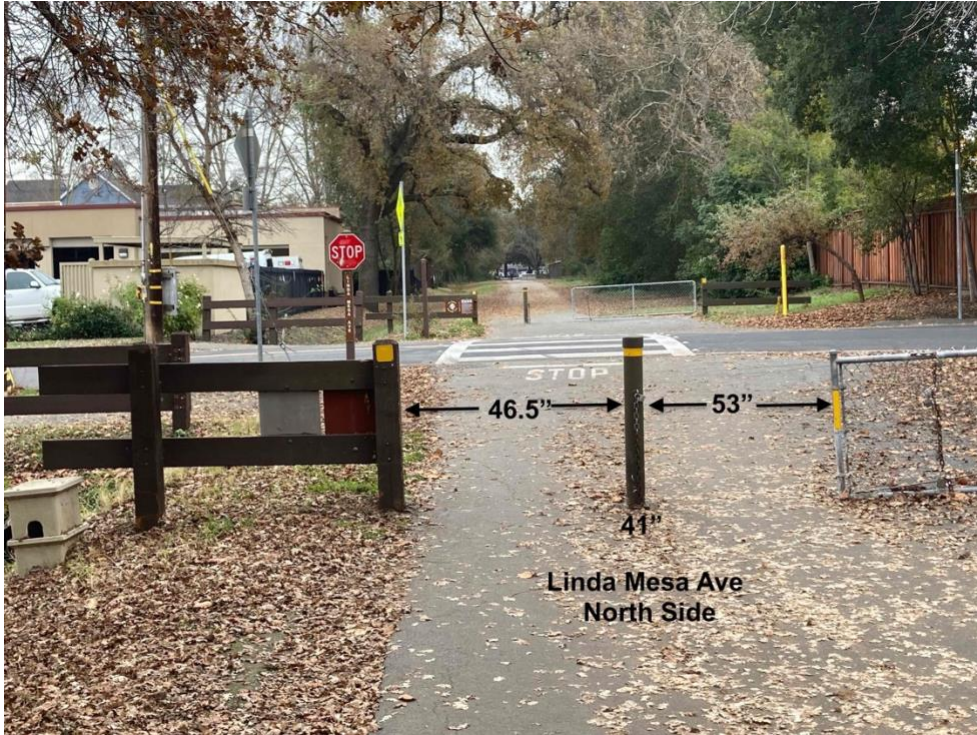
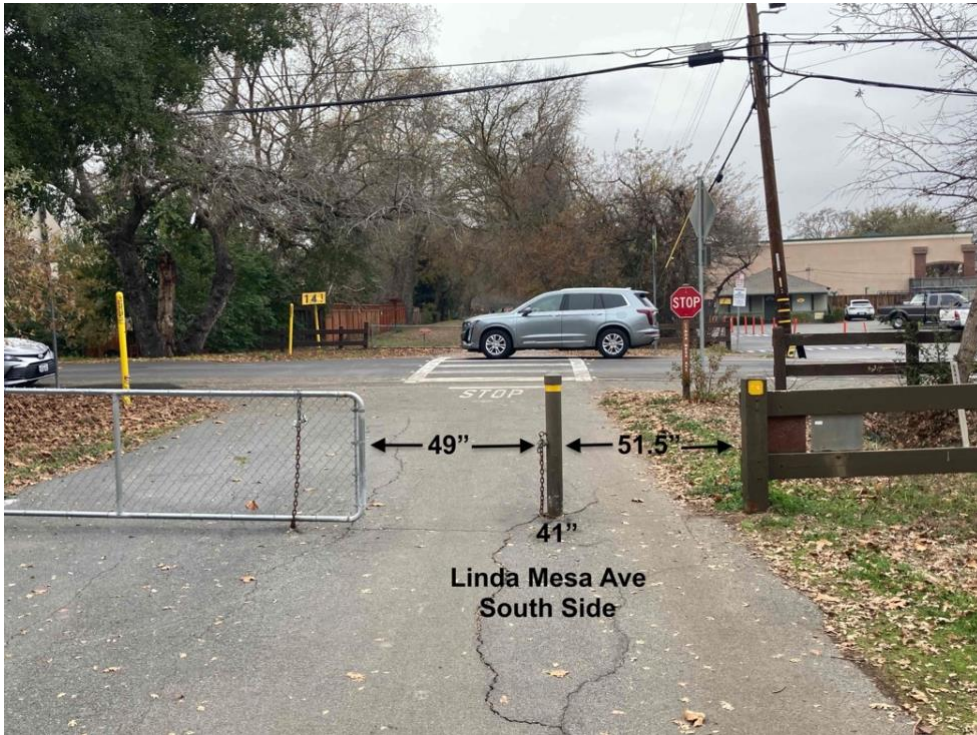
4. **Linda Mesa Ave Crossings:** North and South sides single dark brown bollards (2-path opening). Both sides are below the minimum 60" width recommendation.

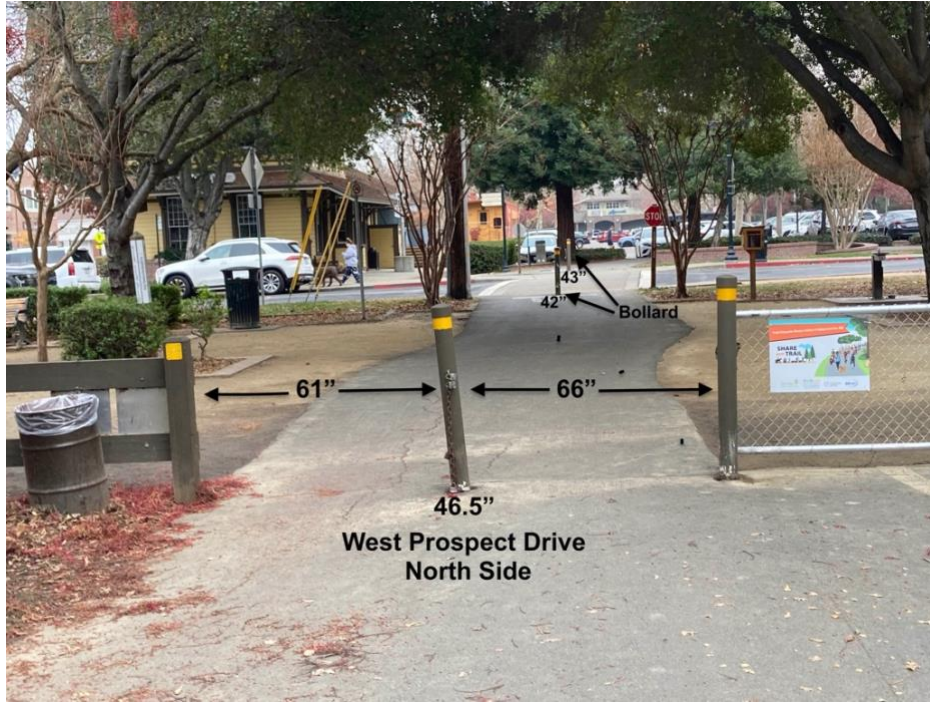
5. **West Prospect Ave IHT Crossings:** North and South Side have six dark brown bollards. The north side has a single bollard 2-path opening which meets the 60-inch minimum recommendation. But there are also two standalone single bollards at the crosswalk on both North & South sides, which present a hazard to unsuspecting cyclists.

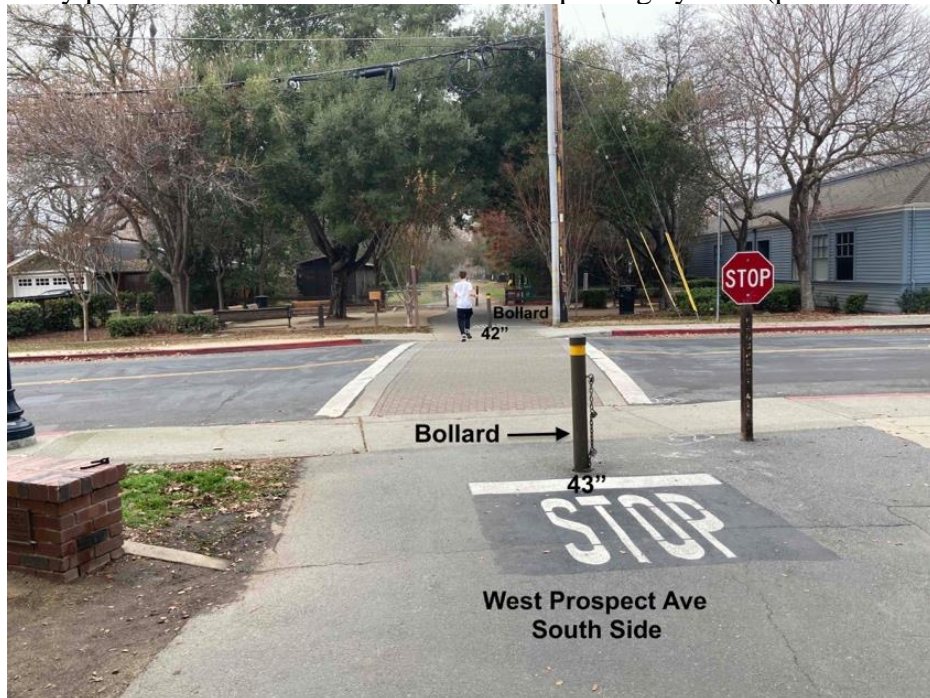
Standalone single bollards in the middle of the trail located in areas that seem unnecessary present an additional hazard to unsuspecting cyclists (photo below).

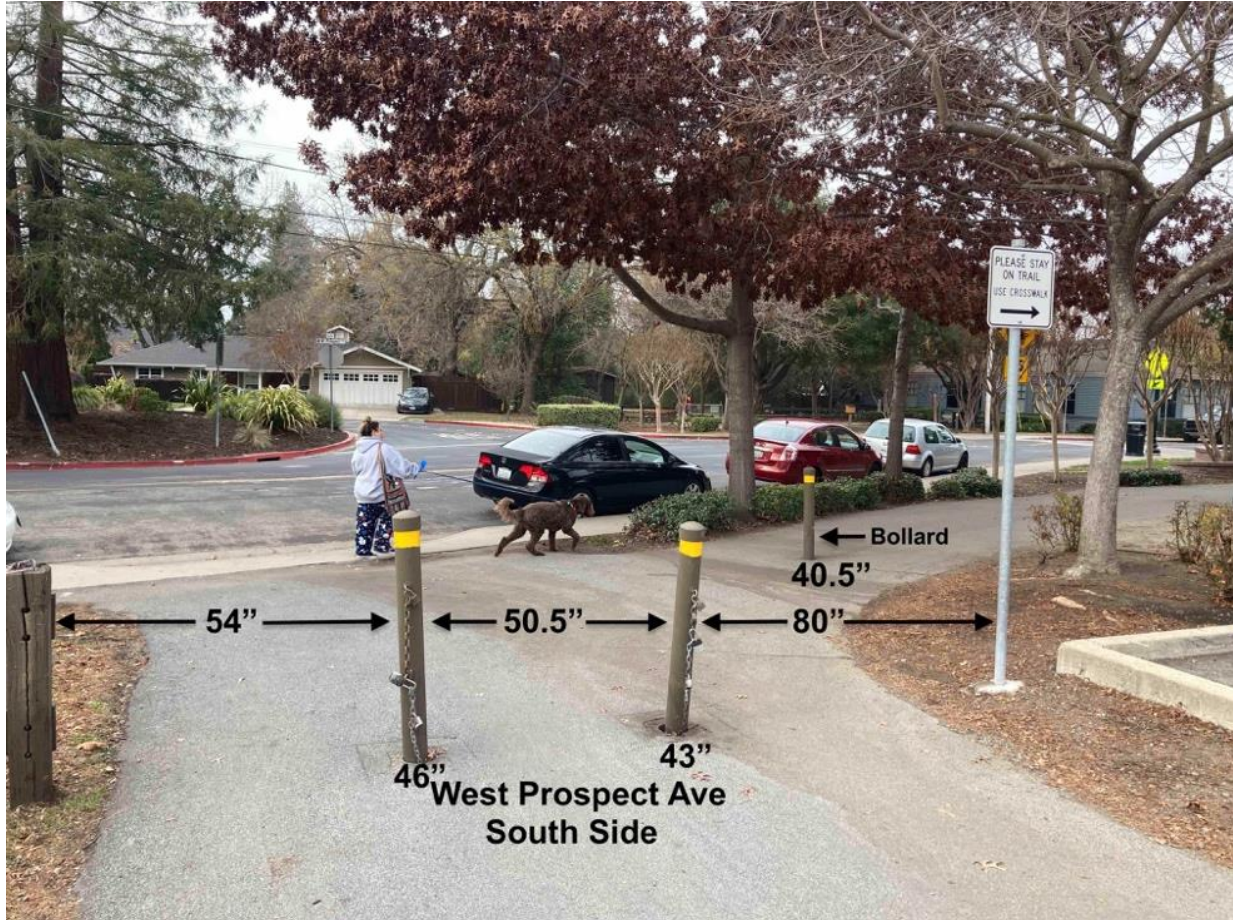
The south side of West Prospect Ave shown below has a confusing and dangerous 3-path opening and an odd standalone single bollard. There should be one to two bollards centered on the driveway, approximately 10+ feet from curb (person walking). The left and center openings are below the minimum 60" width recommendation.

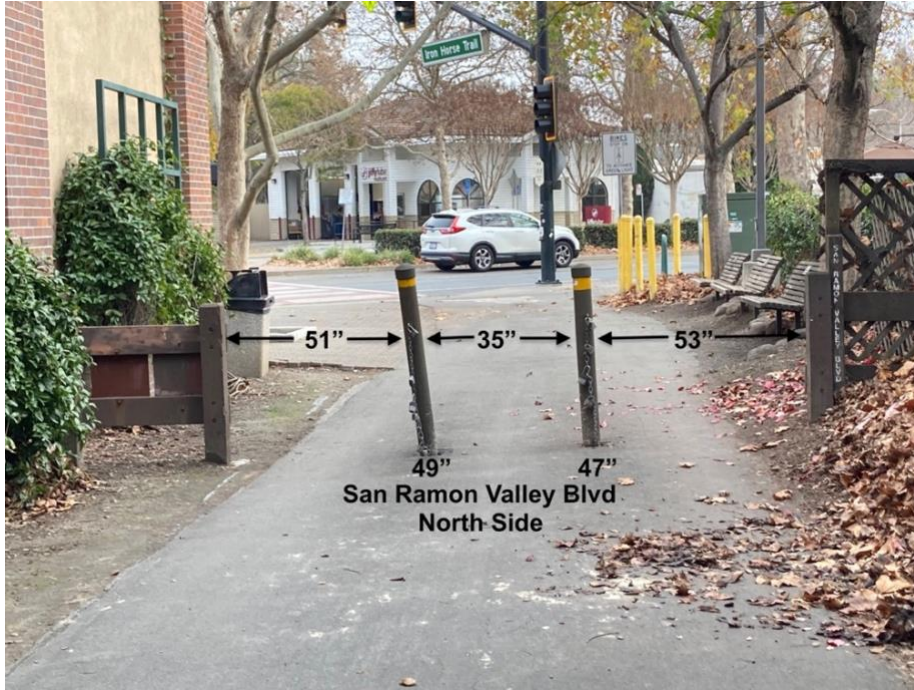
The 3-path opening (photo below) is confusing, potentially dangerous and below the minimum 60" width recommendation. There is no need for bollards at this location. When the bollard on the left tilts toward the center, the distance between is 31".

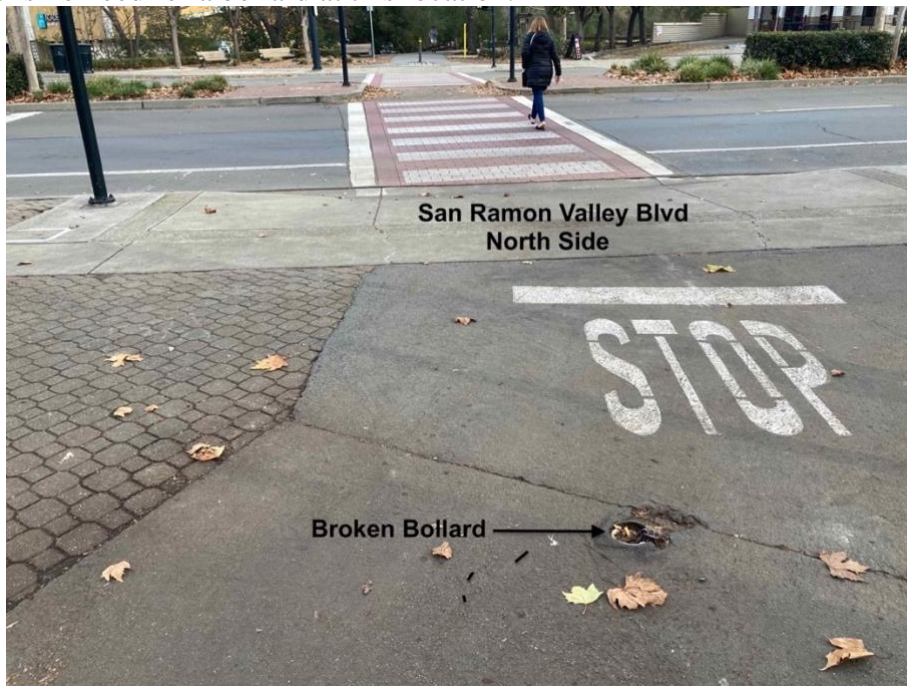
The broken bollard (photo below) is a hazard for pedestrians and cyclists. There is no need for a bollard at this location.

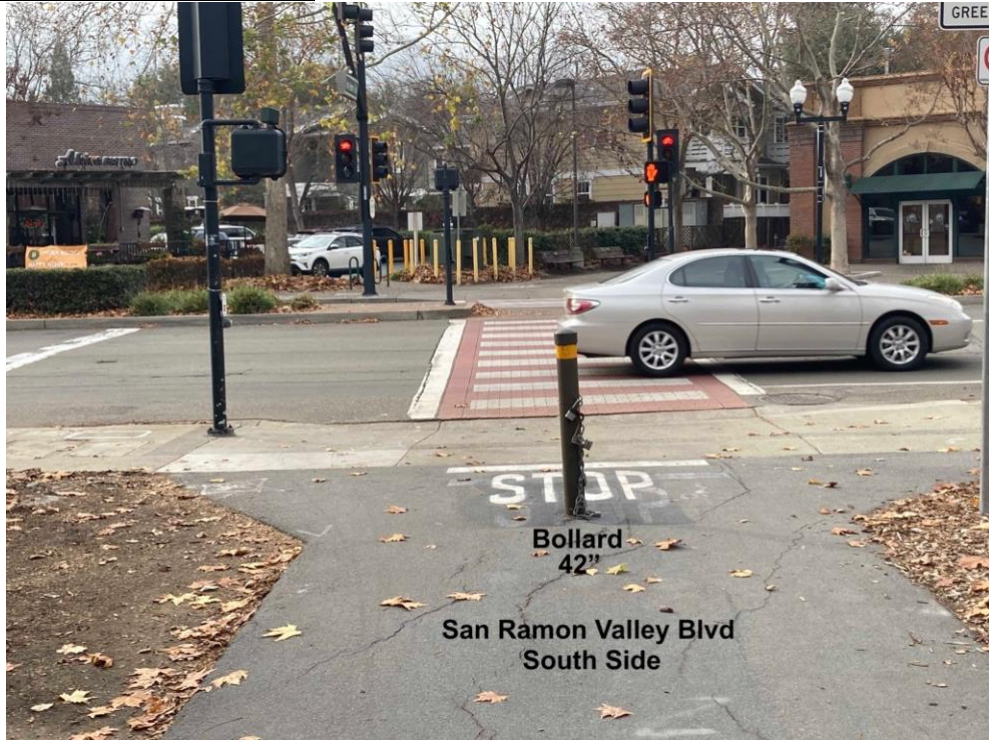
The stand-alone single dark brown bollard below is dangerous and a collision waiting to happen and should be removed.

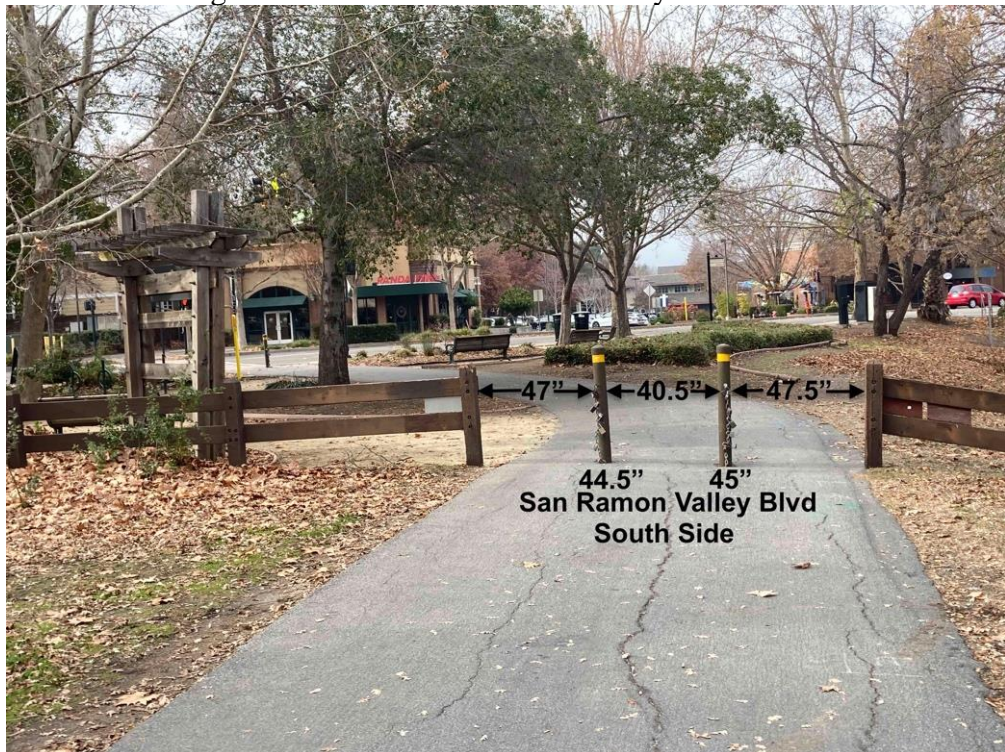
The 3-path opening (photo below) is confusing, potentially dangerous and below the minimum 60" width recommendation. There is no need for bollards at this location. Notice the single dark brown bollard in the background closer to San Ramon Valley Boulevard.

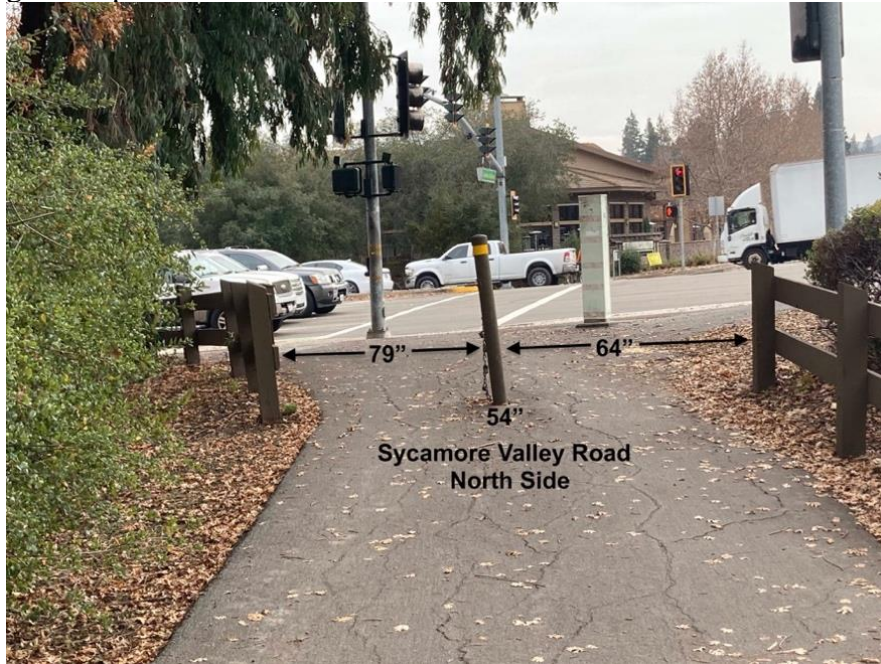
7. **Sycamore Valley Road IHT Crossings:** Even though the two-path openings meet the minimum 60" recommendation, is this single bollard really necessary at this location (photo below)? The large traffic light pole and the vertical electrical box block the opening of the path.

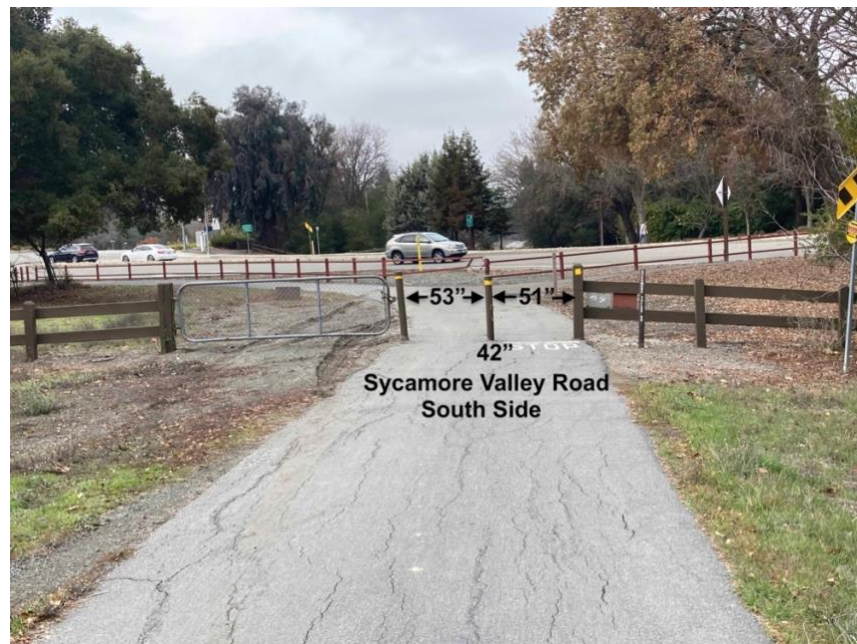
Notice the long red metal barrier-fence running parallel to Sycamore Valley Road with a locked vehicle access gate in the background, which provides access to the trail. Both sides are below the minimum 60" width recommendation. If vehicle access is blocked by the red fence and controlled by a locked gate, is the bollard (photo below) in the middle of the path really necessary?

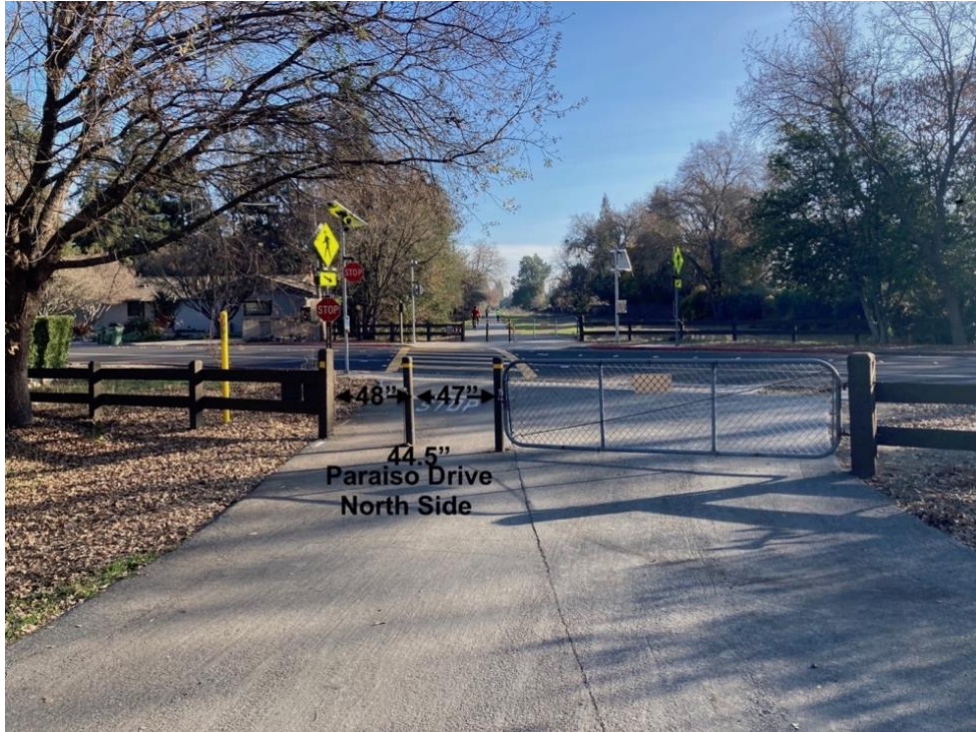
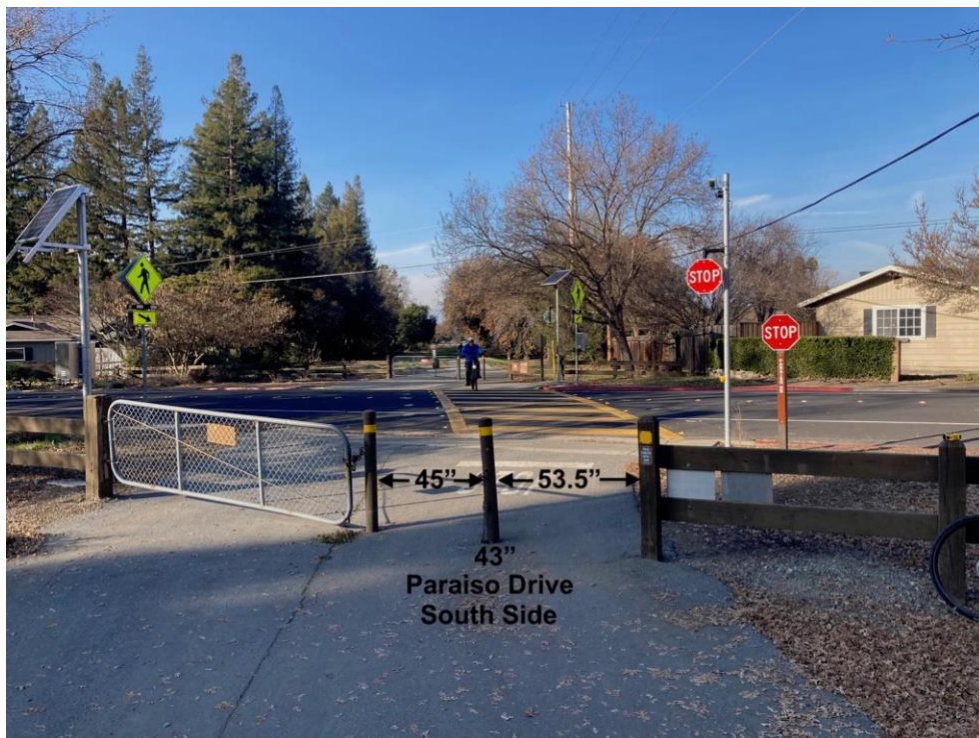
8. **Paraiso Drive IHT Crossings:** North side single bollard (2-path opening). South Side dark brown bollard below (2-path opening). Both sides are well below the minimum 60" width recommendation. Reducing the width of the gate would allow for wider spacing between the bollards.

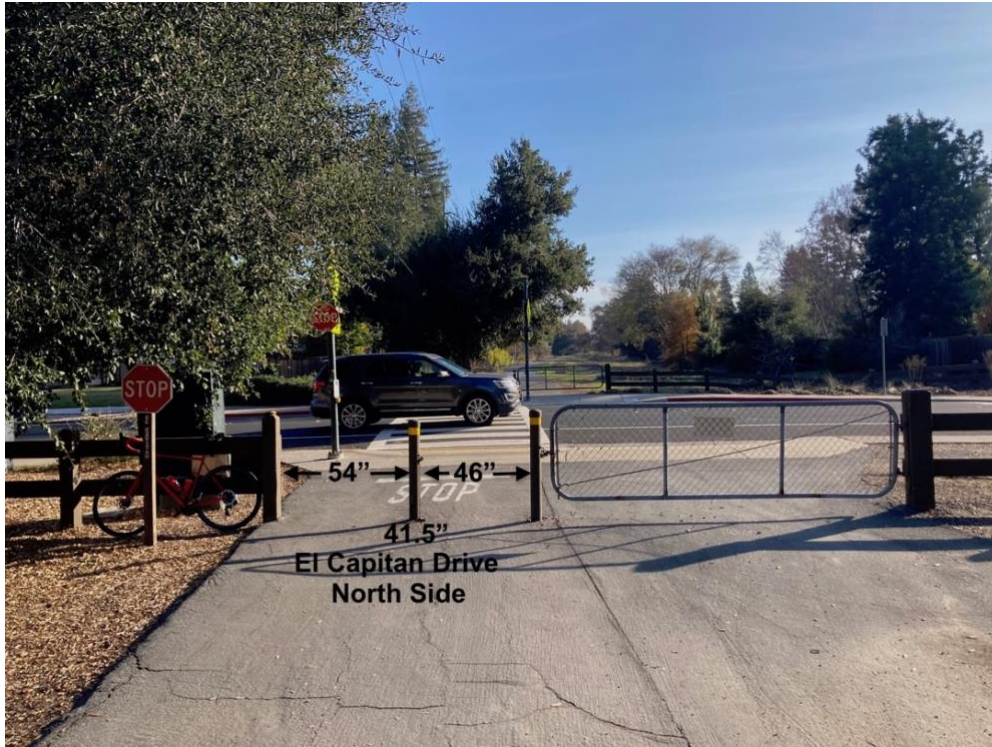
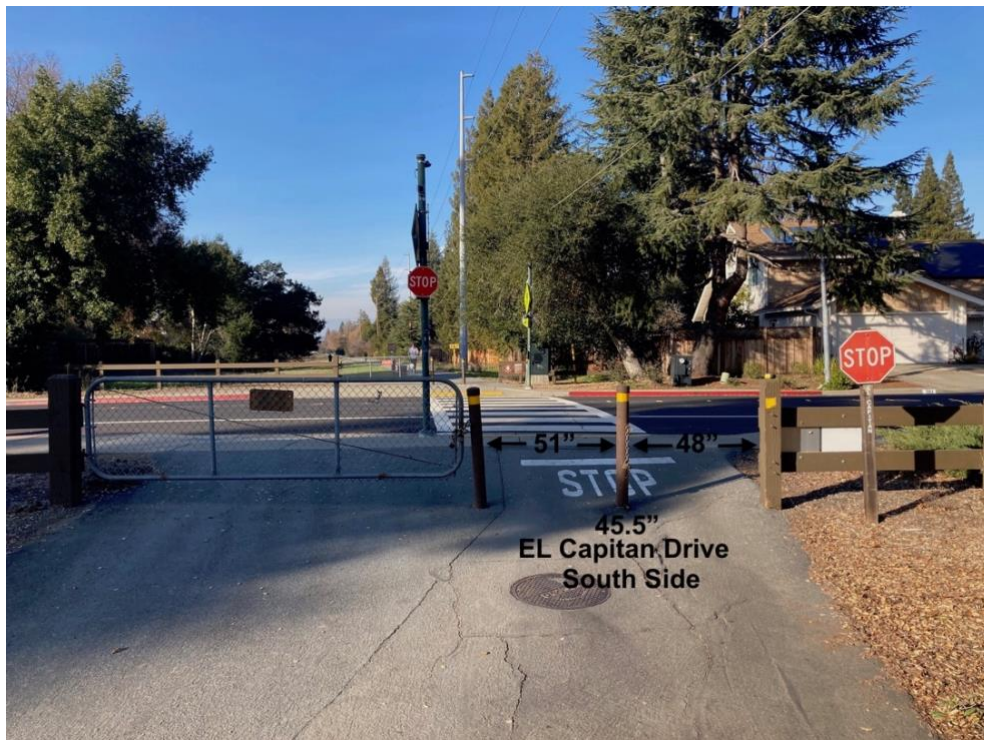
9. **El Capitan Drive IHT Crossings:** North side single dark brown bollard (2-path opening). South Side Below dark brown bollard (2-path opening). Both sides are below the minimum 60" width recommendation.

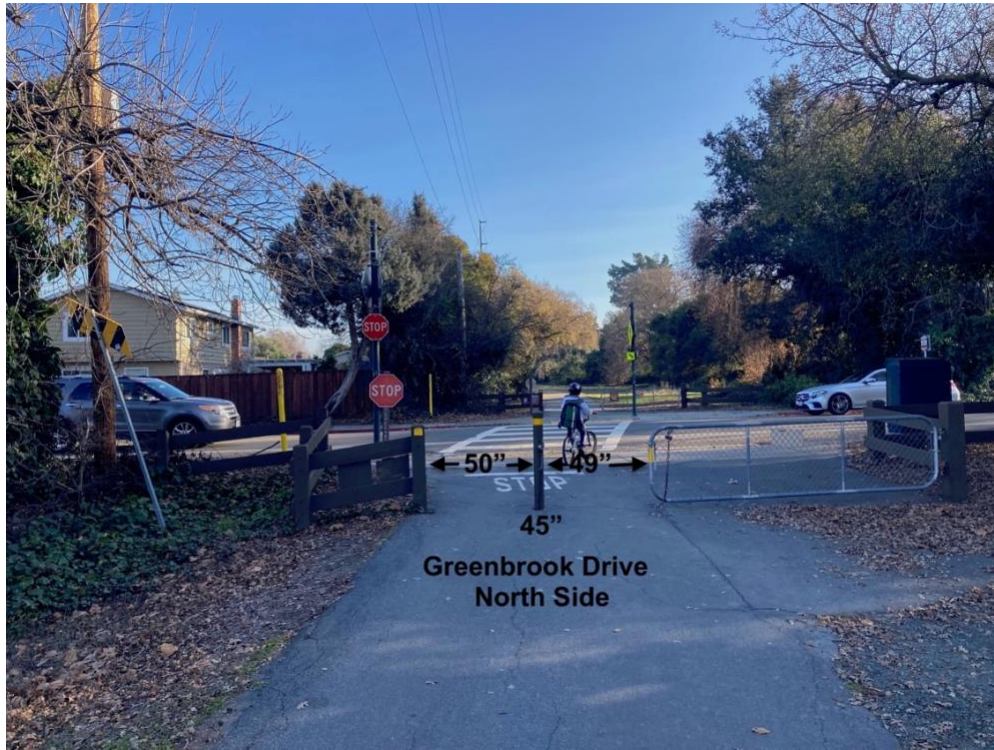
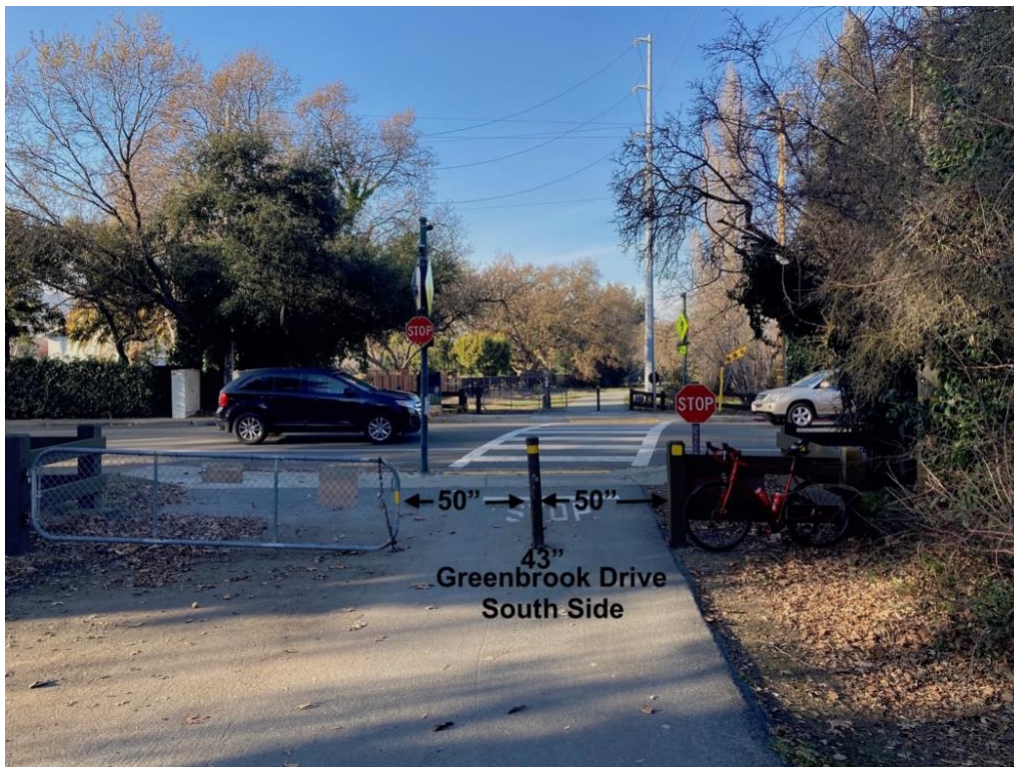
**10. Greenbrook Drive IHT Crossings:** North side single bollard (2-path opening). South Side bollard (2-path opening). Both sides are below the minimum 60" width recommendation. Reducing the width of the gate would allow for wider openings.

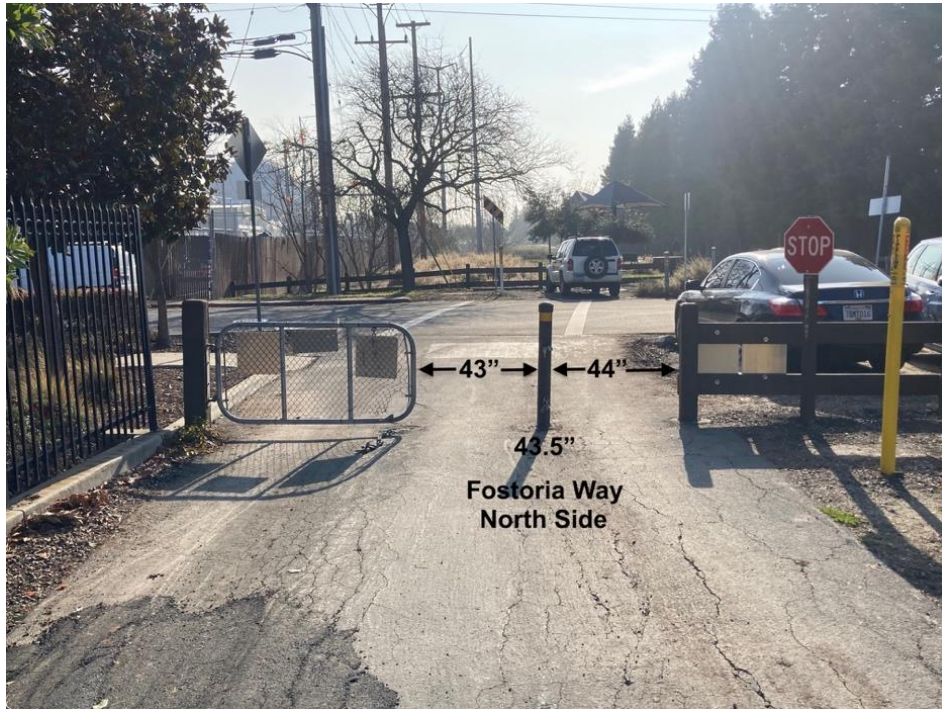
- 11. Fostoria Way IHT Crossings:** North side single dark brown bollard (2-path opening). South Side Below dark brown bollard (2-path opening). Both sides are well below the minimum 60" width recommendation.
