## Arborist Report

**Property Address:** 4301 Appian Way, El Sobrante, CA 94803

**Purpose of Report:** Tree inventory and map of property, including species, location, measurements, condition, and recommendations based on planned development of the site. This report is not a formal tree risk assessment.

## **4301 Appian Way Development Project, El Sobrante, California Biological Resources Assessment**

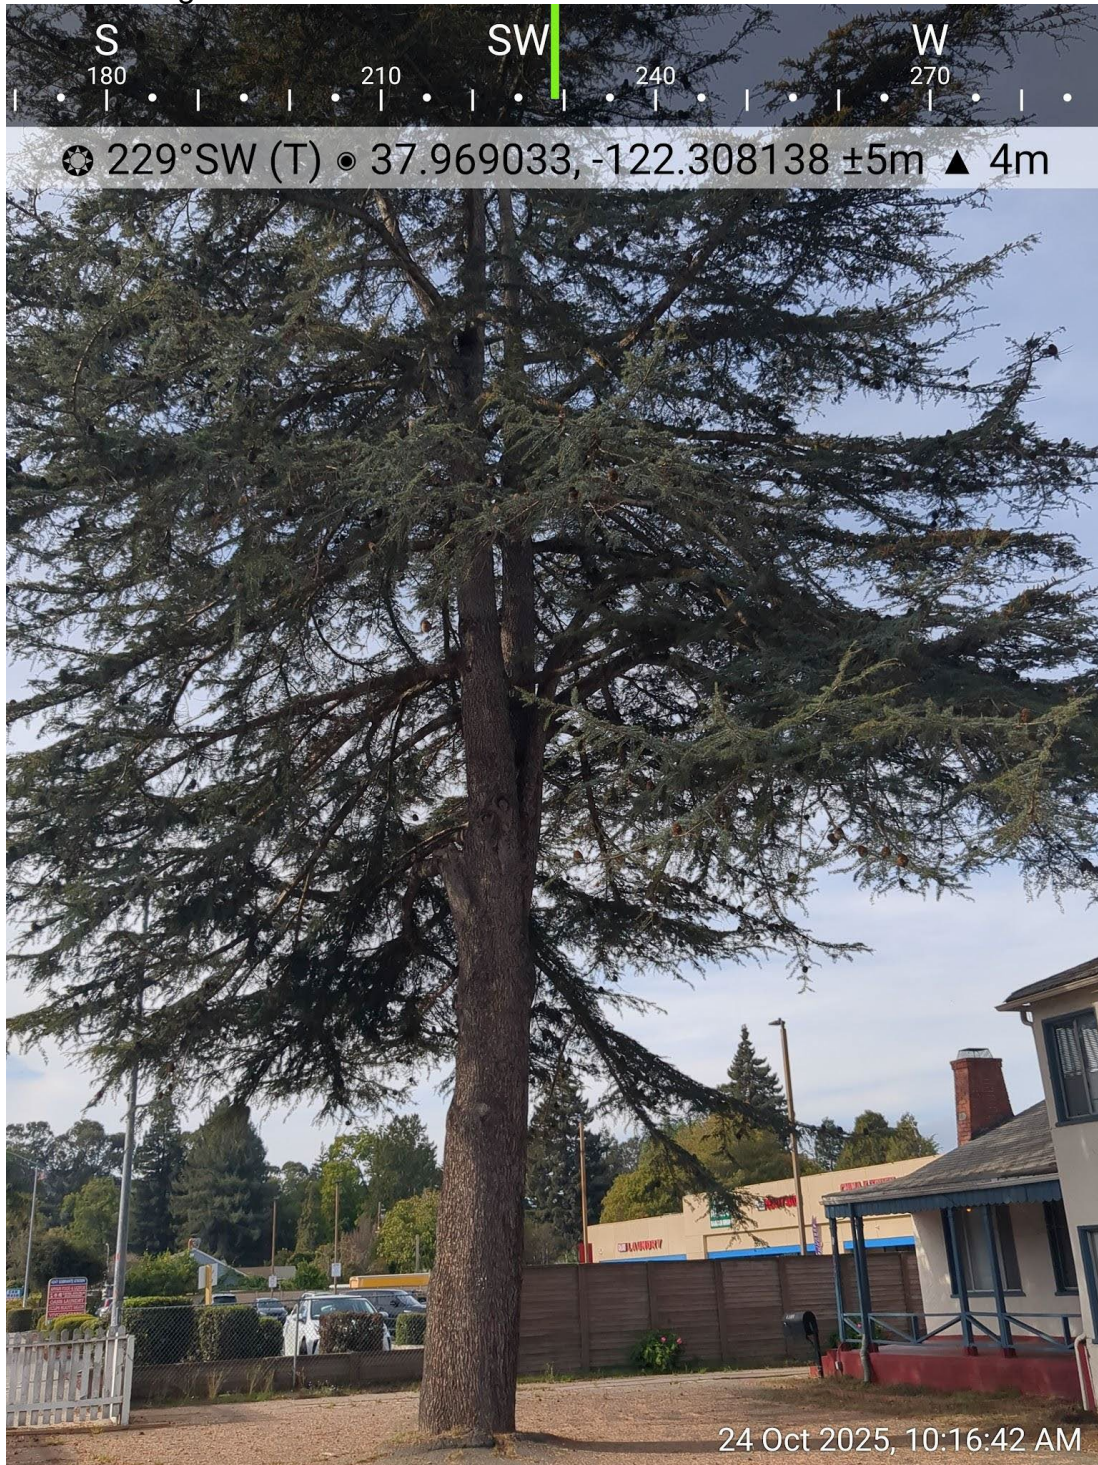
Photo 1. Tree 1, Deodar Cedar (*Cedrus deodara*) at south corner of property in front of main building.

- **Location:** South corner of property in front of main building.
- **Coordinates:** 37.9689601, -122.3082426
- **Height:** Approx. 70 ft
- **DBH (Diameter at Breast Height):** 30 inches
- **Dripline Radius:** 30 ft
- **Condition:** Fair
- **Observations:** Main trunk splits into codominant stems at about 30 ft from the ground. Soil compaction is present around root flare and the root zone due to foot traffic and pavement. Limbs overhang roofline of current main building.
- **Recommendation:** Removal. The tree falls fully within the planned construction limits and the planned location of Unit 1 falls within the tree's dripline.

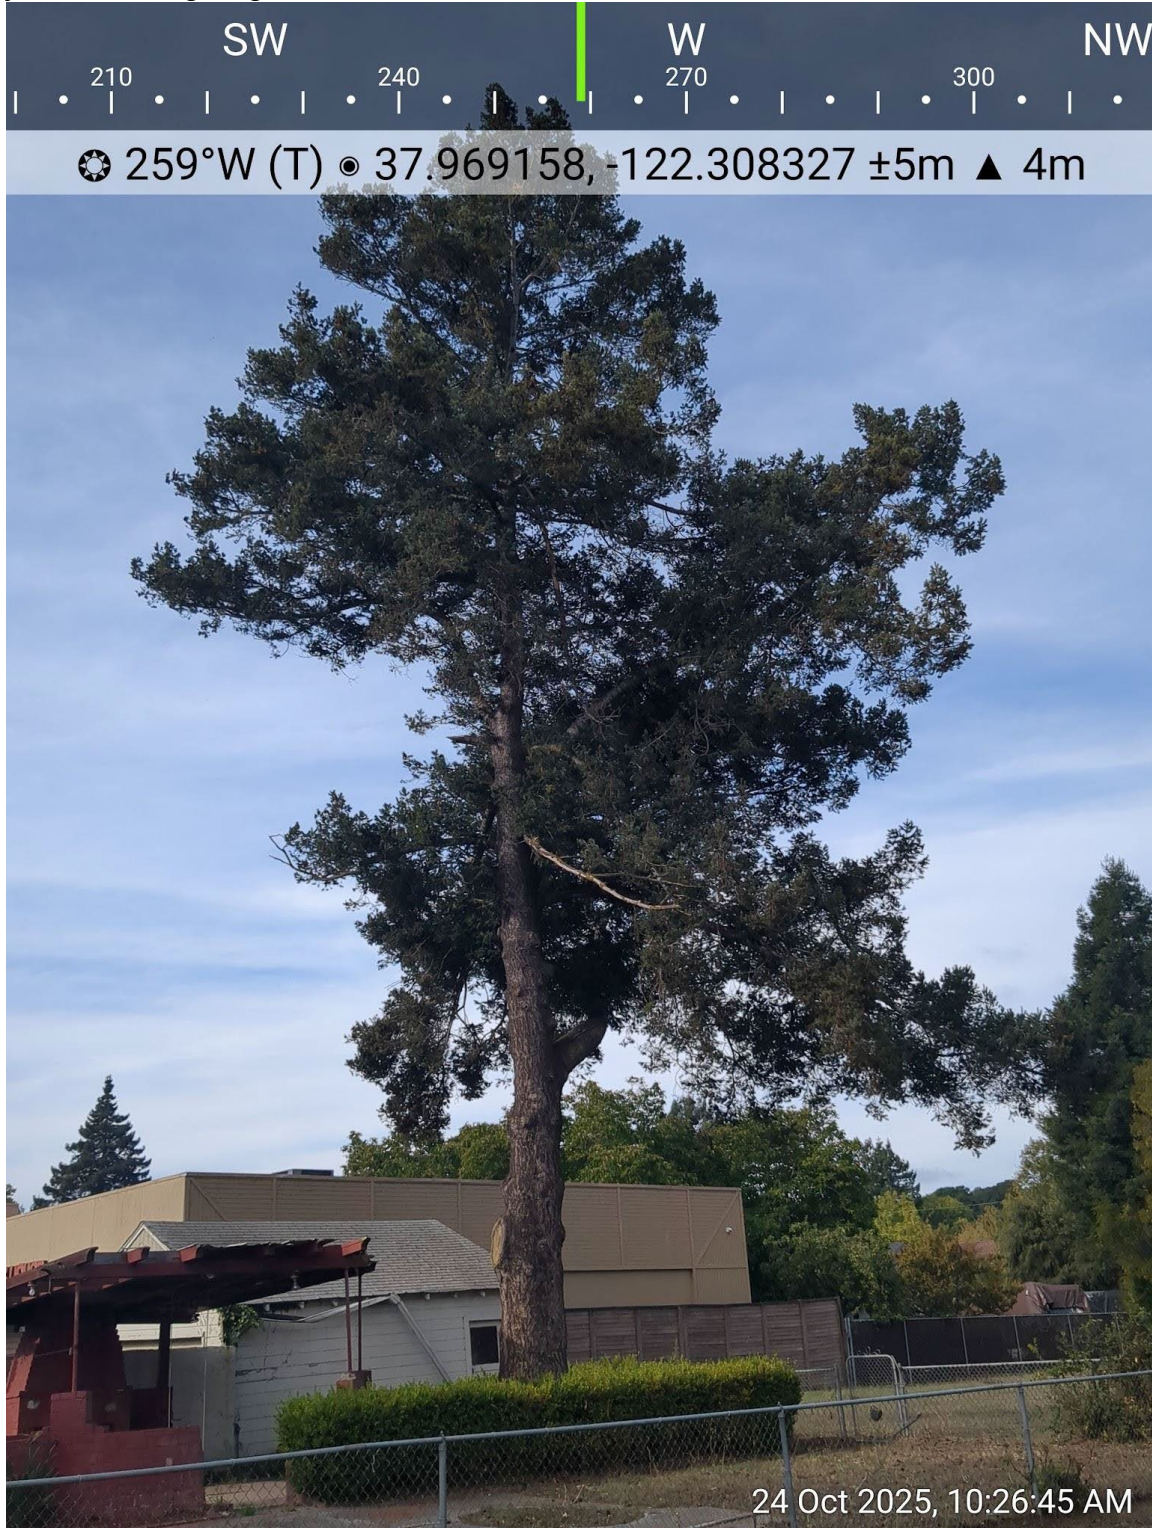
Photo 2. Tree 2, Douglas fir (*Pseudotsuga menziesii*), in backyard behind main building, just north of garage.

- **Location:** Backyard behind main building, just north of garage.
- **Coordinates:** 37.9691206, -122.3085470
- **Height:** Approx. 80 ft
- **DBH (Diameter at Breast Height):** 32 inches
- **Dripline Radius:** 20 ft
- **Condition:** Fair
- **Observations:** Canopy shows some signs of dieback. Soil compaction is present around root flare and the root zone due to foot traffic and pavement.
- **Recommendation:** Removal. The tree falls fully within the planned construction limits and the planned locations of Units 4 and 5.

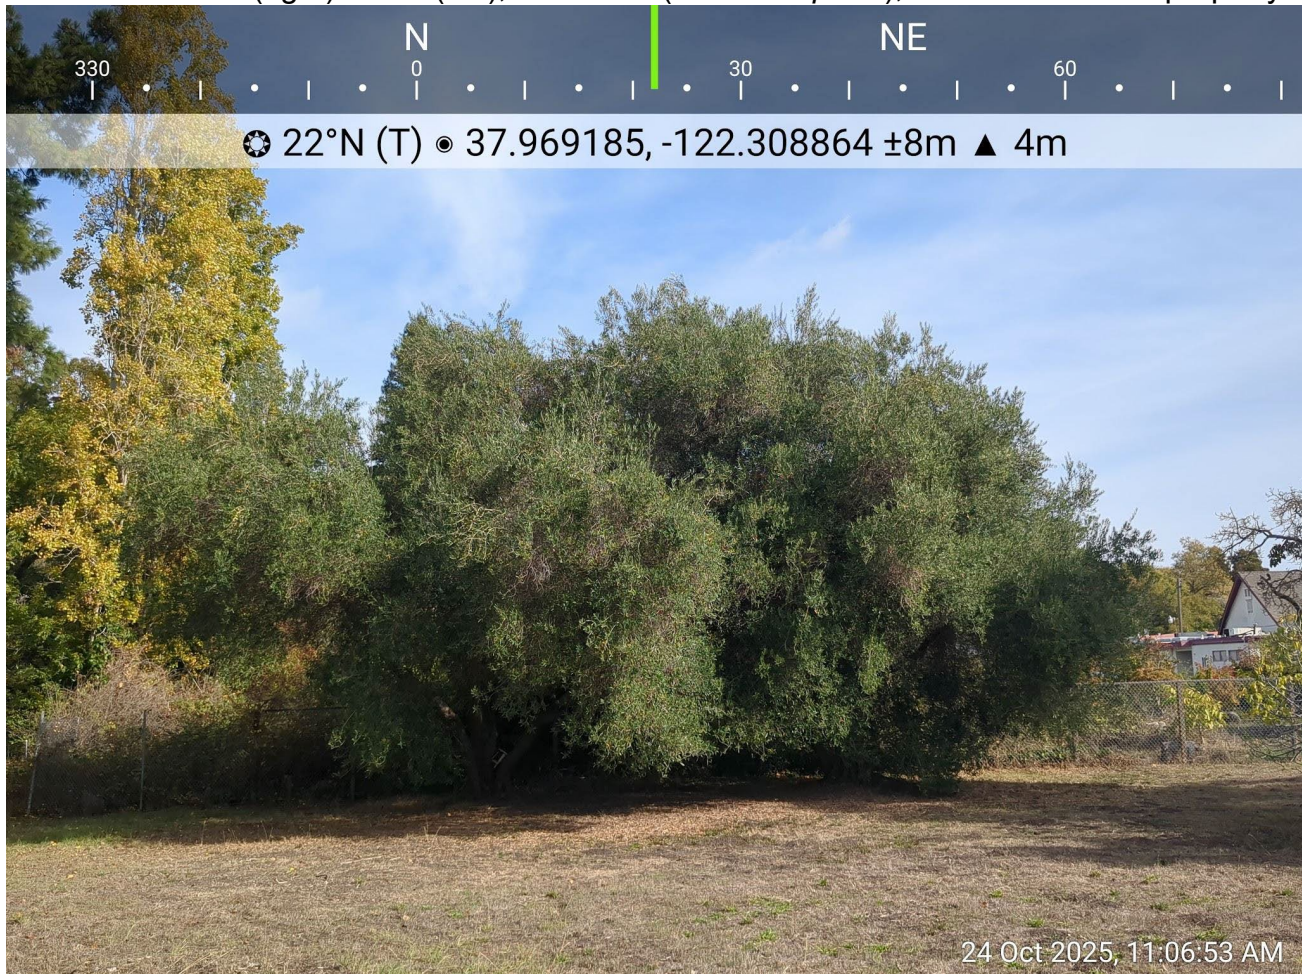
Photo 4. Trees 7 (right) and 8 (left), both olive (*Olea europaea*), at north corner of property.

- **Location:** North corner of property.
- **Coordinates:** 37.9693423, -122.3086825
- **Height:** Approx. 40 ft
- **DBH (Diameter at Breast Height):** 4x codominant stems, 7 inches, 7 inches, 7 inches, and 11 inches, respectively.
- **Dripline Radius:** 20 ft
- **Condition:** Good
- **Observations:** None.
- **Recommendation:** Removal. The tree falls partially within the planned construction limits and its dripline partially overlaps the planned location of Unit 8. The tree is unlikely to survive grading and soil compaction even if tree protection

- **Location:** North corner of property.
- **Coordinates:** 37.9693767, -122.3087901
- **Height:** Approx. 40 ft
- **DBH (Diameter at Breast Height):** 5x codominant stems, 7 inches, 9 inches, 7 inches, 6 inches, and 10 inches, respectively.
- **Dripline Radius:** 20 ft
- **Condition:** Good
- **Observations:** None.
- **Recommendation:** Removal. The tree falls partially within the planned construction limits and its dripline partially overlaps the planned location of Unit 8. The tree is unlikely to survive grading and soil compaction even if tree protection measures are implemented.

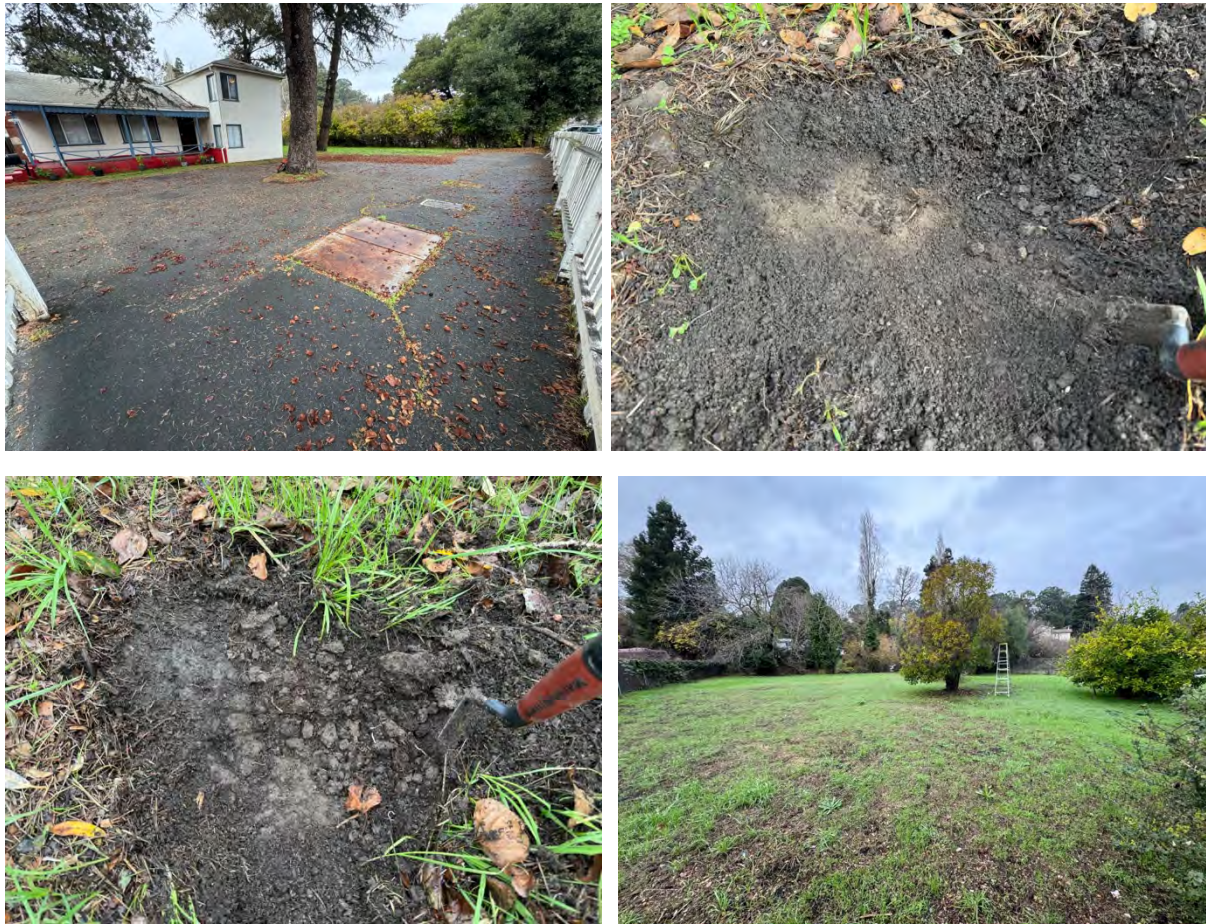
Alexi Atteberry surveyed the area of potential effect (APE) at 4301 Appian Way on December 28, 2023. Mr. Atteberry is a qualified archaeologist with nearly 10 years of experience in California archaeology. The project area was surveyed in approximately 10-meter transects. The majority of ground surface within the project area was unpaved and soil exposure using a hand trowel was conducted throughout the transects.

*Figure 5: clockwise from left: overview from southeast corner of project area, looking northwest; soil exposure in the northeast corner; overview of western part of parcel, looking west; soil exposure in the northwest area.*

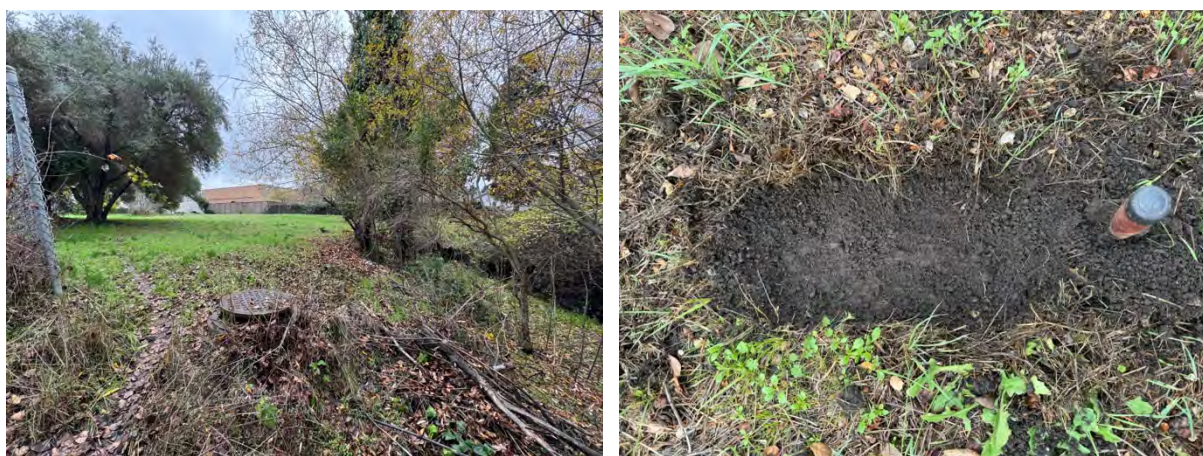
Ground visibility of was good, except for the southeast part of the property, where a single-family home and driveway are located. Most of the project area is covered with grass and small trees, with moderate obstruction of view near the creek due to a heavy growth of English ivy (*Hedera helix*). Due to significant rainfall prior to survey, observed soils fell within range of damp to wet, affecting the Munsell color reading. Throughout the project area, the soil type was observed as a loam with rock inclusions ranging from 10% in the majority of the survey area to approximately 20% in the west-northwest part of the property near the creek bank. In the northeast corner the soil color was a very dark grayish brown (Munsell 10YR 3/2) with low moisture, transitioning to a very dark brown (Munsell 10YR 2/2) loam with increased moisture in the northwest; and finally a black (Munsell 10YR 2/1) loam in the southwest area.

*Figure 6: at left, overview from the northwest corner, looking southeast; at right, soil exposure in the center of the project area.*

Observed materials throughout the project area include brick fragments and other building debris such as nails and wood, as well as modern refuse near the creek. No cultural material from the historic or prehistoric periods was observed throughout the project area.

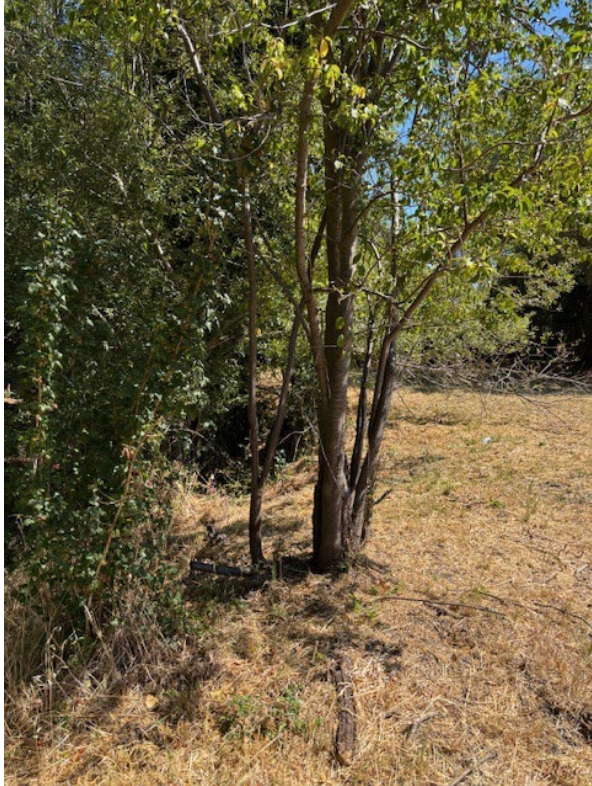
Photo 4. Appian Creek Riparian Corridor. Facing north.
