ARBORIST REPORT

Prepared For: Craig & Caitlin Hornsby
15 Morningside Place
Alamo, CA 94507

SUPPLEMENTAL REPORT

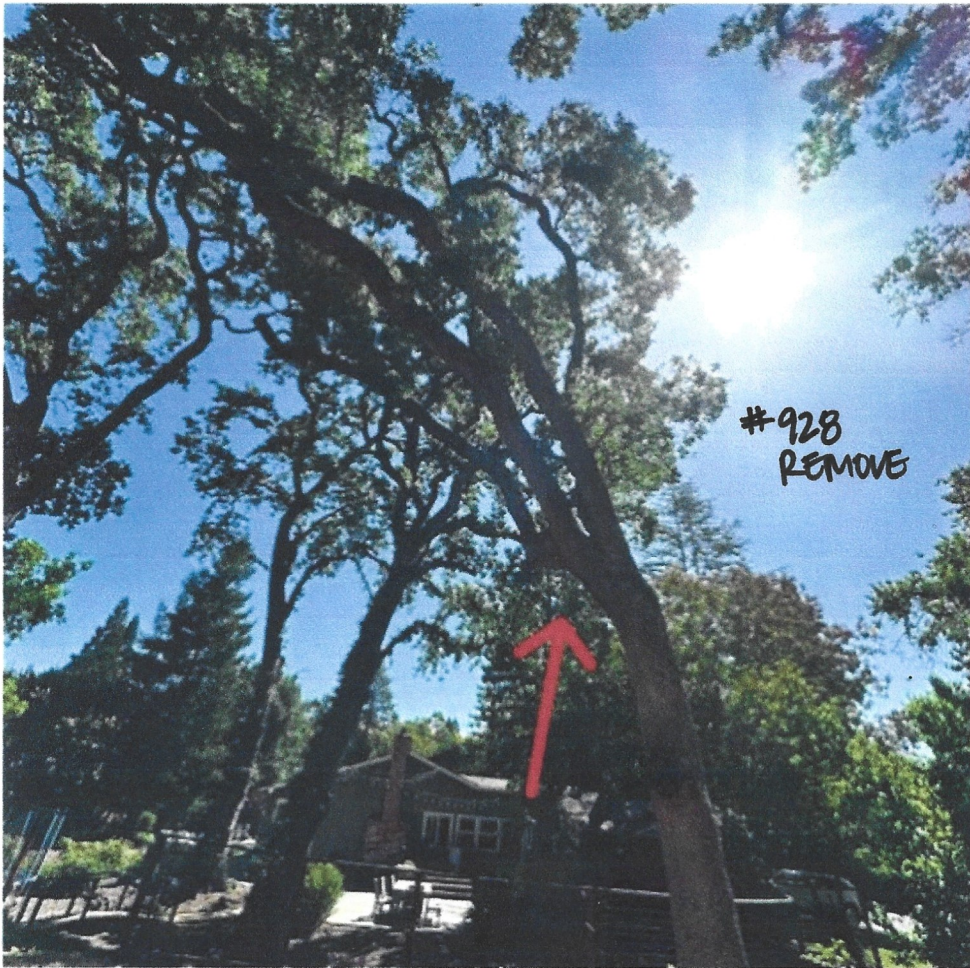
#928
REMOVE

Tree Specifications #928:

Condition: Poor

Location: Backyard crowded between 2 mature Oaks

- This tree is overcrowded by two trees which has caused it to grow with an excessive lean. Due to the above and its poor structure I recommend this tree be removed.
