Contra Costa County Zoning Administrator

1. PUBLIC COMMENTS
2. VARIANCE: CONTINUED PUBLIC HEARING

NEW RESIDENCE
 1518 BARTH AVE, SAN PABLO, CA 94806
 APN 419192015

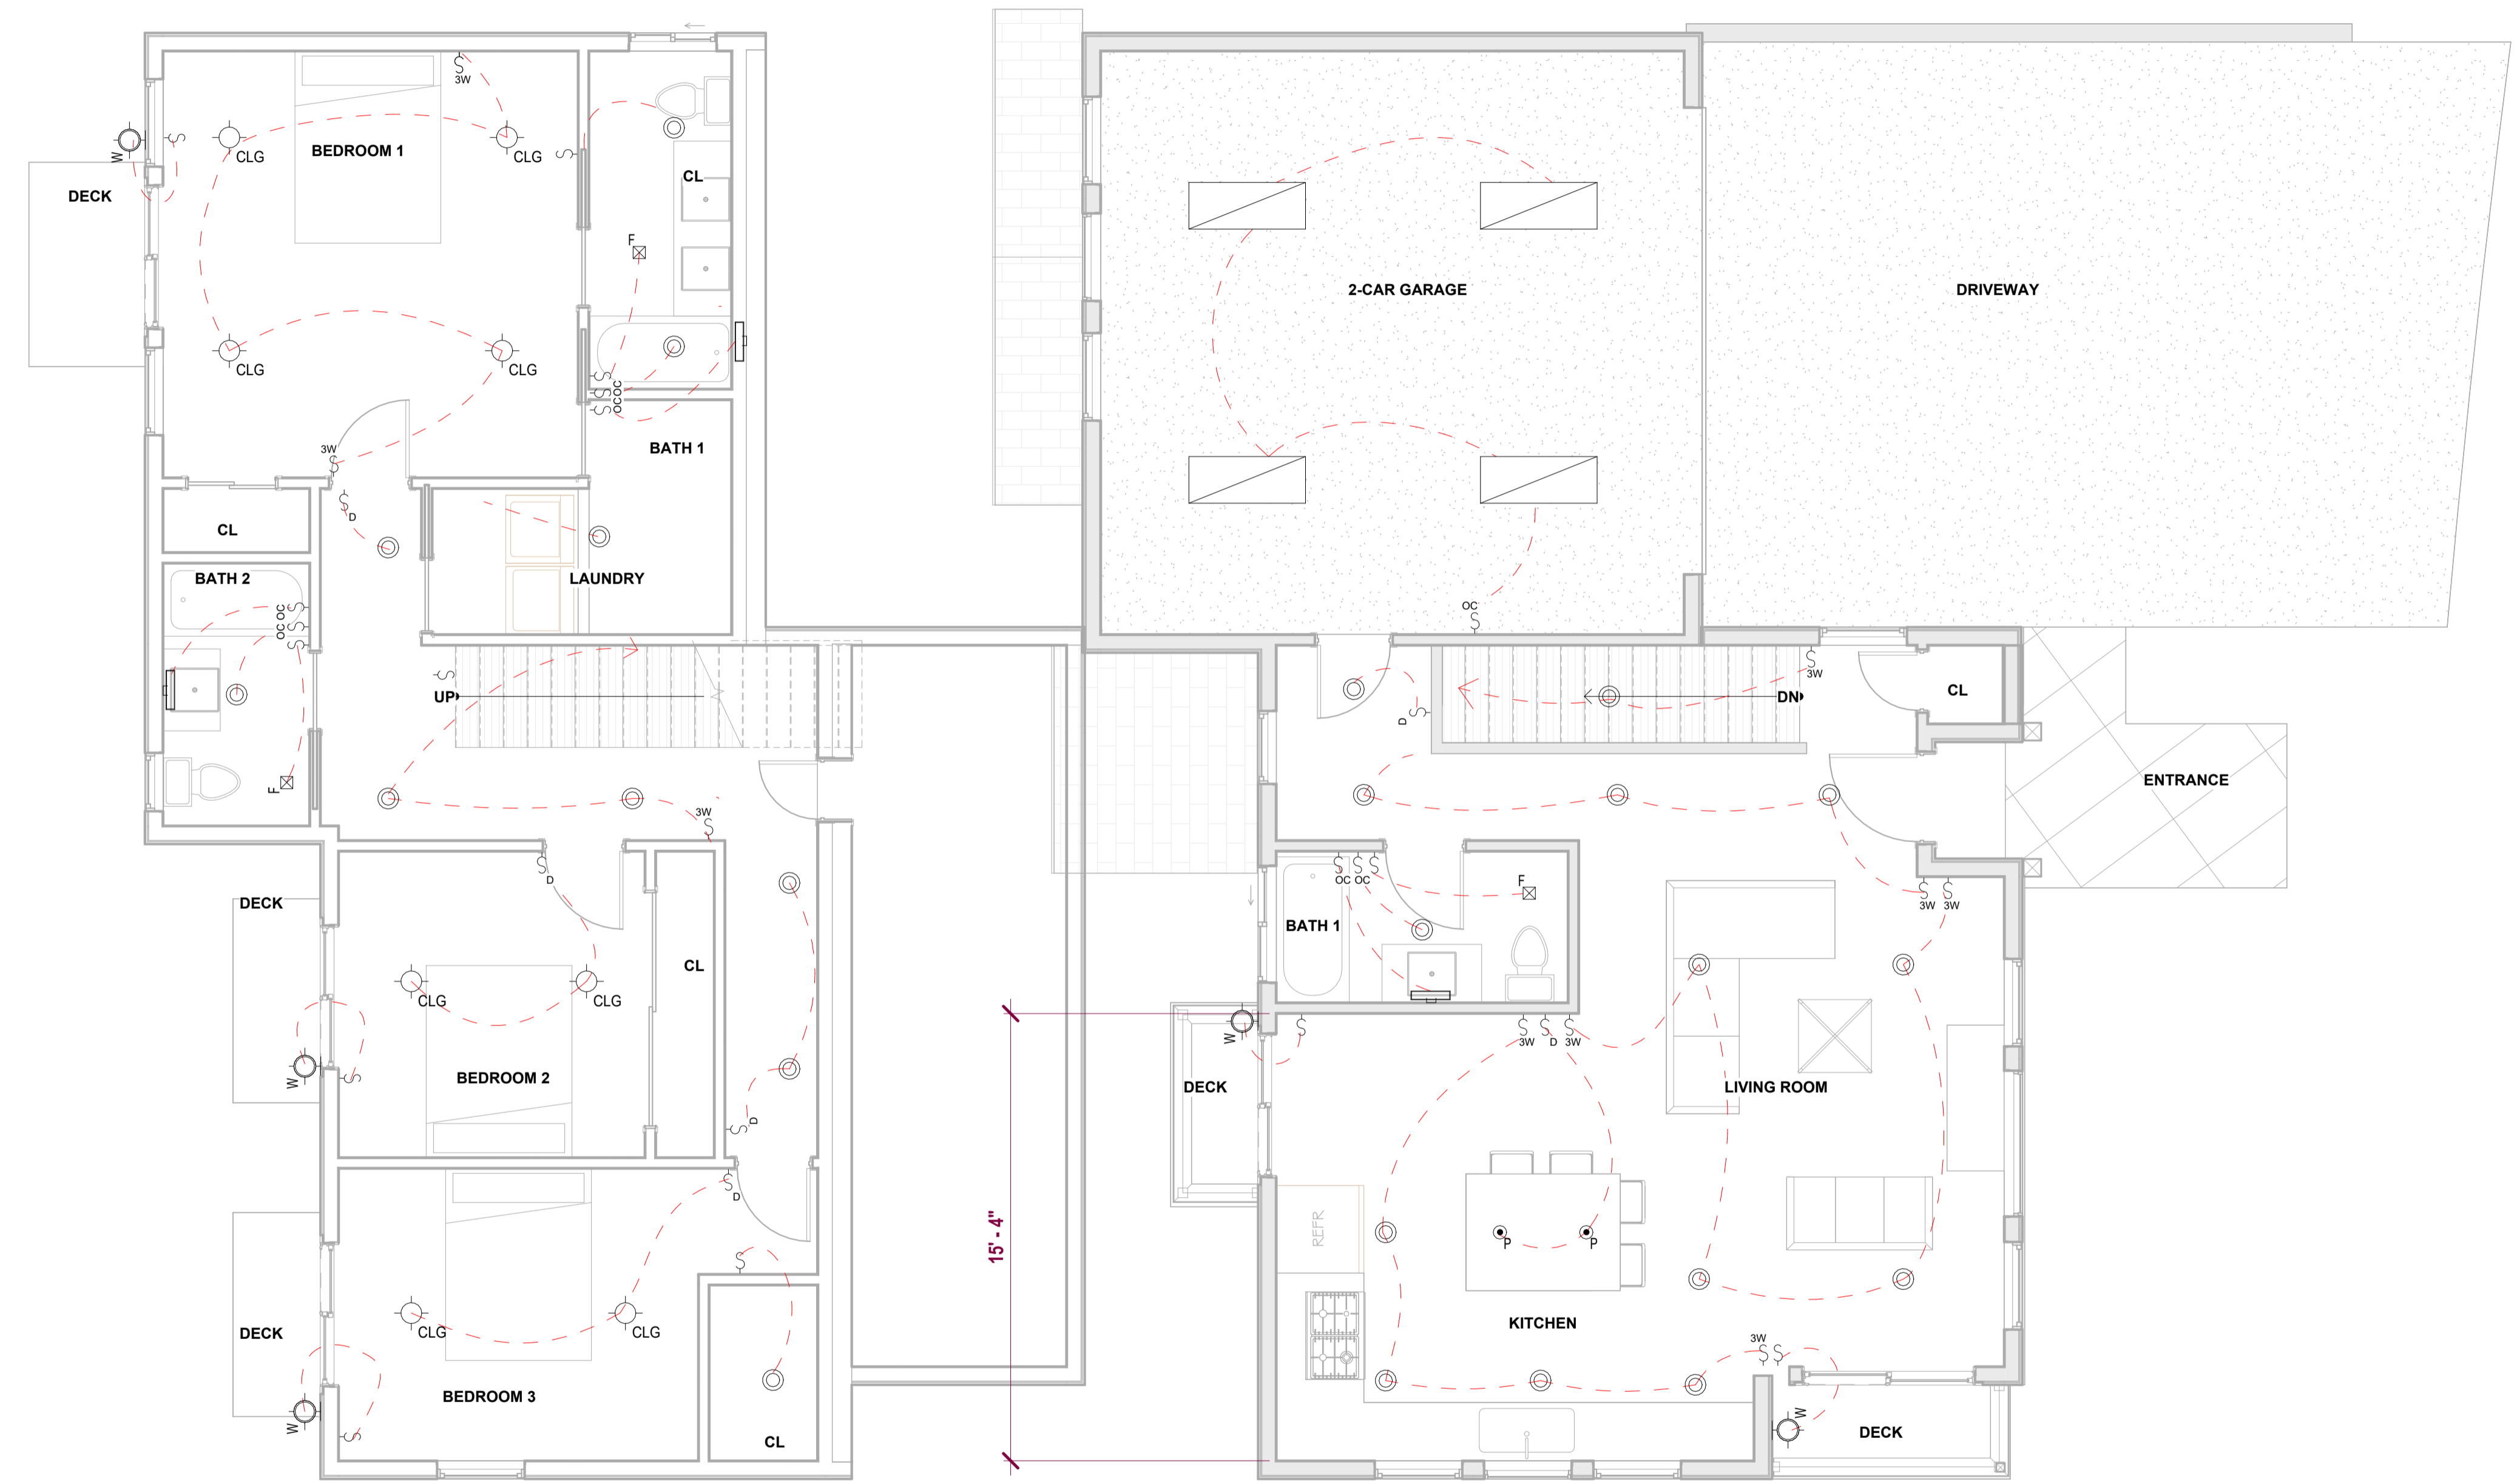
2 LOWER LEVEL ELECTRICAL PLAN
1/4" = 1'-0"

1 FIRST FLOOR ELECTRICAL PLAN
1/4" = 1'-0"

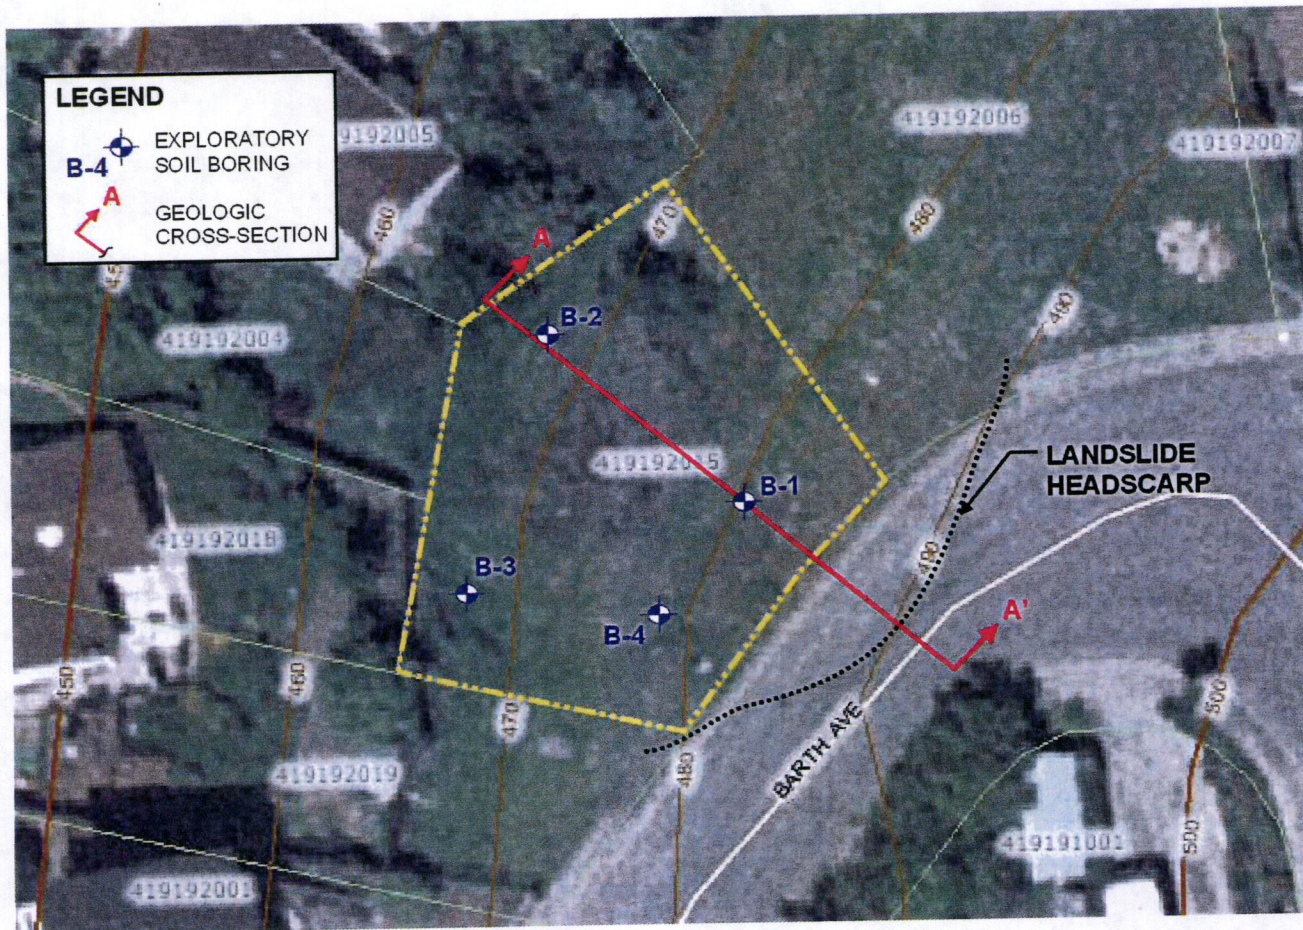
FIGURE 3

SOURCE: CONTRA COSTA COUNTY GIS

The subsurface conditions in the vicinity of the proposed new residence were explored by drilling and sampling four exploratory borings. The exploratory drilling was performed on 12 July 2007, using a "Minuteman" portable-type drilling rig equipped with 4-inch diameter solid stem, continuous flight augers. The borings were drilled to depths between 14.5 and 26.5 feet below the existing grade. Drive samples of the site materials were obtained using California Modified (CM) and Standard Penetration (SPT) samplers. The samplers were advanced using a 140-pound hammer with a free fall drop of 30 inches. The number of blows required to drive each of the samplers 6 inches was recorded and the uncorrected blow counts are shown on the boring logs in Appendix A. Samples obtained from the borings were retained for possible laboratory testing and analyses. The approximate locations of the borings are shown on Figures 3 and 4.
