April 24, 2025 rev. July 22, 2025

1850 ALAMEDA DIABLO **Historic Resource Evaluation**

The following report summarizes and develops the subject property's historical resource status for the purposes of applying for the Mills Act's historic preservation tax incentive.

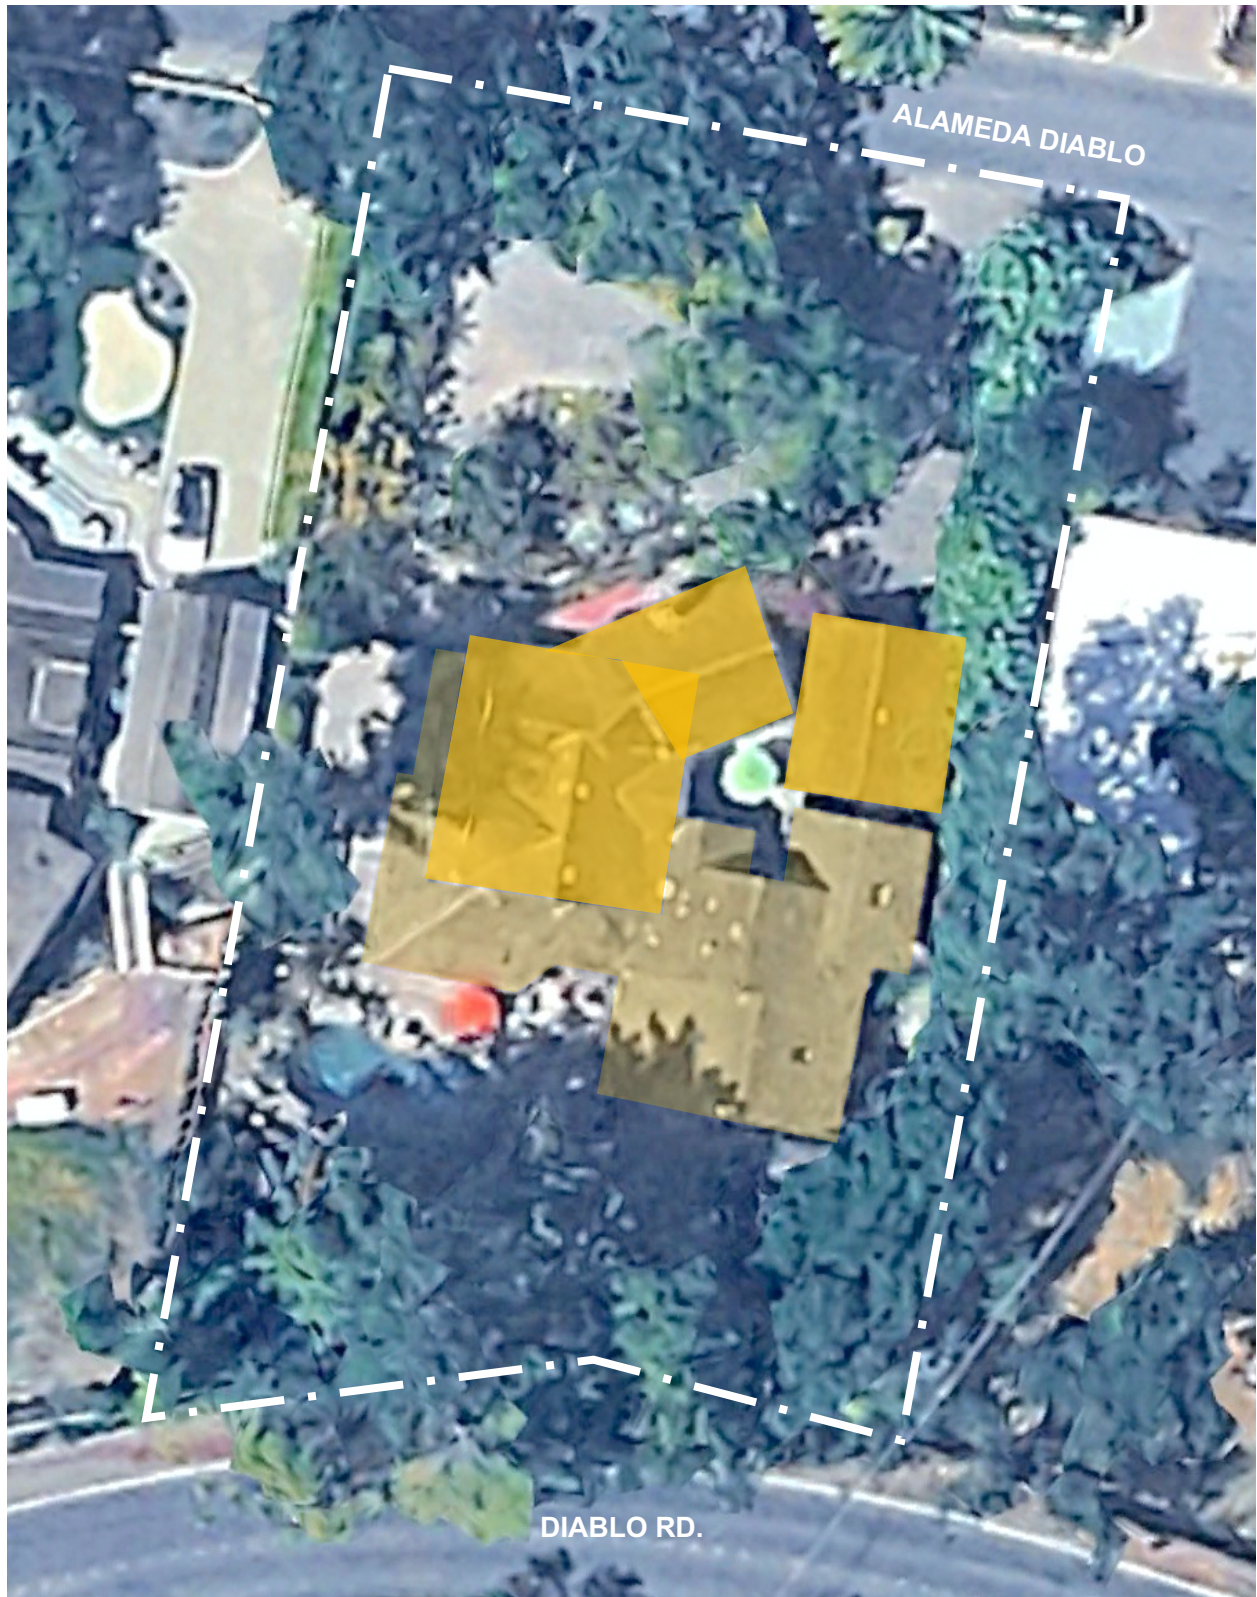
Fig.5 – 1850 Alameda Diablo – Site aerial depicting original house and carport (bright orange) with rearward additions (north is up)

Site and Exteriors (figs.5-24, sketch plan fig.31)

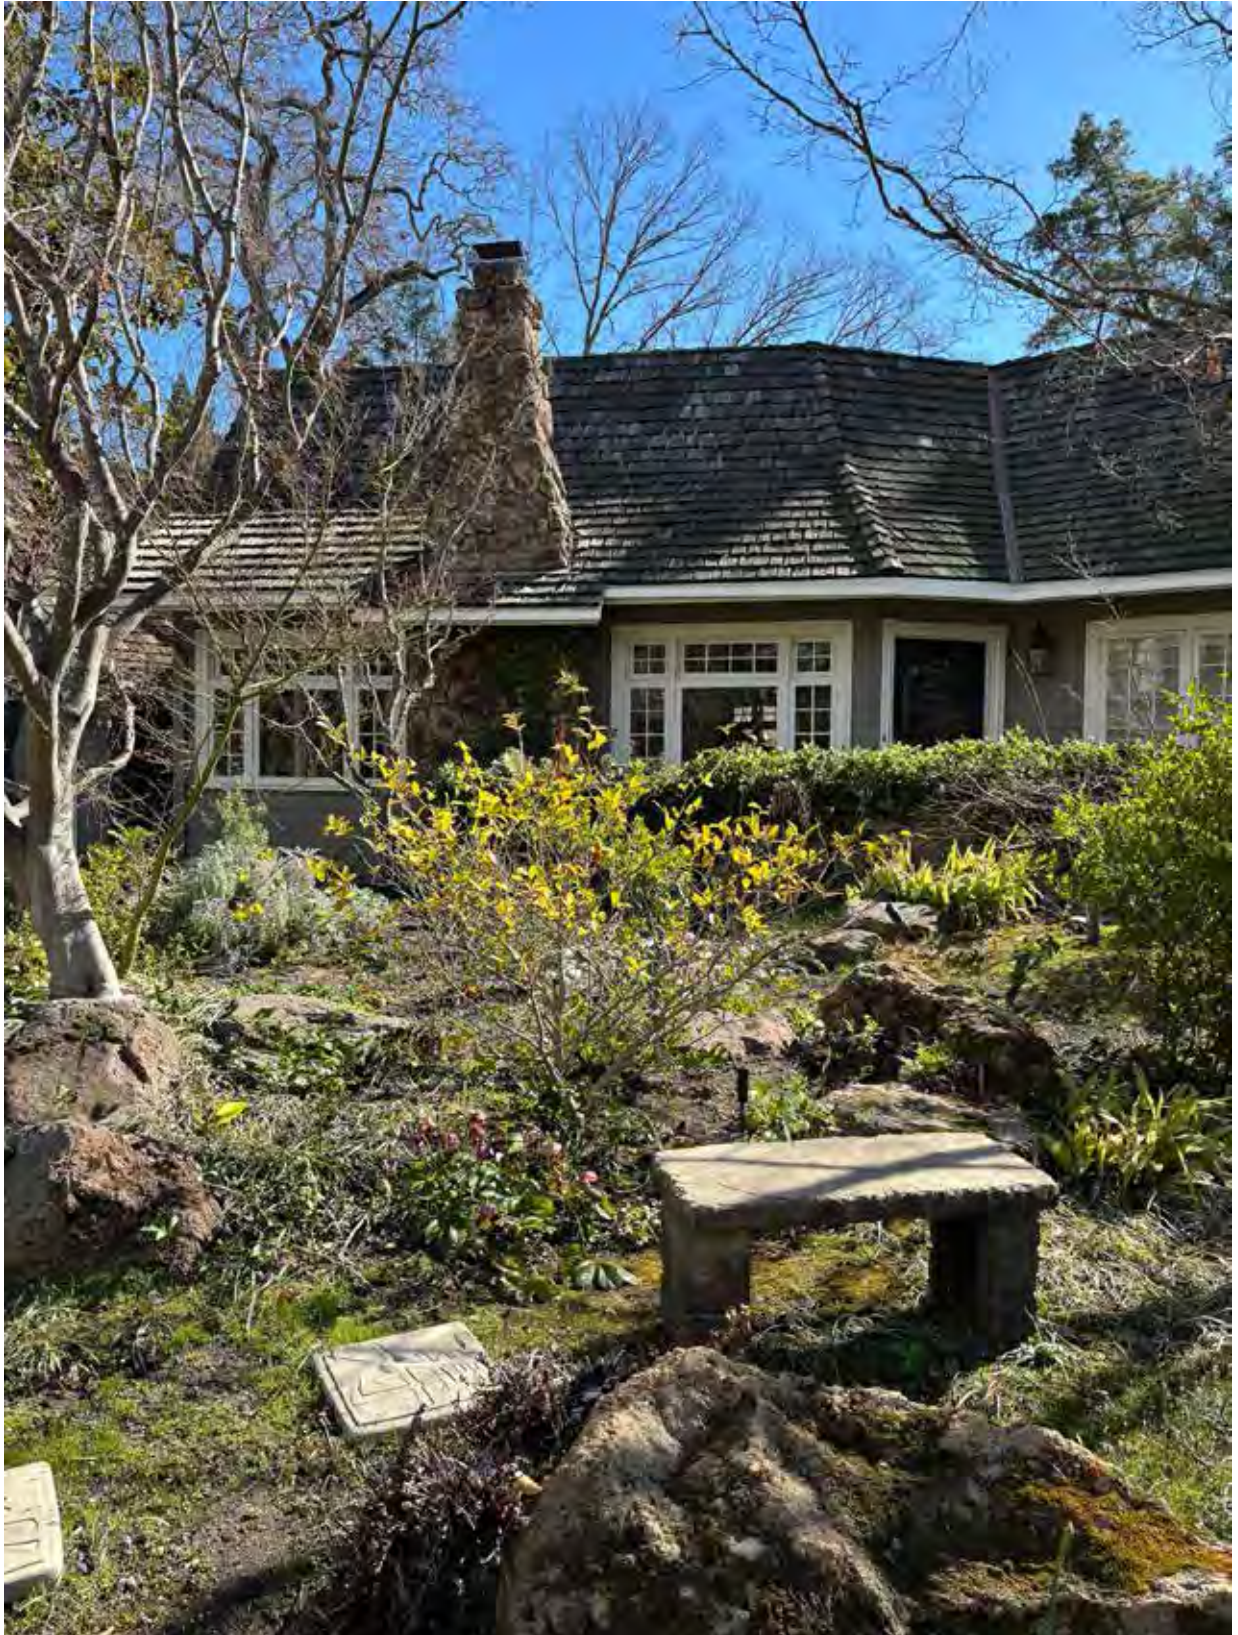
Fig.8 – 1850 Alameda Diablo – Canted front (north) façade and front garden, looking south

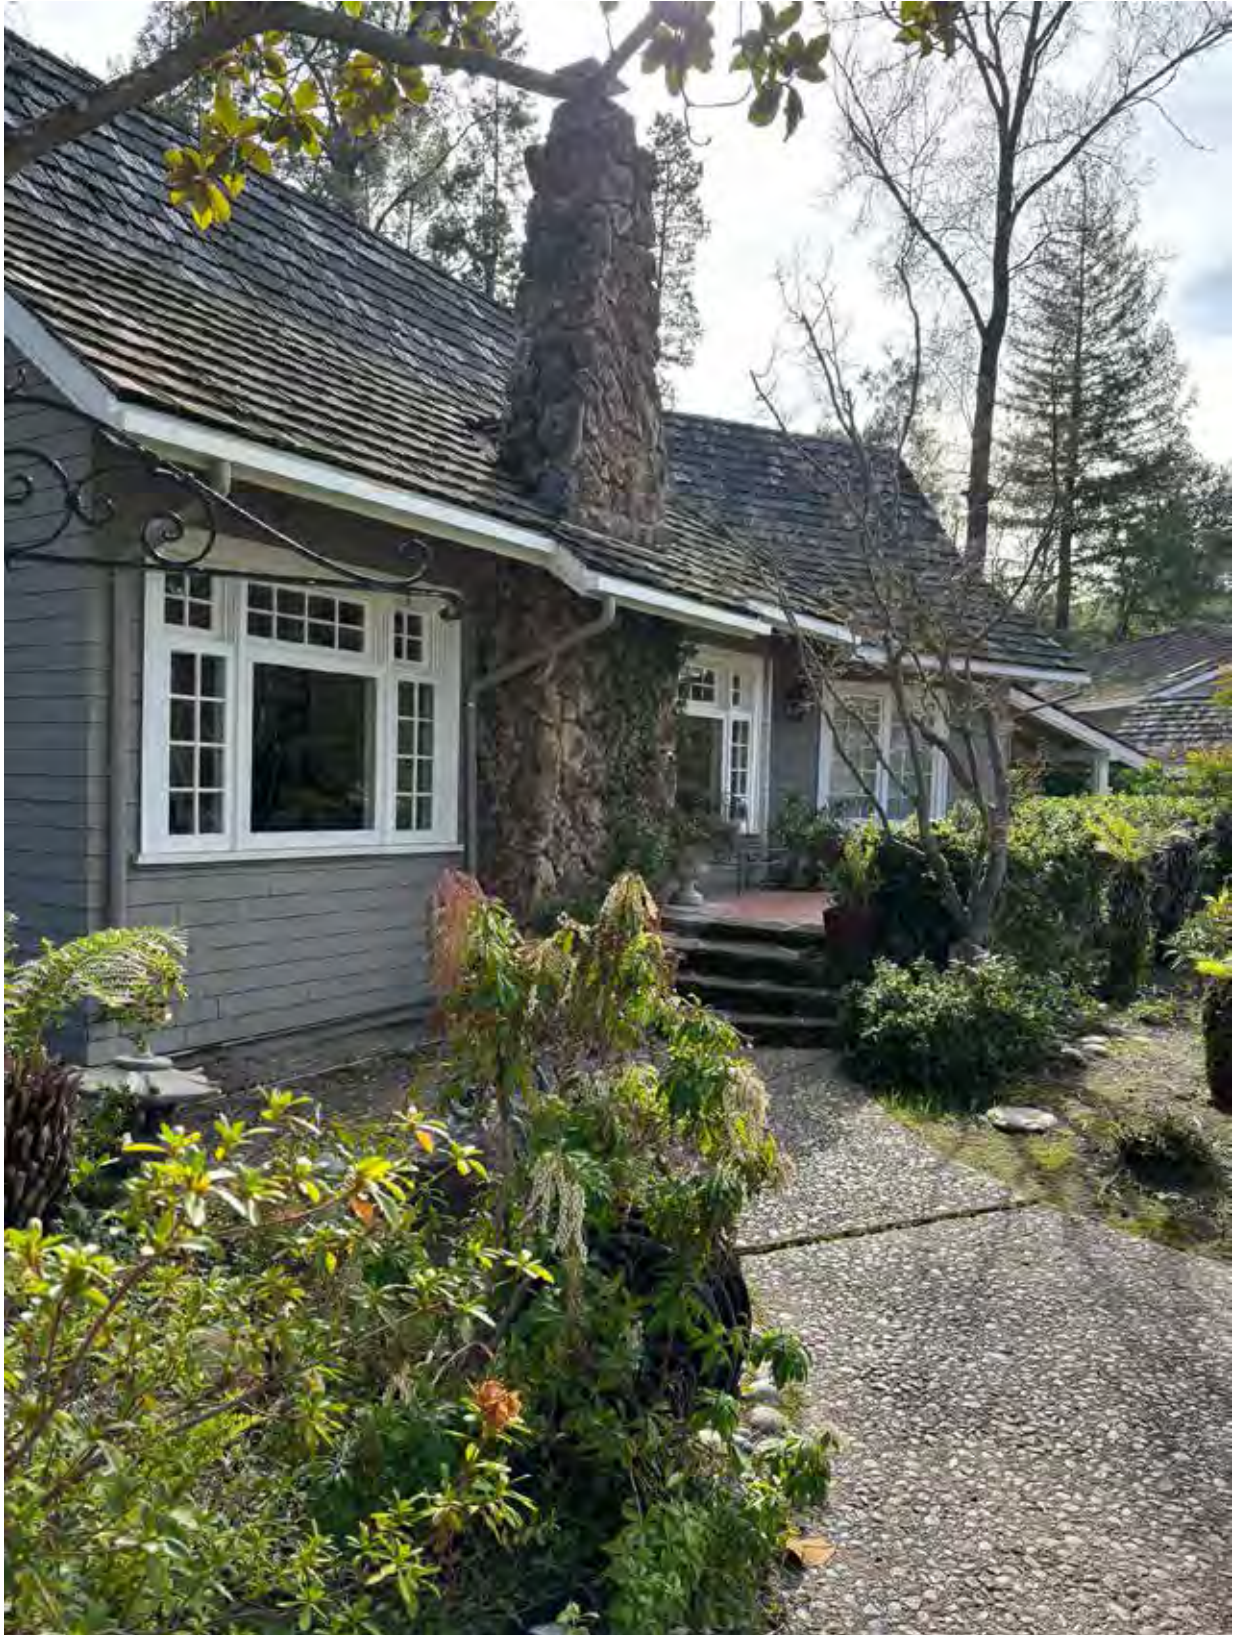
Fig.9 – 1850 Alameda Diablo – Canted front (north) façade and walks, looking southwest

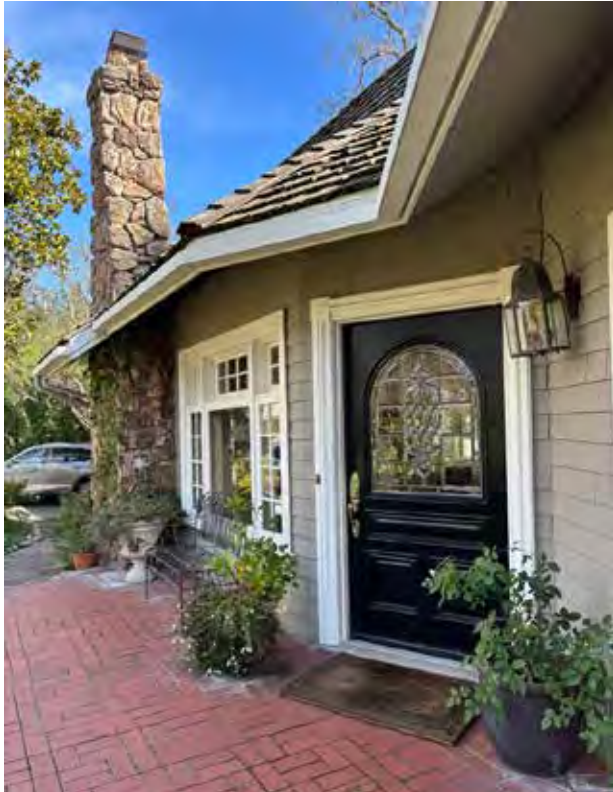
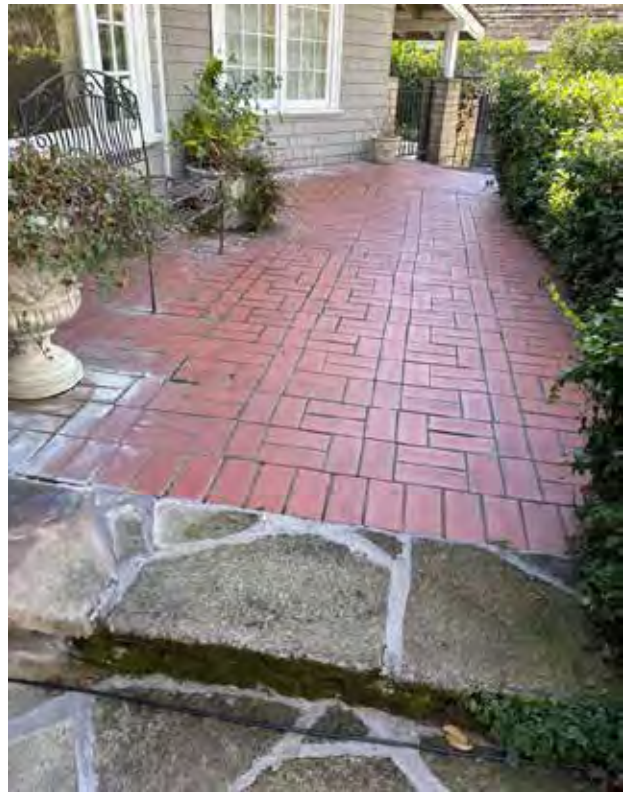
Figs.10-11 – 1850 Alameda Diablo – Canted front façade and entry (left); Front entry terrace (right)

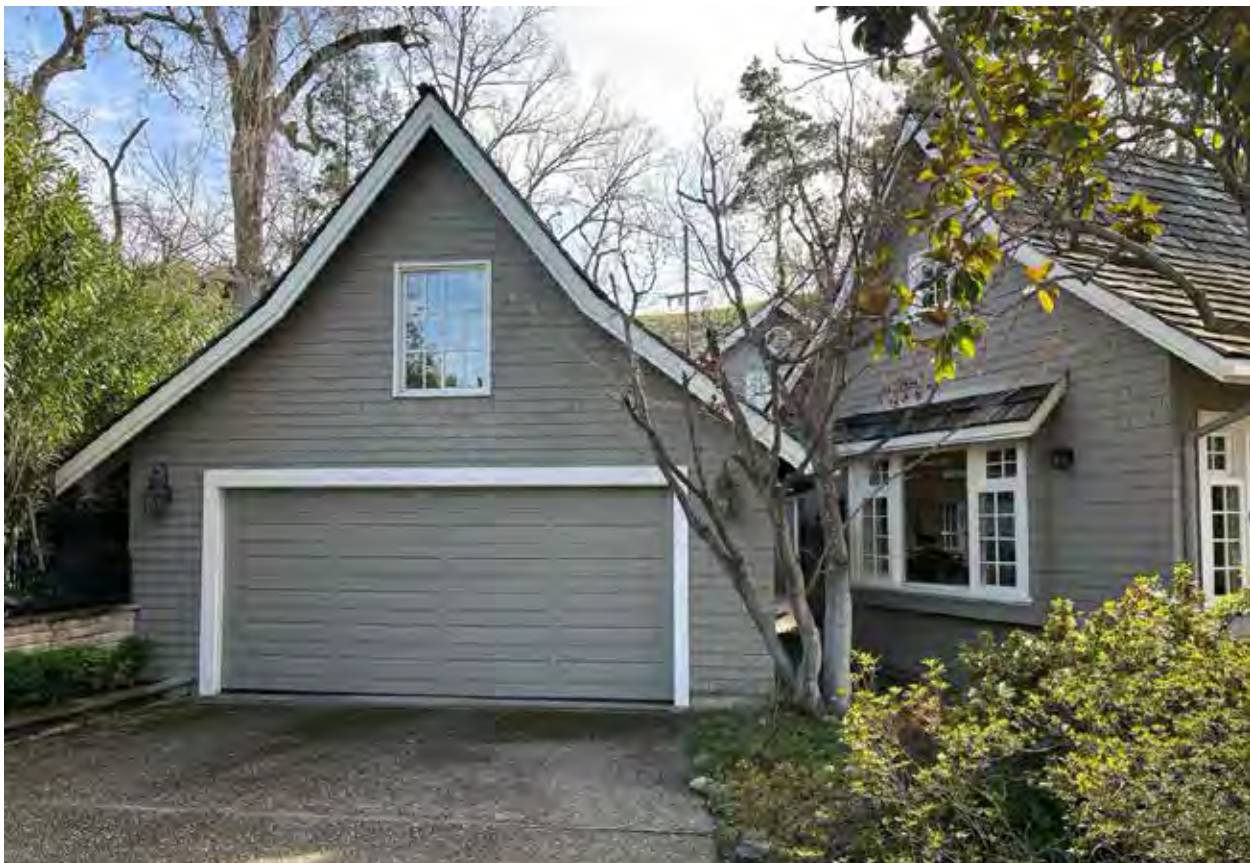
Fig.12 – 1850 Alameda Diablo – Garage front and east side of living room wing

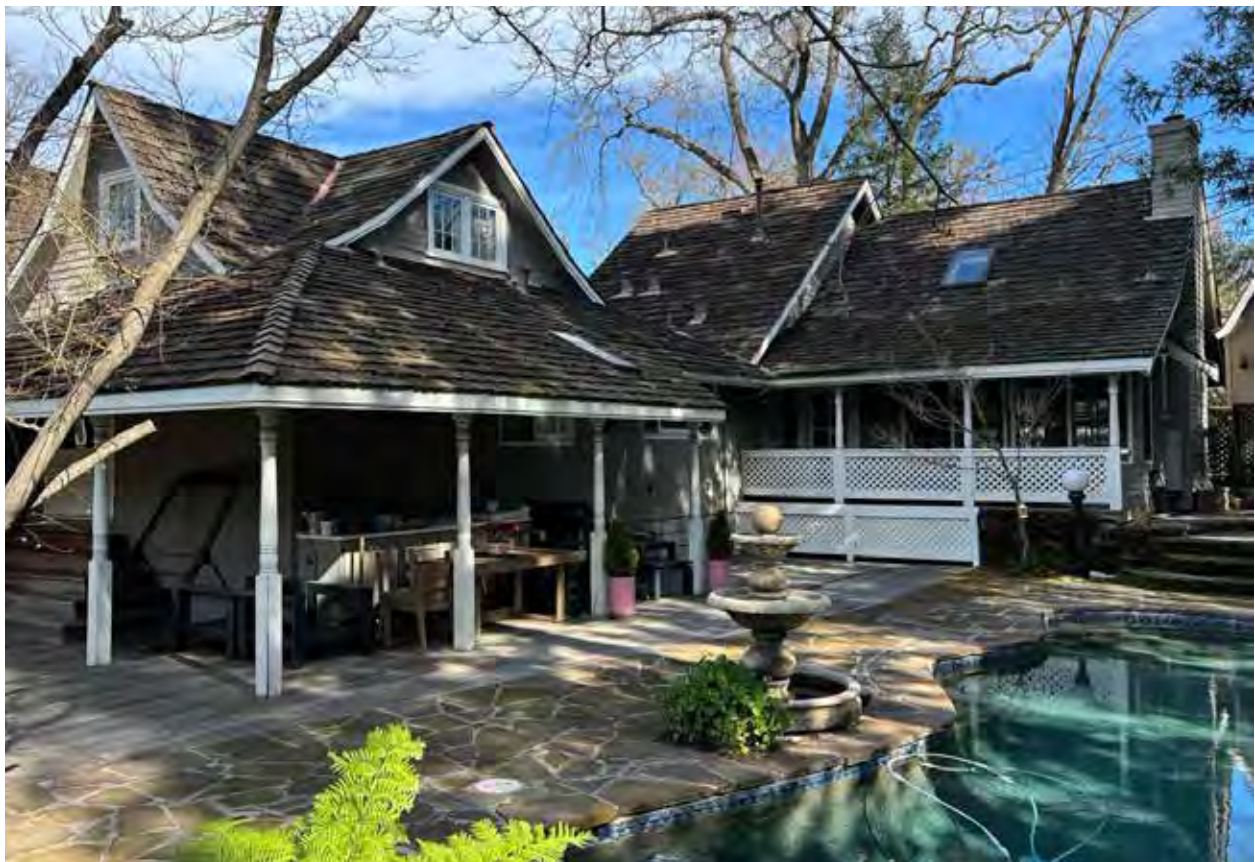
Fig.14 – 1850 Alameda Diablo – Rear of house (left and center) and family room wing (right)

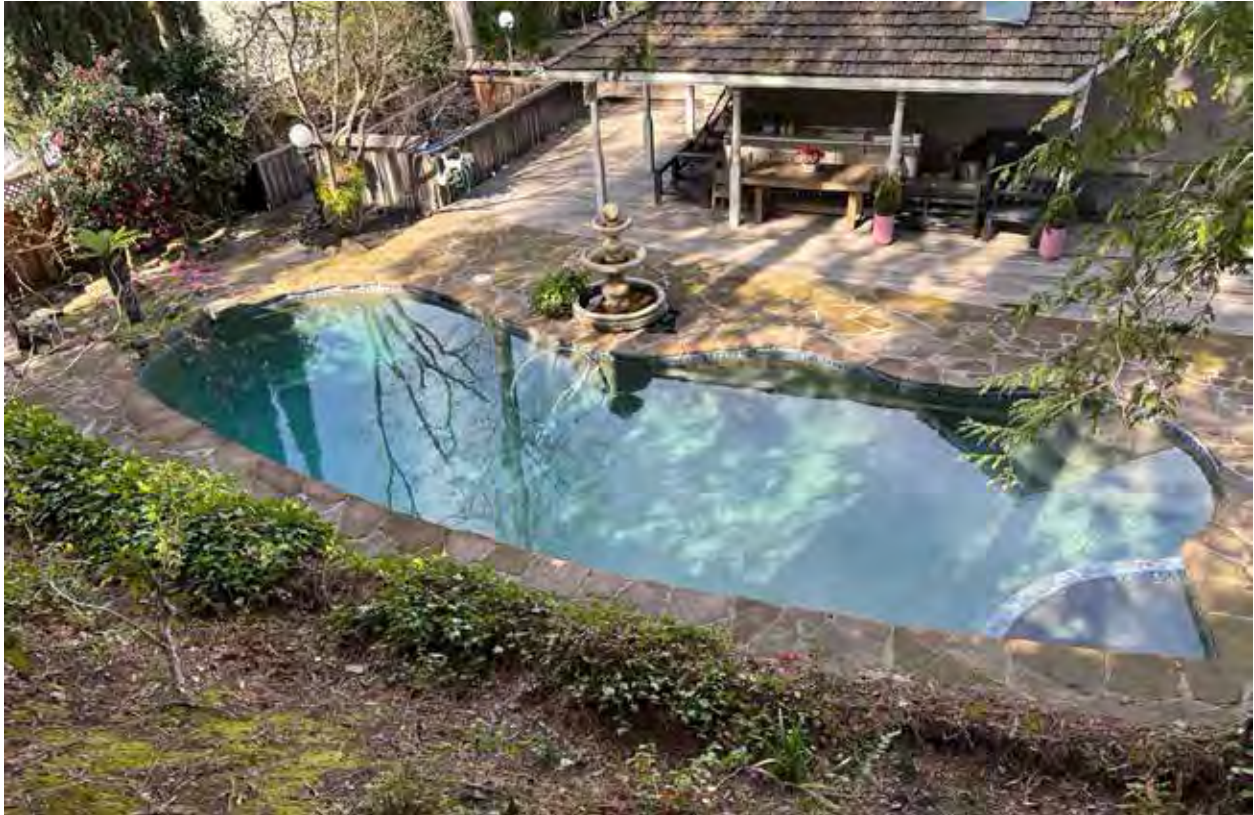
Fig.17 – 1850 Alameda Diablo – Rear of house with creek deck, creek portal and bridge (at upper left) and pool

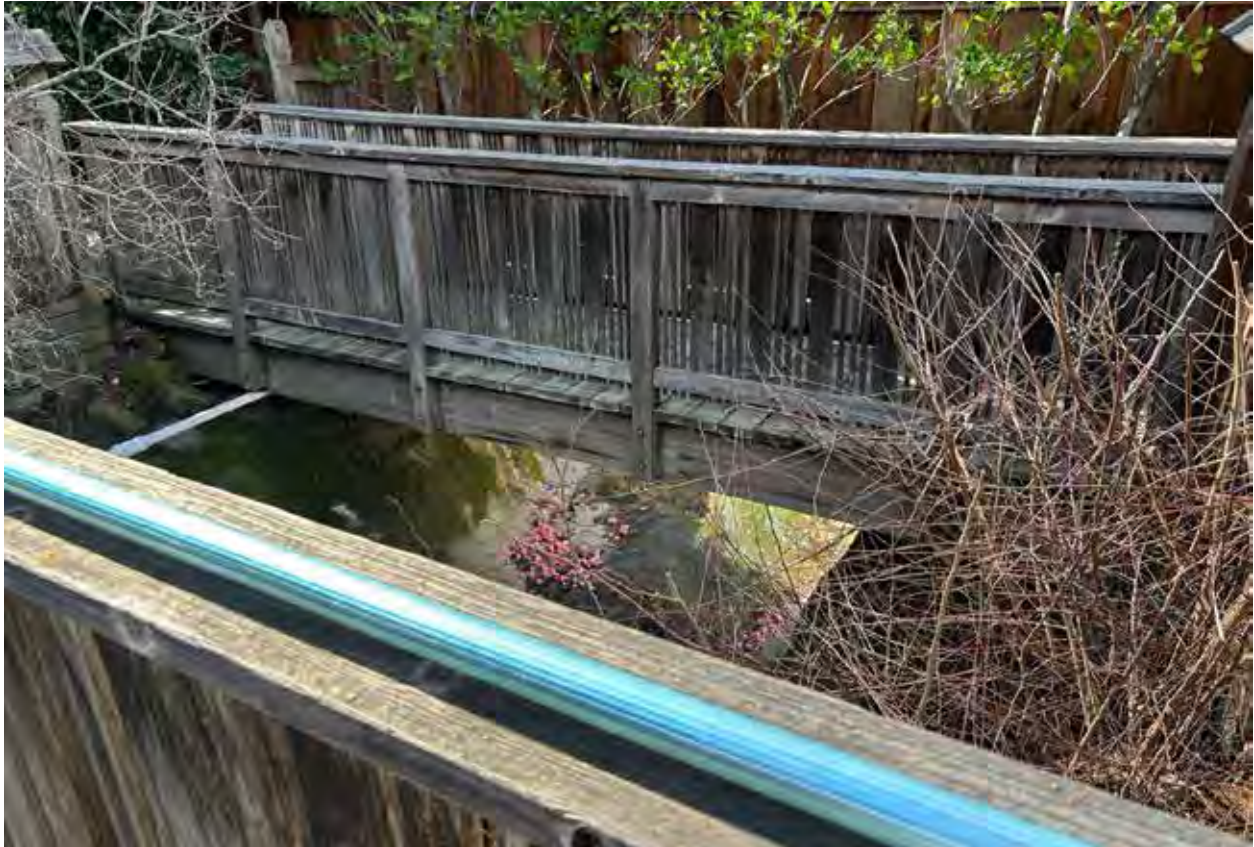
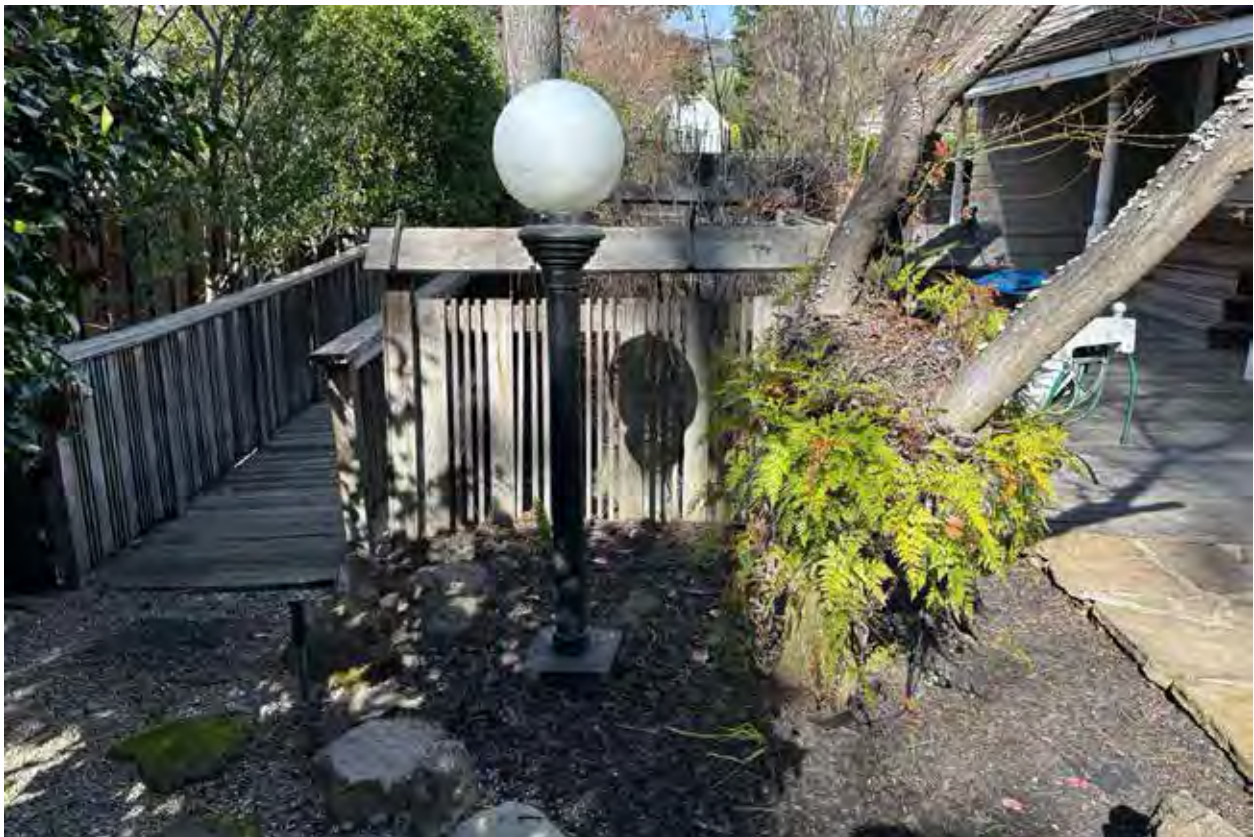
Figs.20-21 – 1850 Alameda Diablo – Creek portal and bridge

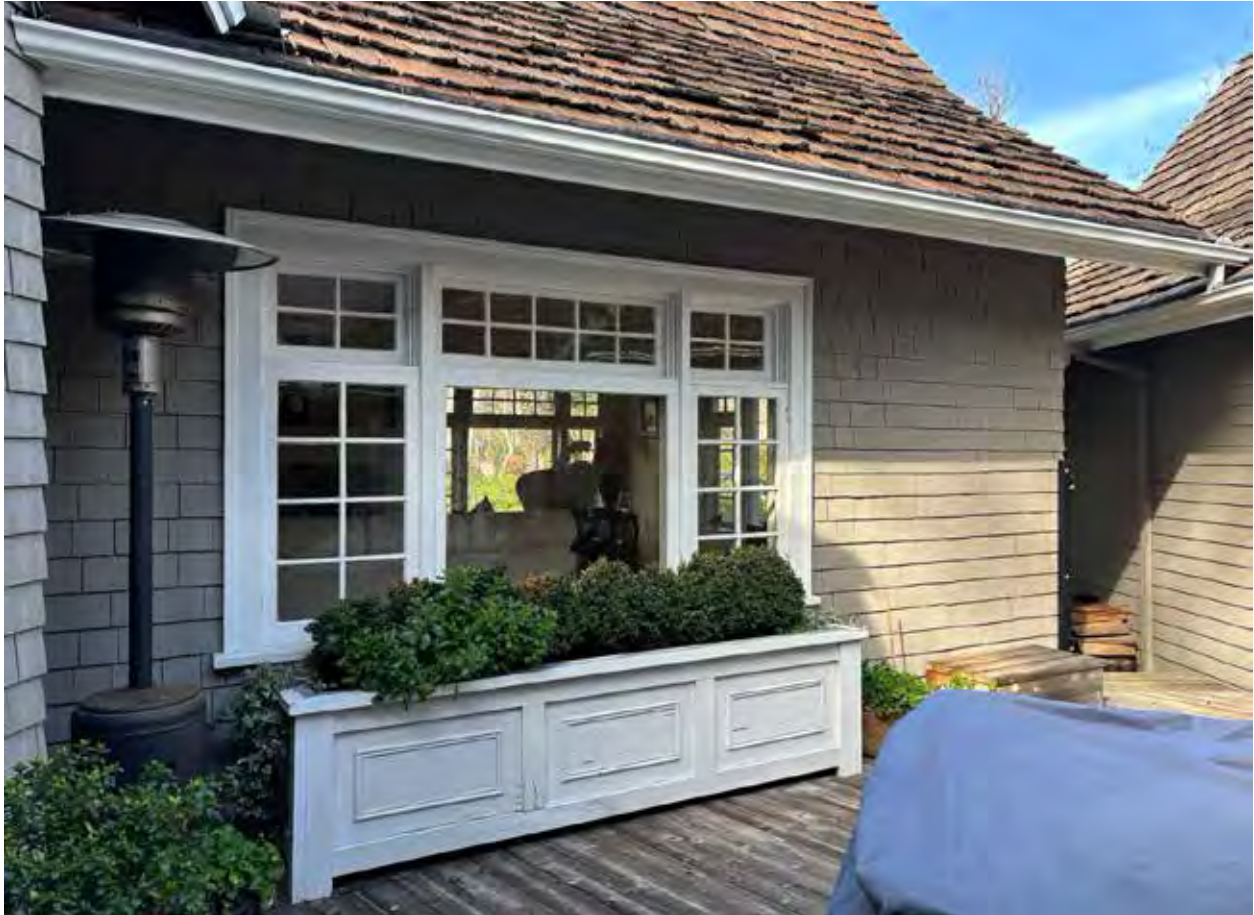
Fig.22 – 1850 Alameda Diablo – South side, living room wing from interior court
